How to Avoid Installation Errors When Installing Slate Roofs

**ARCHITECTS AND INSTALLERS
SEMINAR SERIES**

Slate Roofing Contractors Association of North America, Inc.

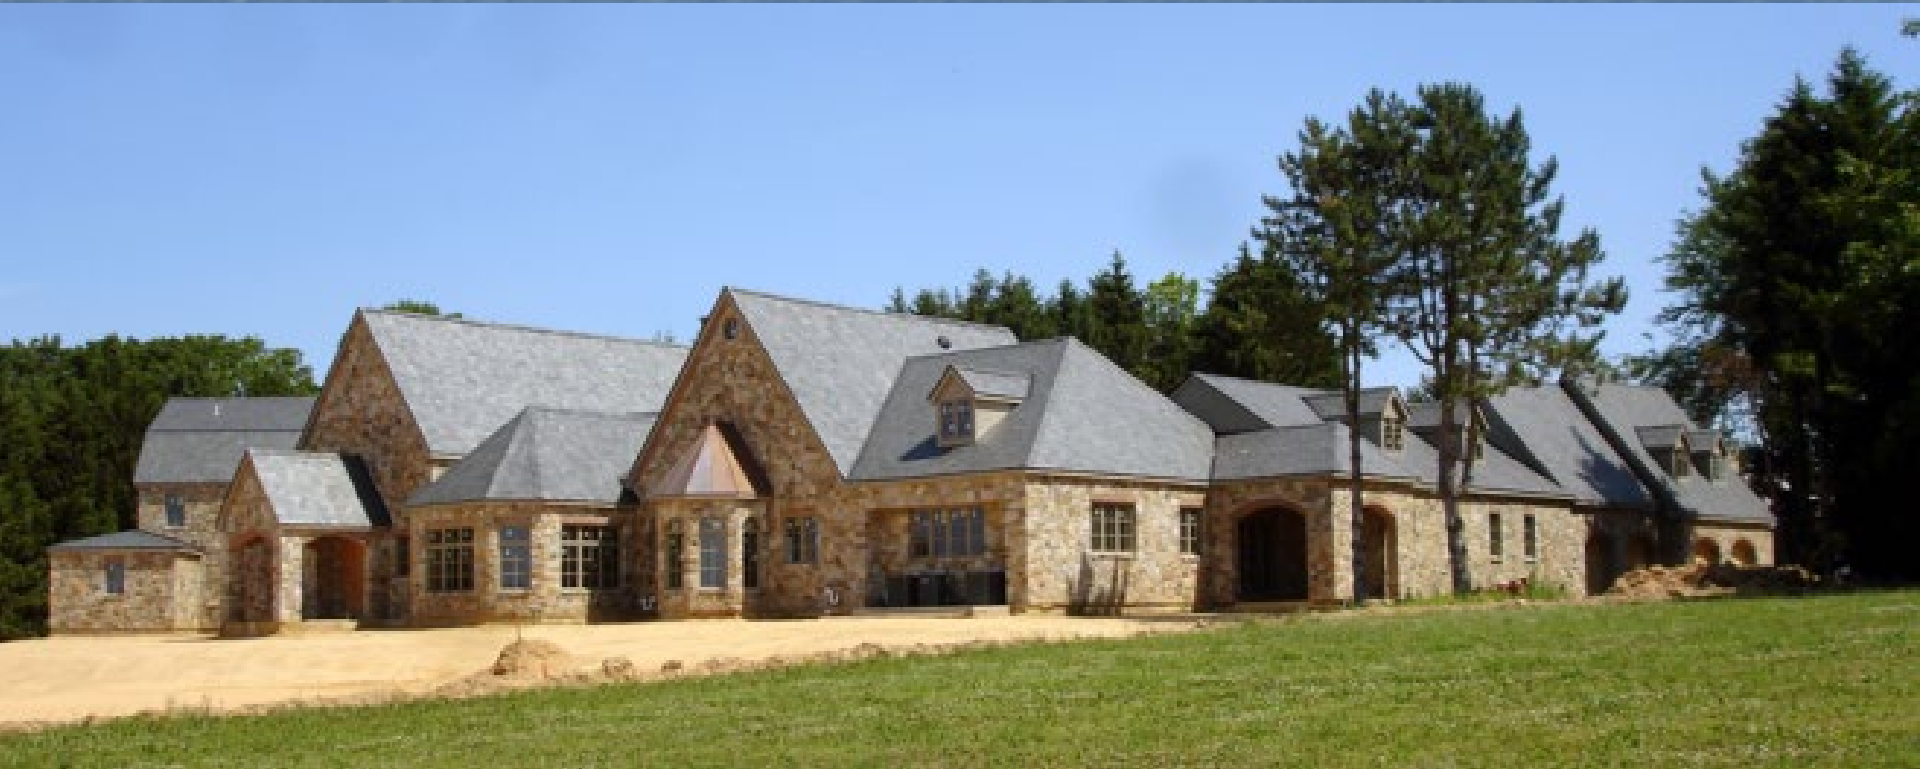
For example, this new slate roof had to be completely taken off and reslated.

Overlap was incorrect, as were the fasteners and the flashing material.

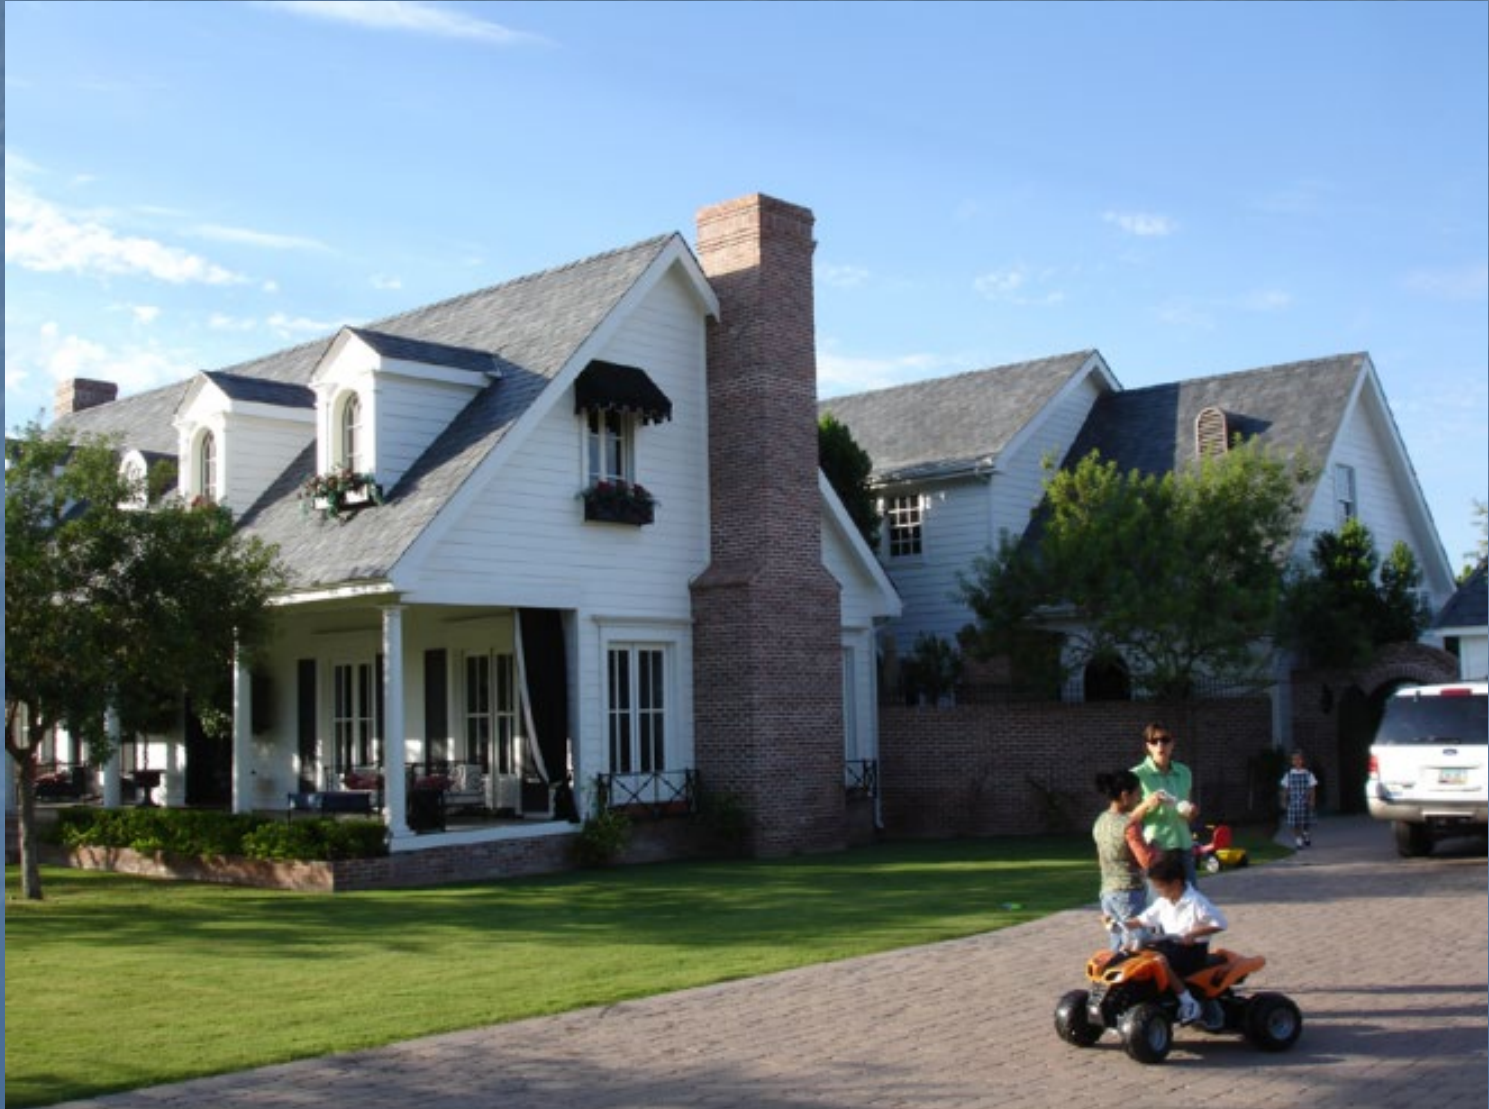
This new slate roof was condemned.

Installation components were poor, as were the flashings.

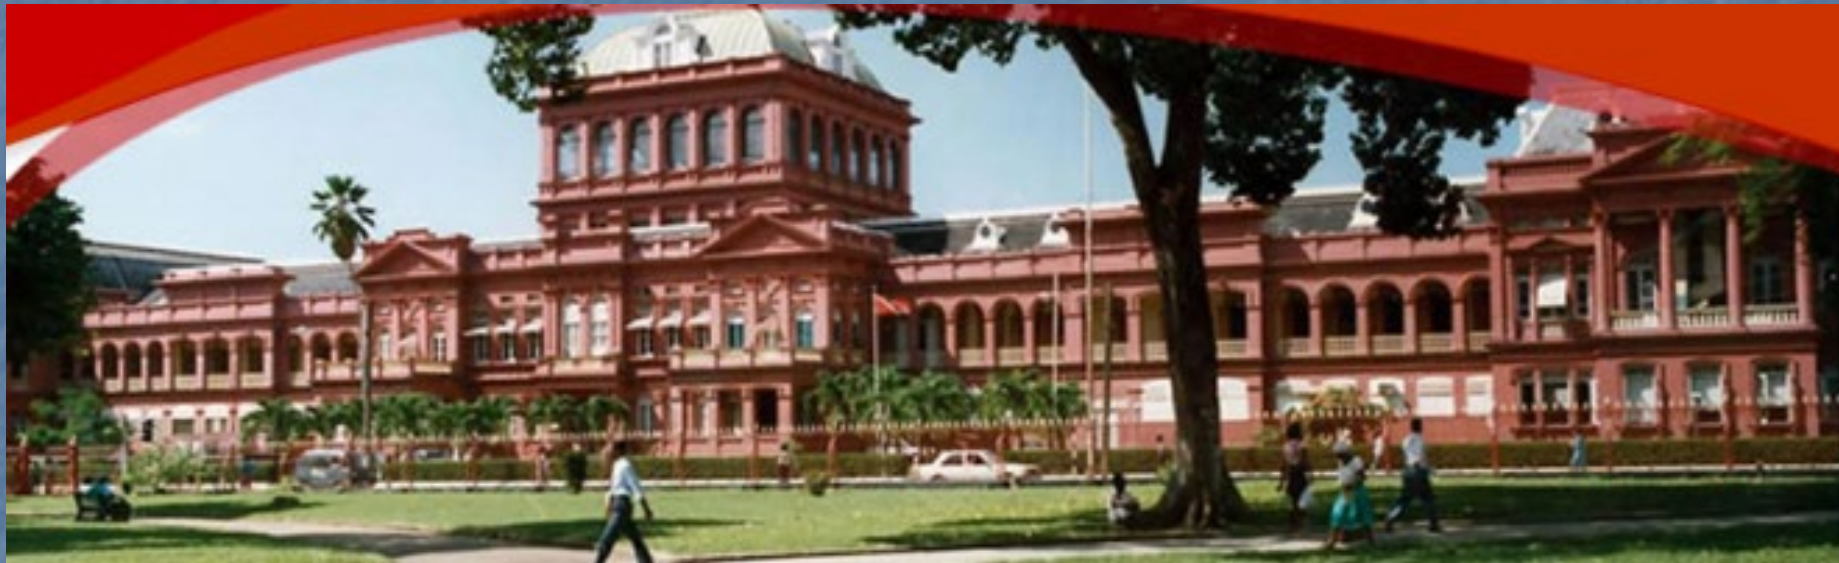
This new slate roof also had to be removed and replaced.

Replacement slates were poor quality and were installed with poor techniques in the early 2000s. The roof was entirely, and correctly, replaced again in 2019.

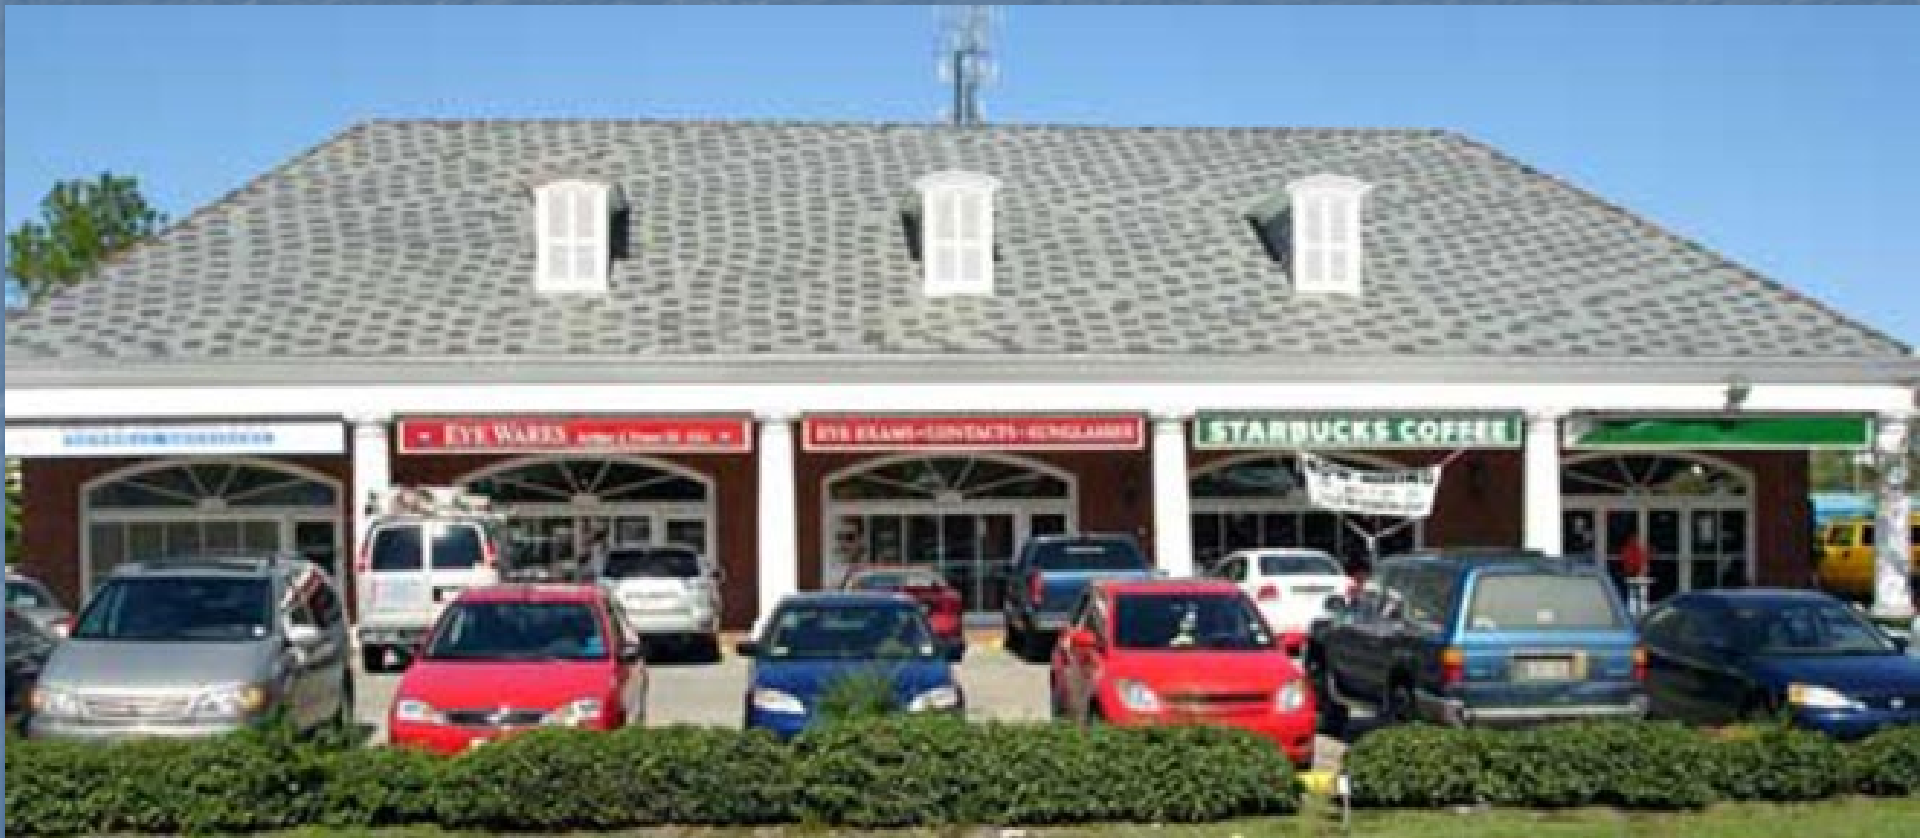
This new slate roof also had to be removed and replaced.

This shopping center roof, installed by storm chasers, had incorrect overlap.

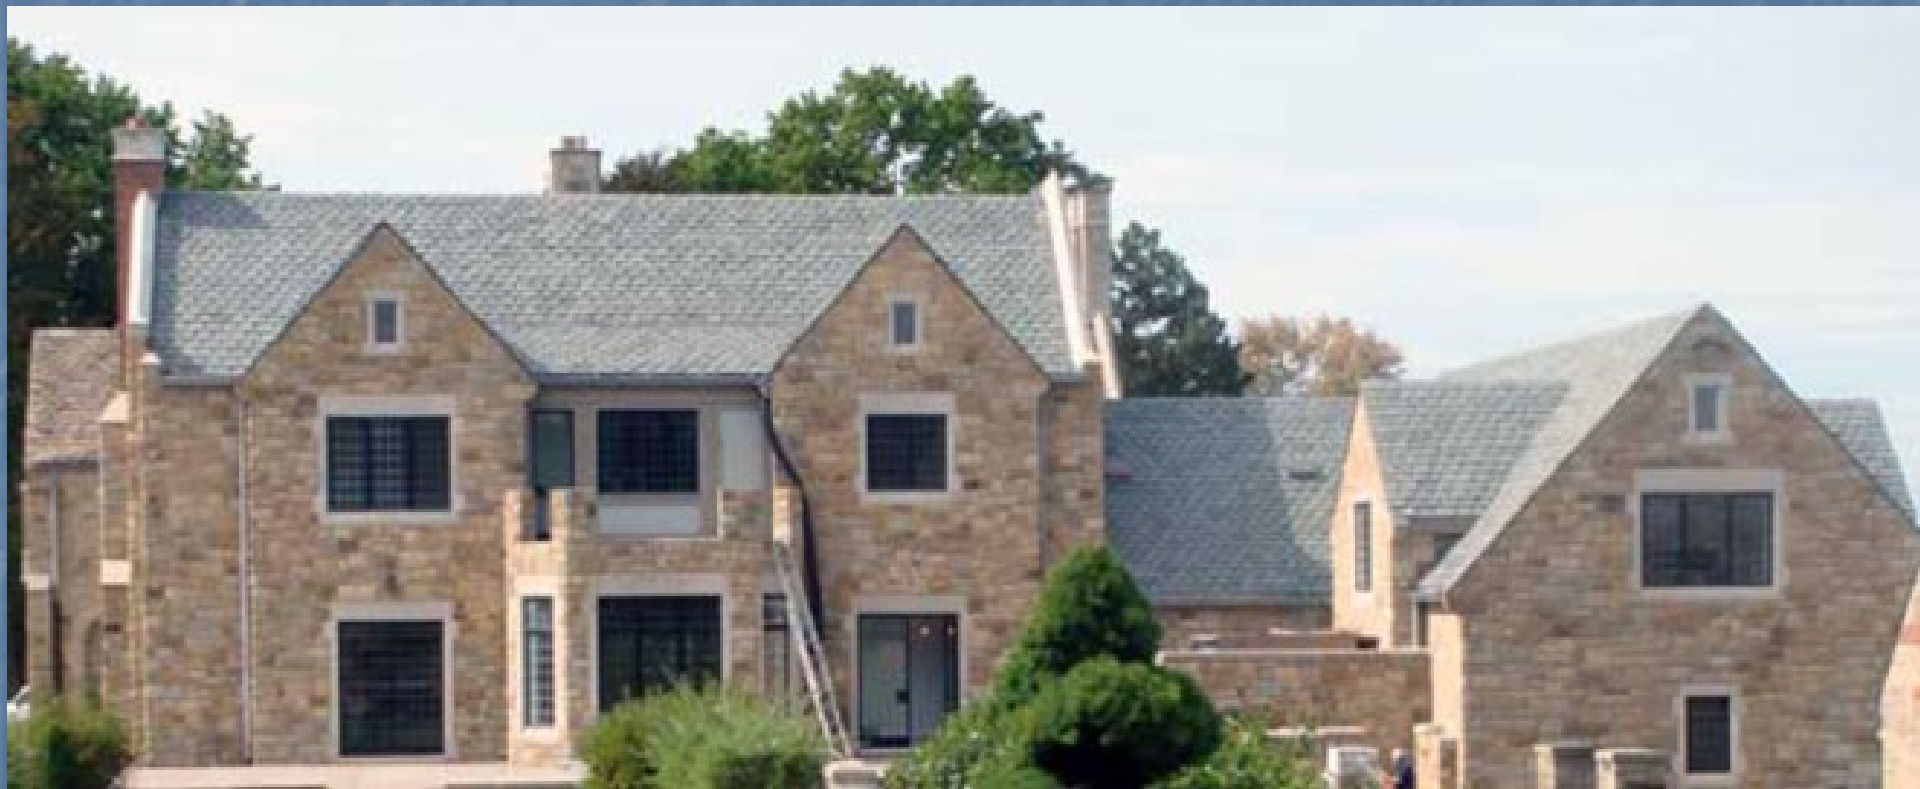
This new slate roof also had to be removed and replaced.

This multi-million-dollar home had slates installed without any headlap.

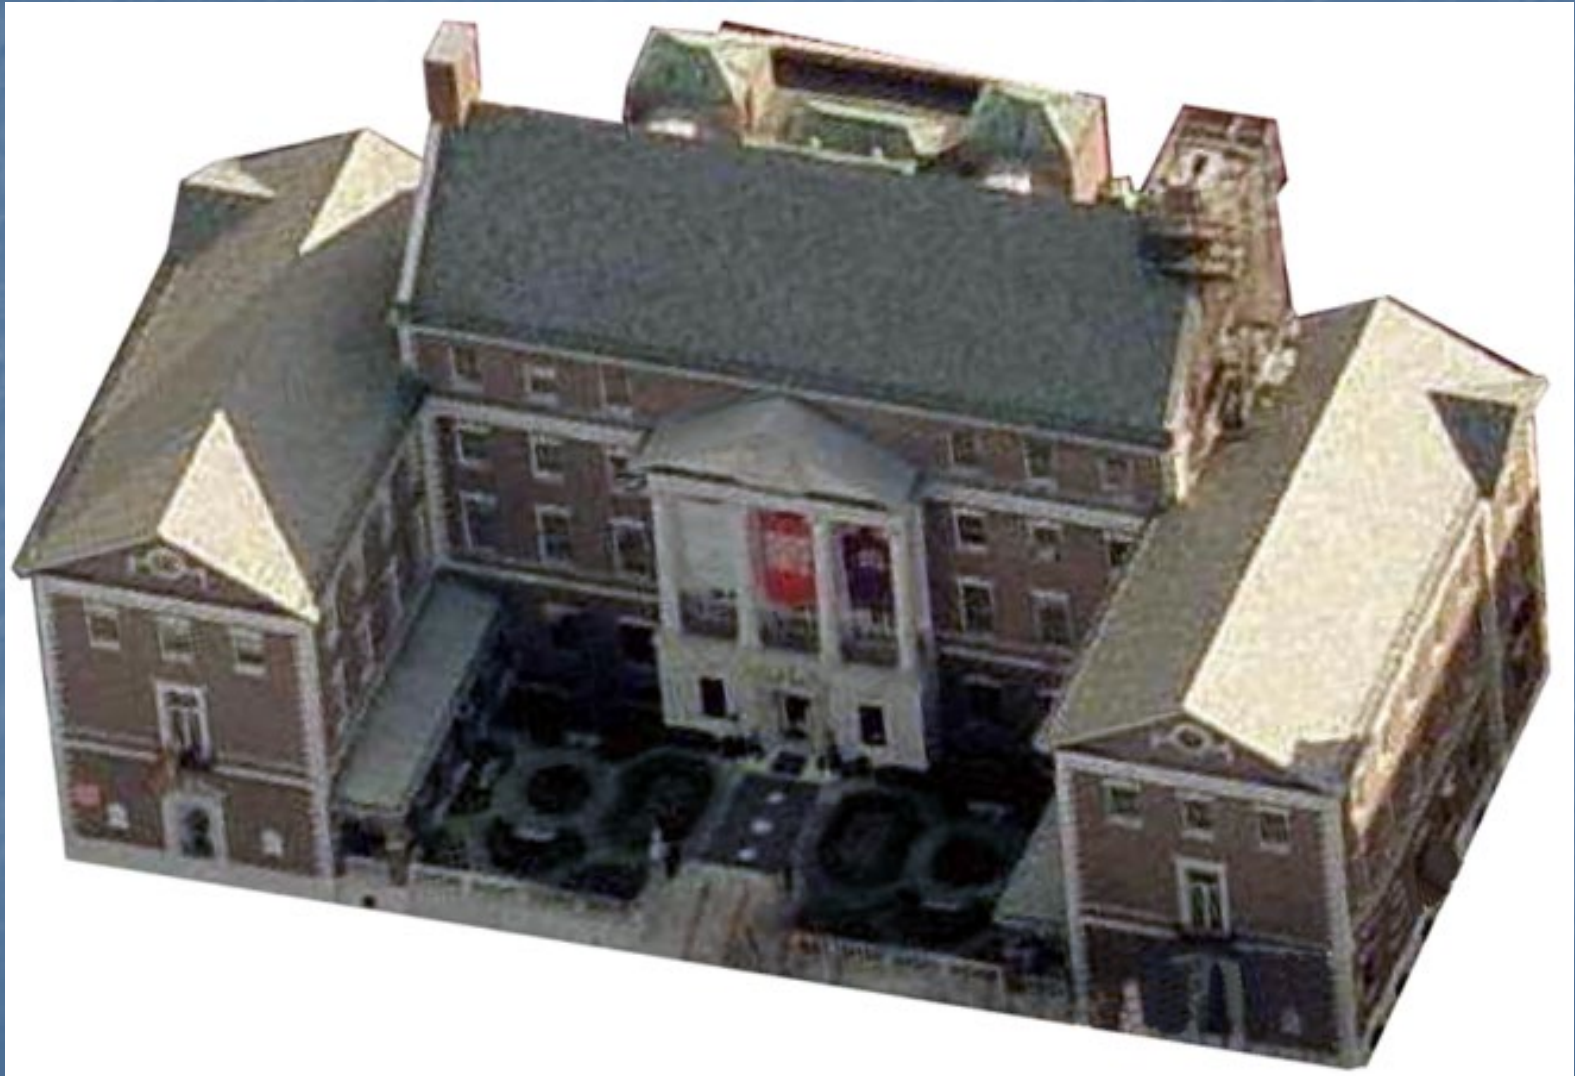
This new slate roof also had to be removed and replaced.

This Manhattan roof was slated with poor quality imported slates that failed.

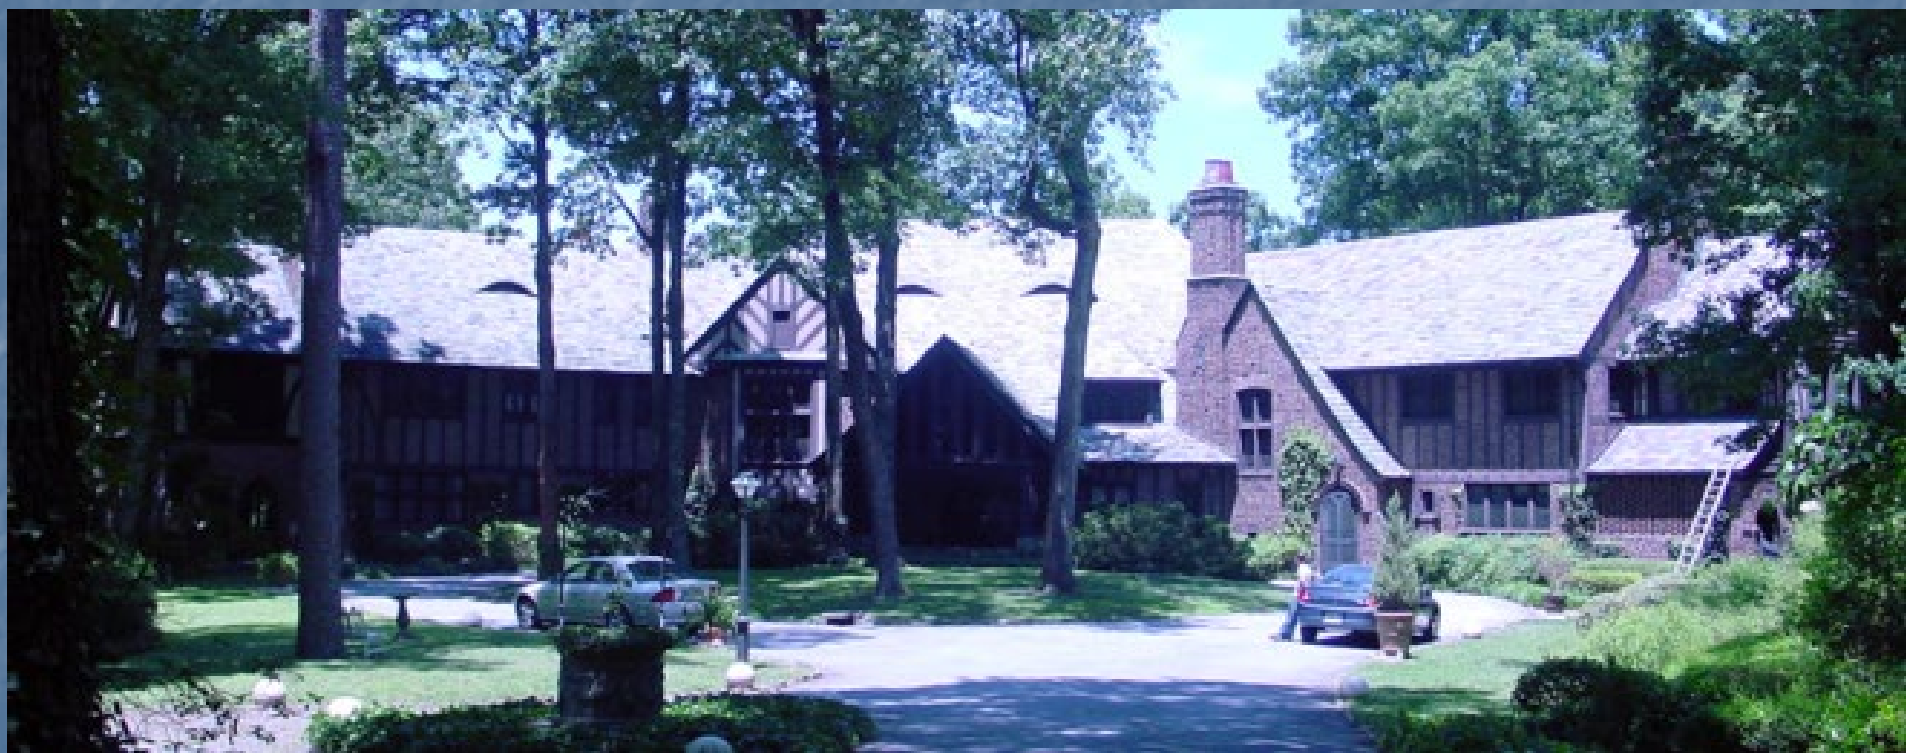
This replacement slate roof
had to be slated a 3RD time.

This historic home had been reslated with no headlap.

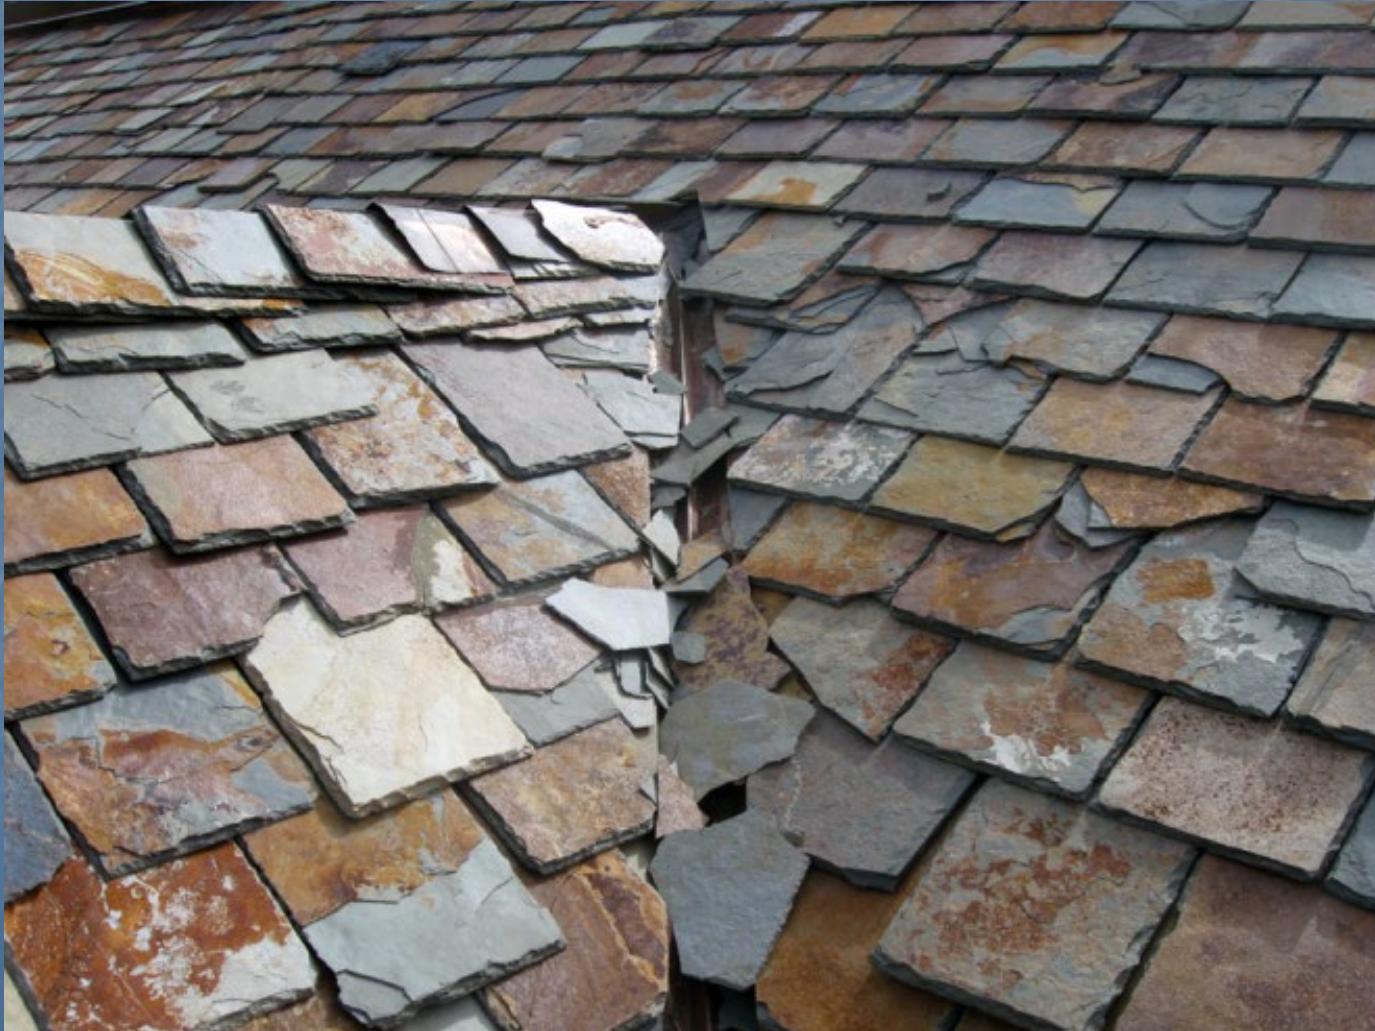
This China multi-color roof fell apart. Always use slates with a proven track record from confirmed and reputable sources.

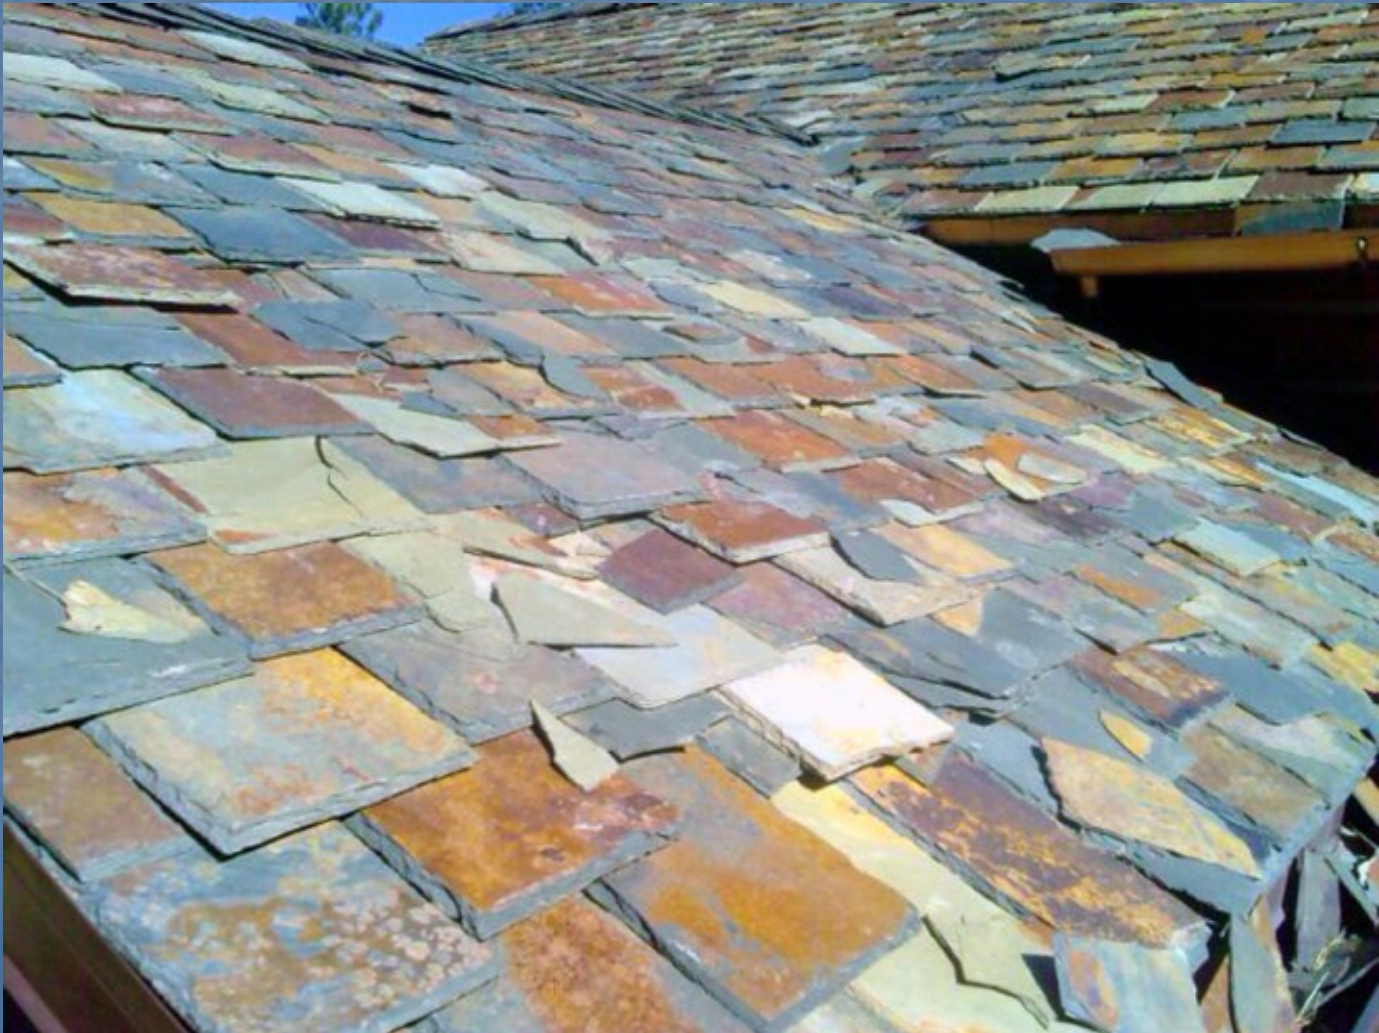
Some imported slates may not fare well in freeze-thaw cycles. Use slates that have a history of success.

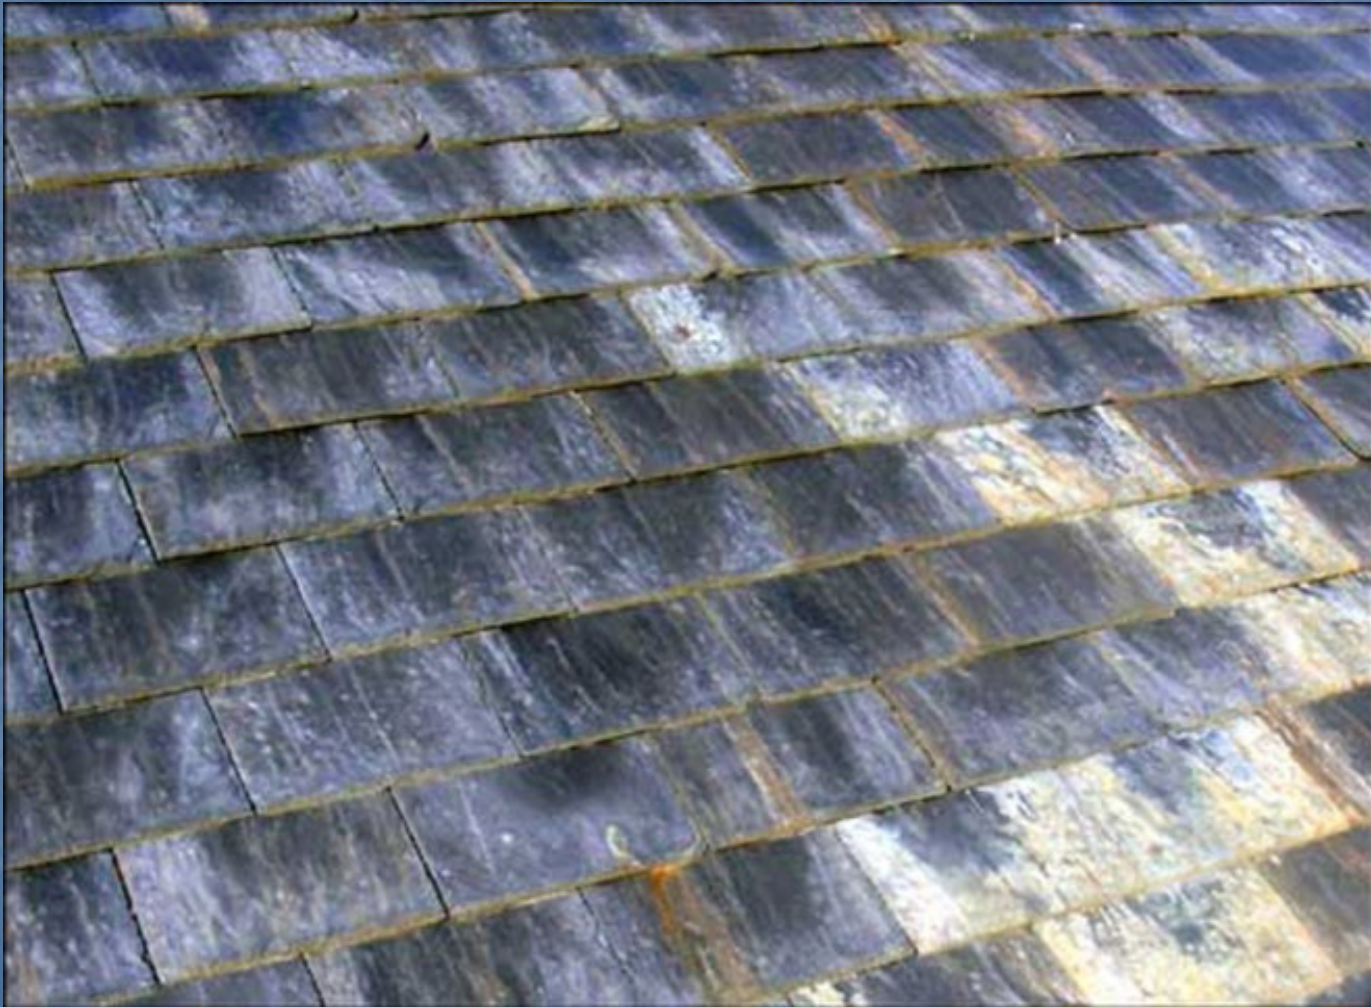
These Chinese slates were marketed as “unfading black” slates. Don’t gamble on low-cost products.

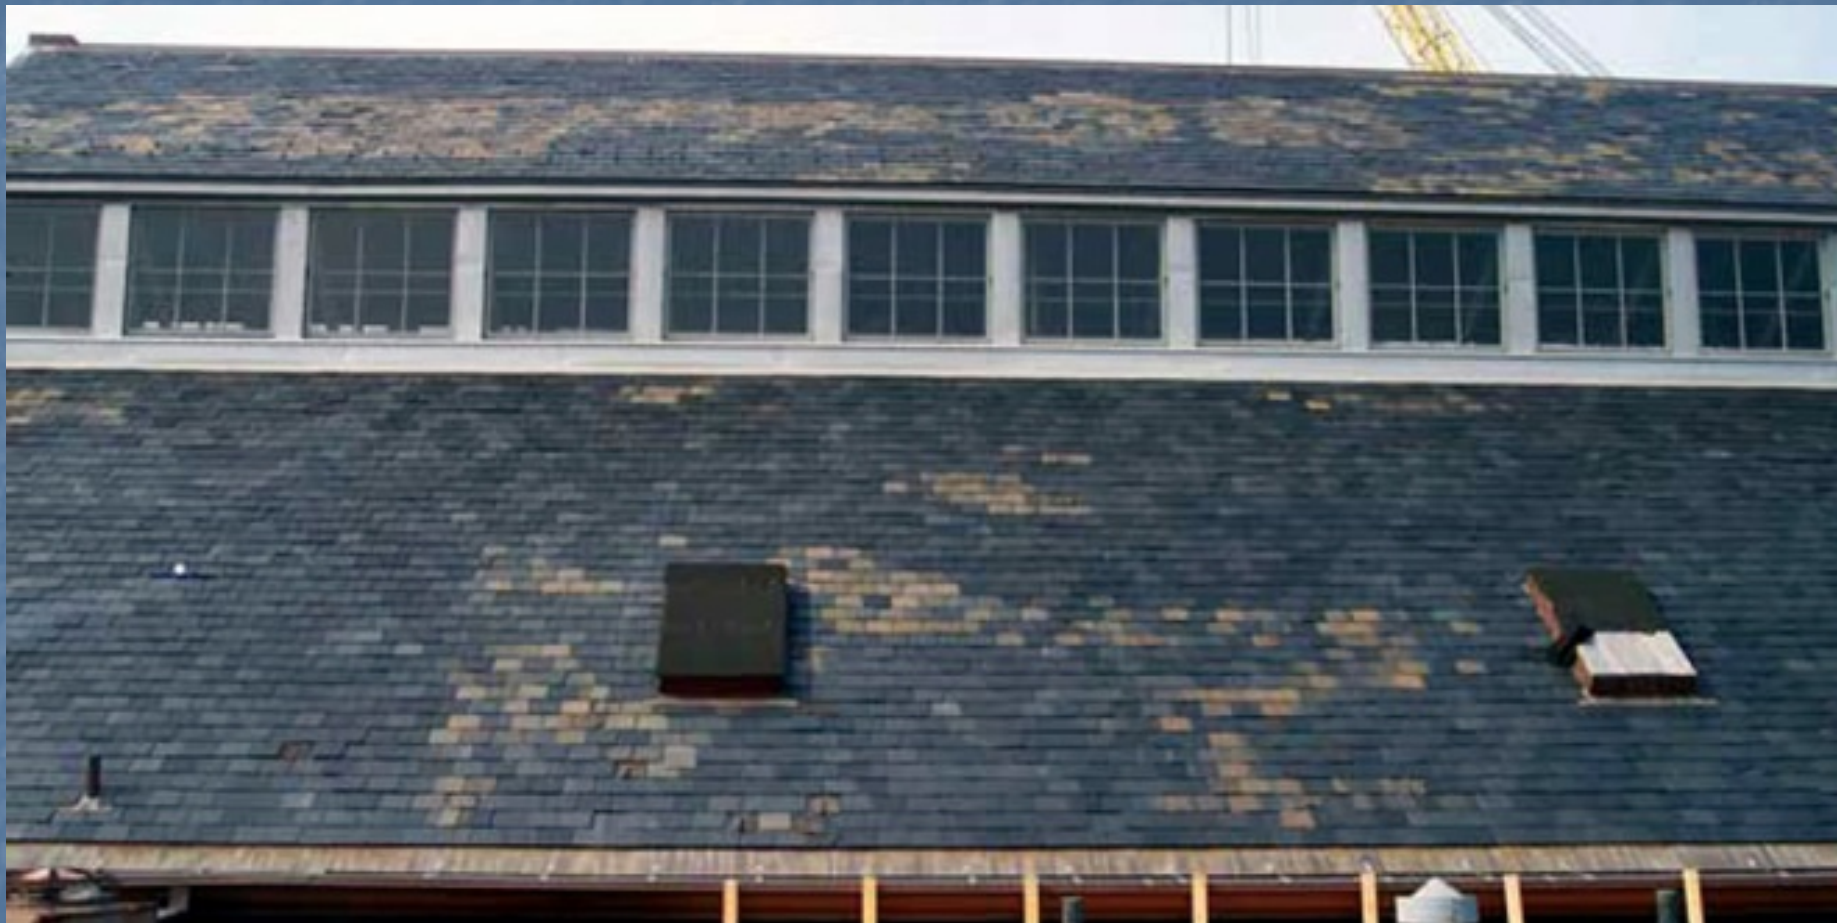
This roof had to be removed because of slate failure.
The slates were imported from China.

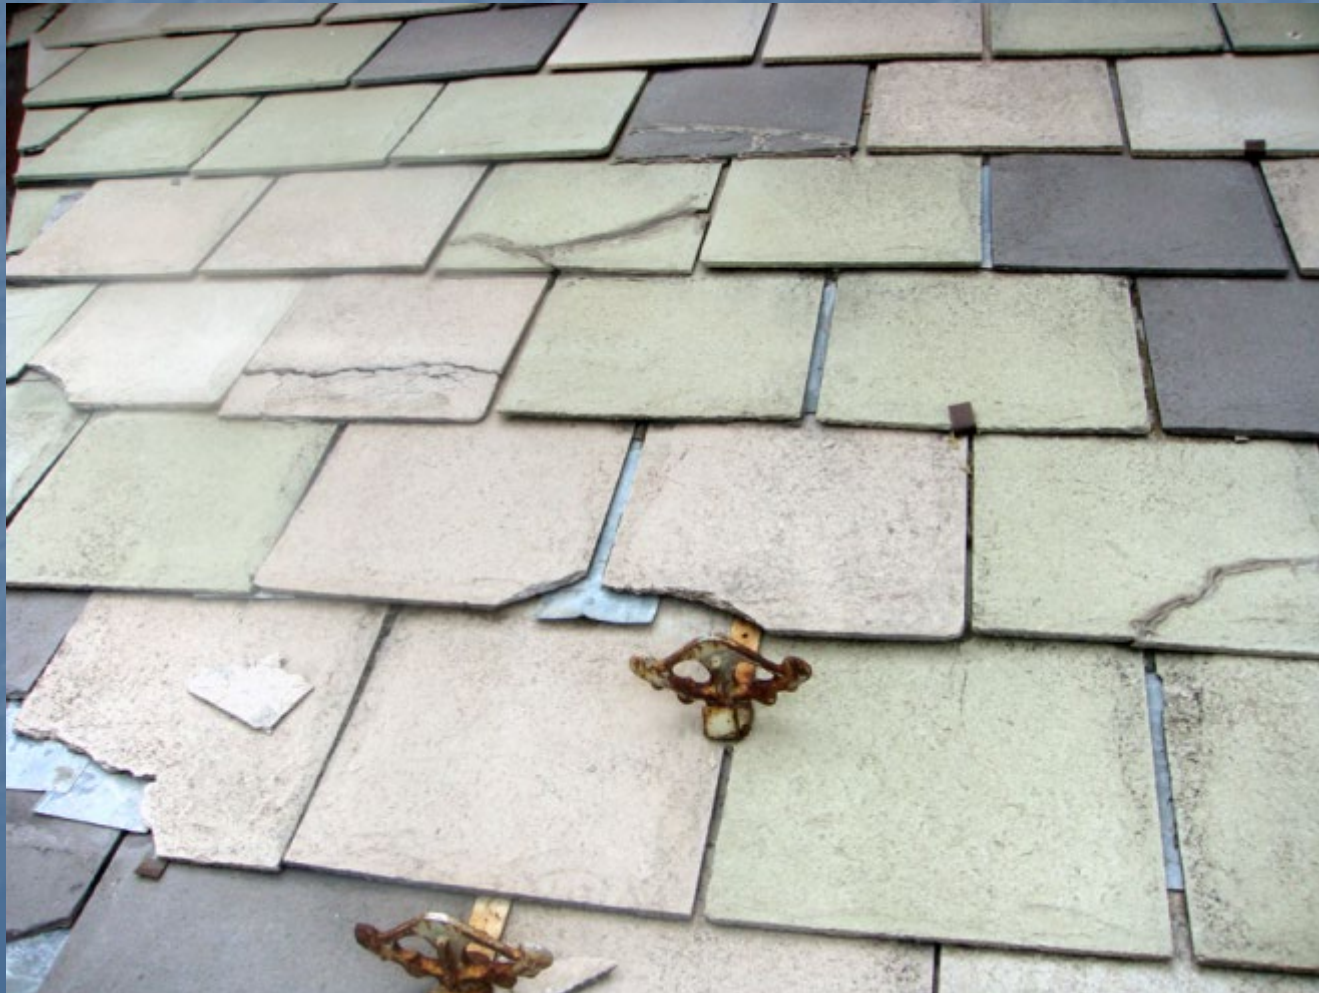
Fake “slates” at 20 years of age are failing.
Use only genuine quarried roofing slates.

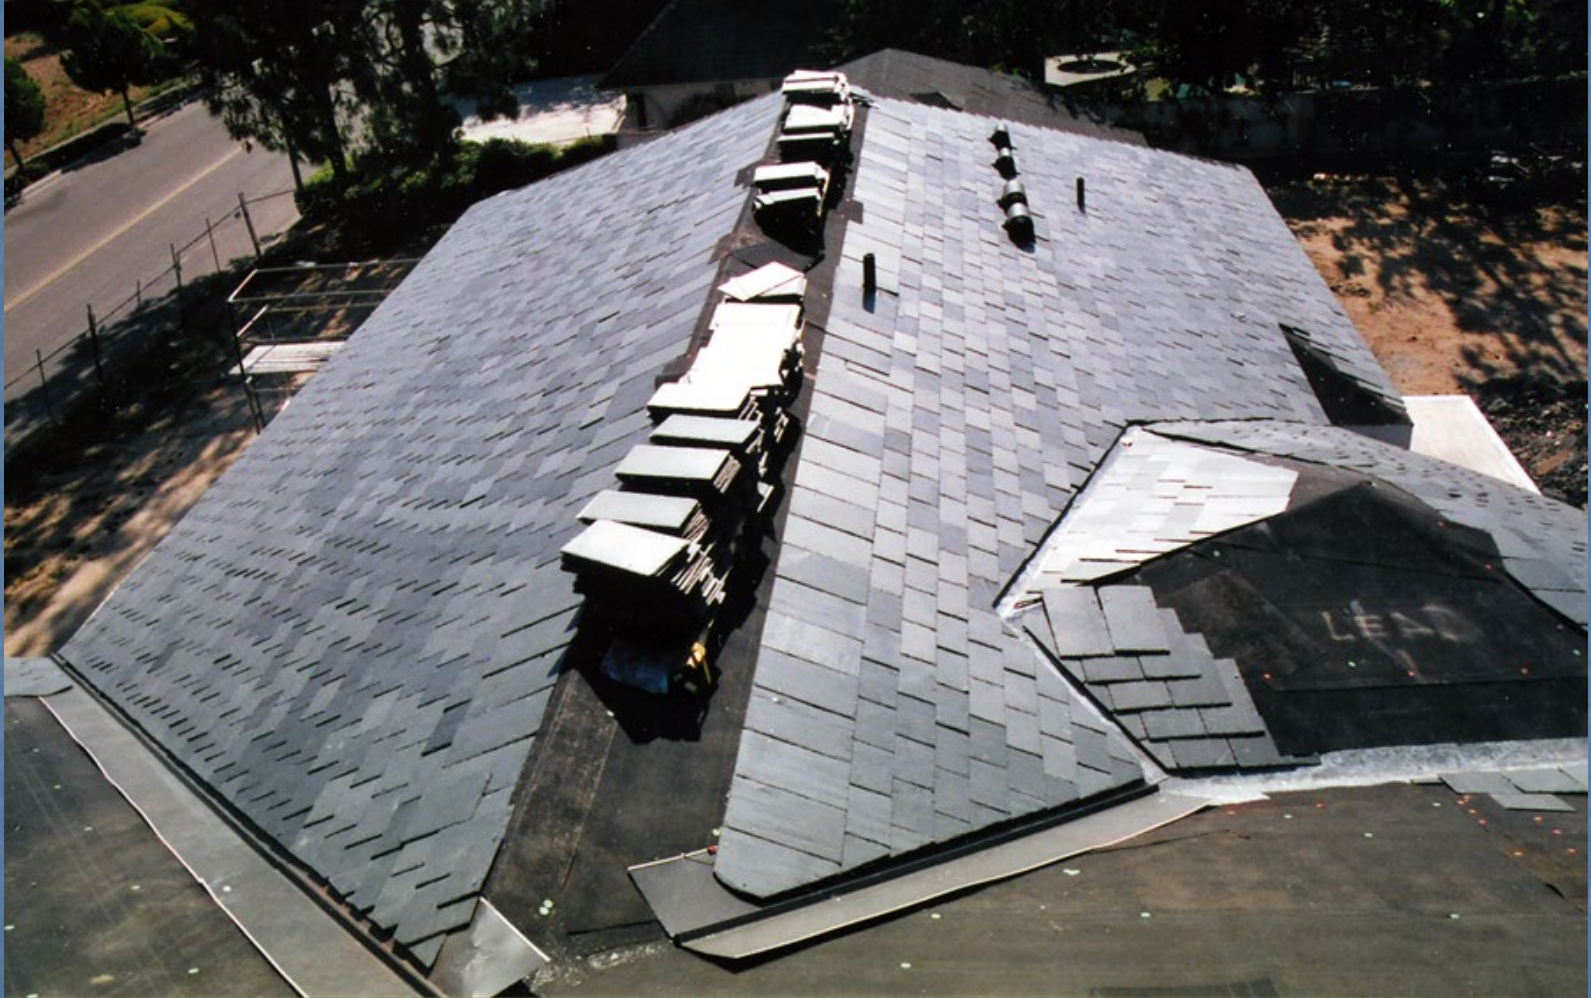
Unmarked pallets from different foreign quarries did not blend well on the roof.

Make sure all slate pallets are marked with the quarry origin!

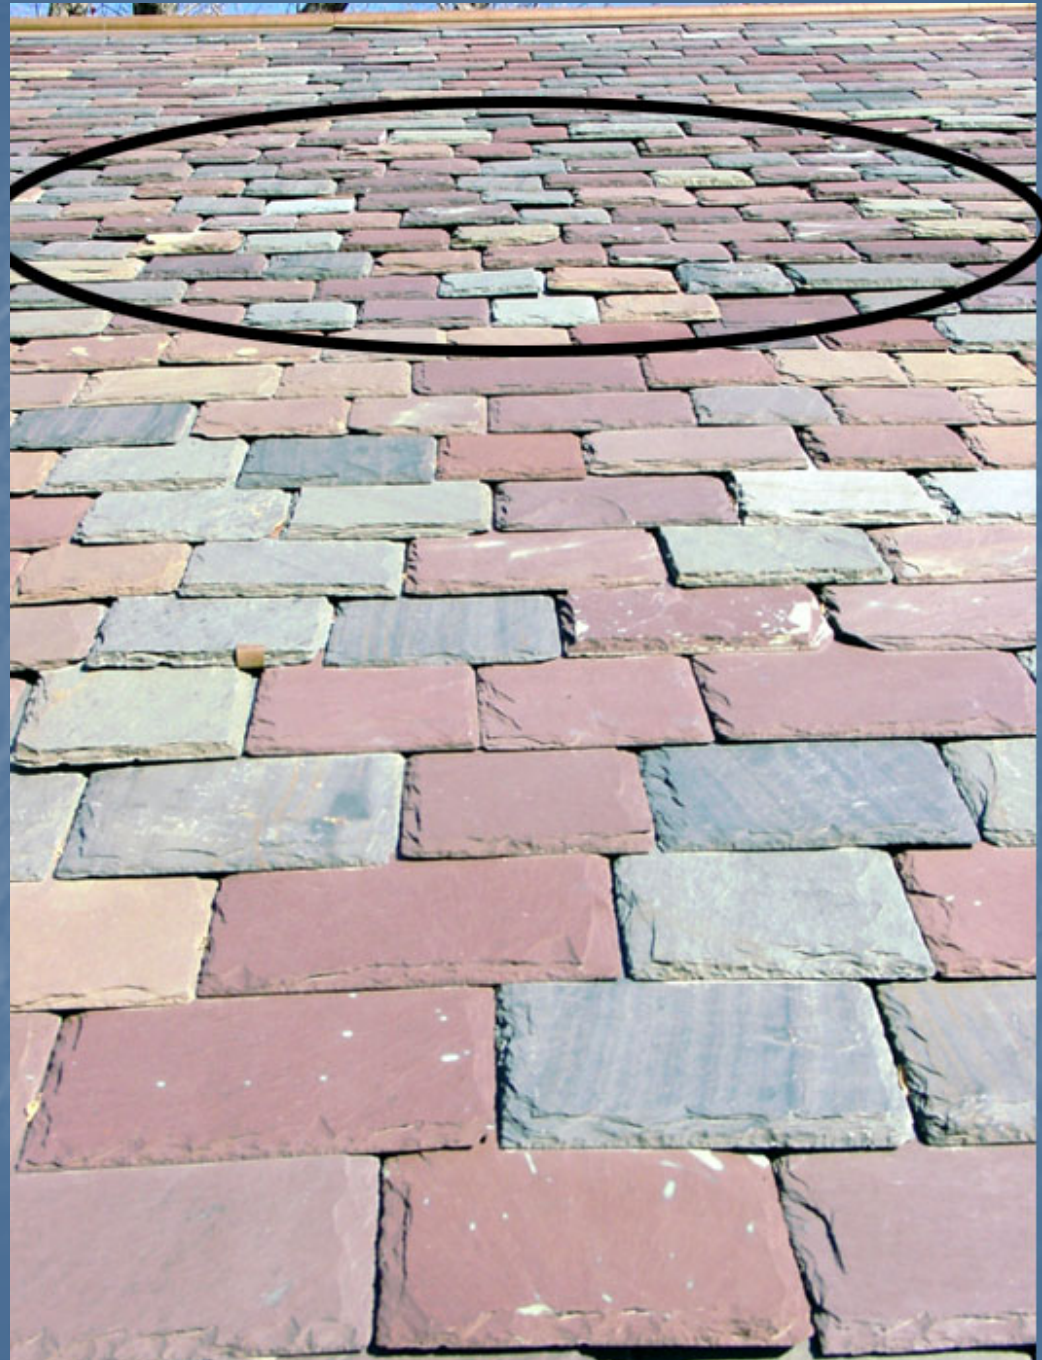
Note that the mid-length slates on this graduated roof were thicker than the slates below them. The slate thicknesses should have been checked by the contractor prior to installation. The graduation scheme should have been detailed in the contract documents!

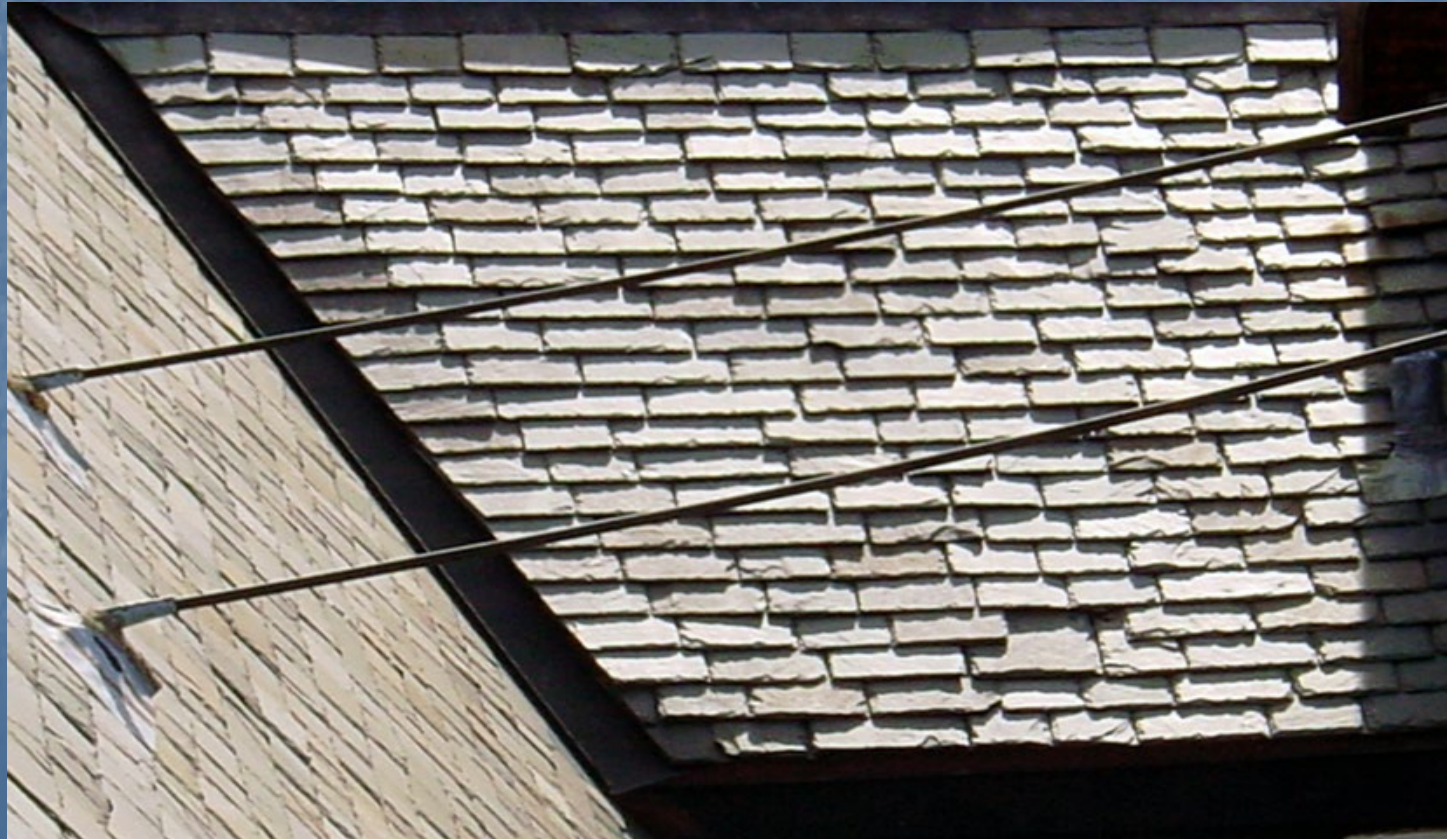
These 12" long slates were too small for the 200 square 12-story roof. 356 slates/square greatly increased the labor costs. The contractor went bankrupt in the middle of the job. Size your slates correctly!
