How to Avoid Installation Errors When Installing Slate Roofs

**ARCHITECTS AND INSTALLERS
SEMINAR SERIES**

Slate Roofing Contractors Association of North America, Inc.

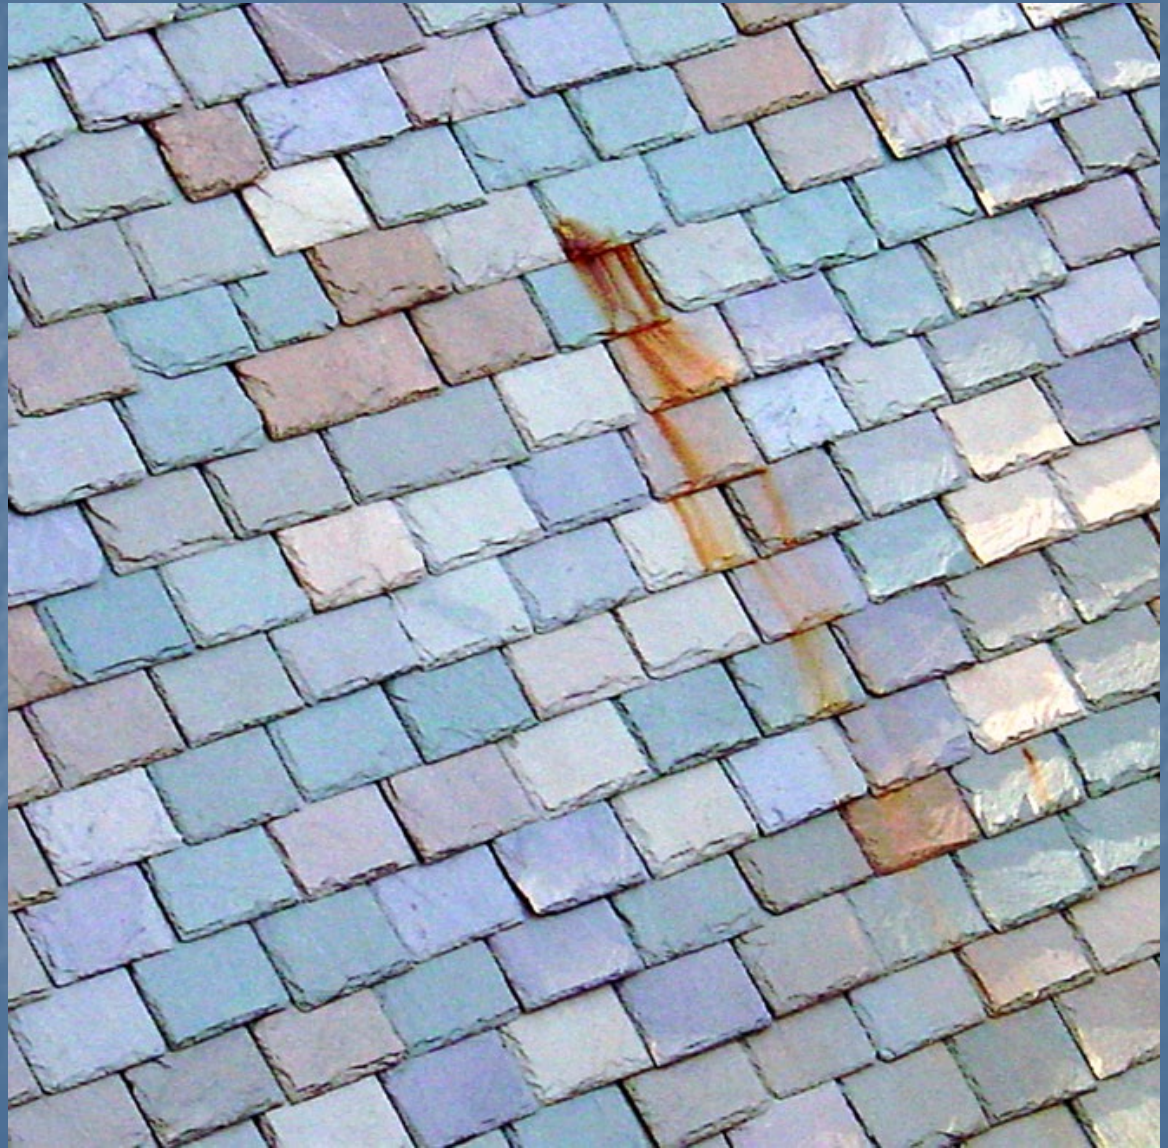
These faulty slates had iron inclusions that defaced the roof. This is an installation error. The contractor should have culled out the few bad slates.

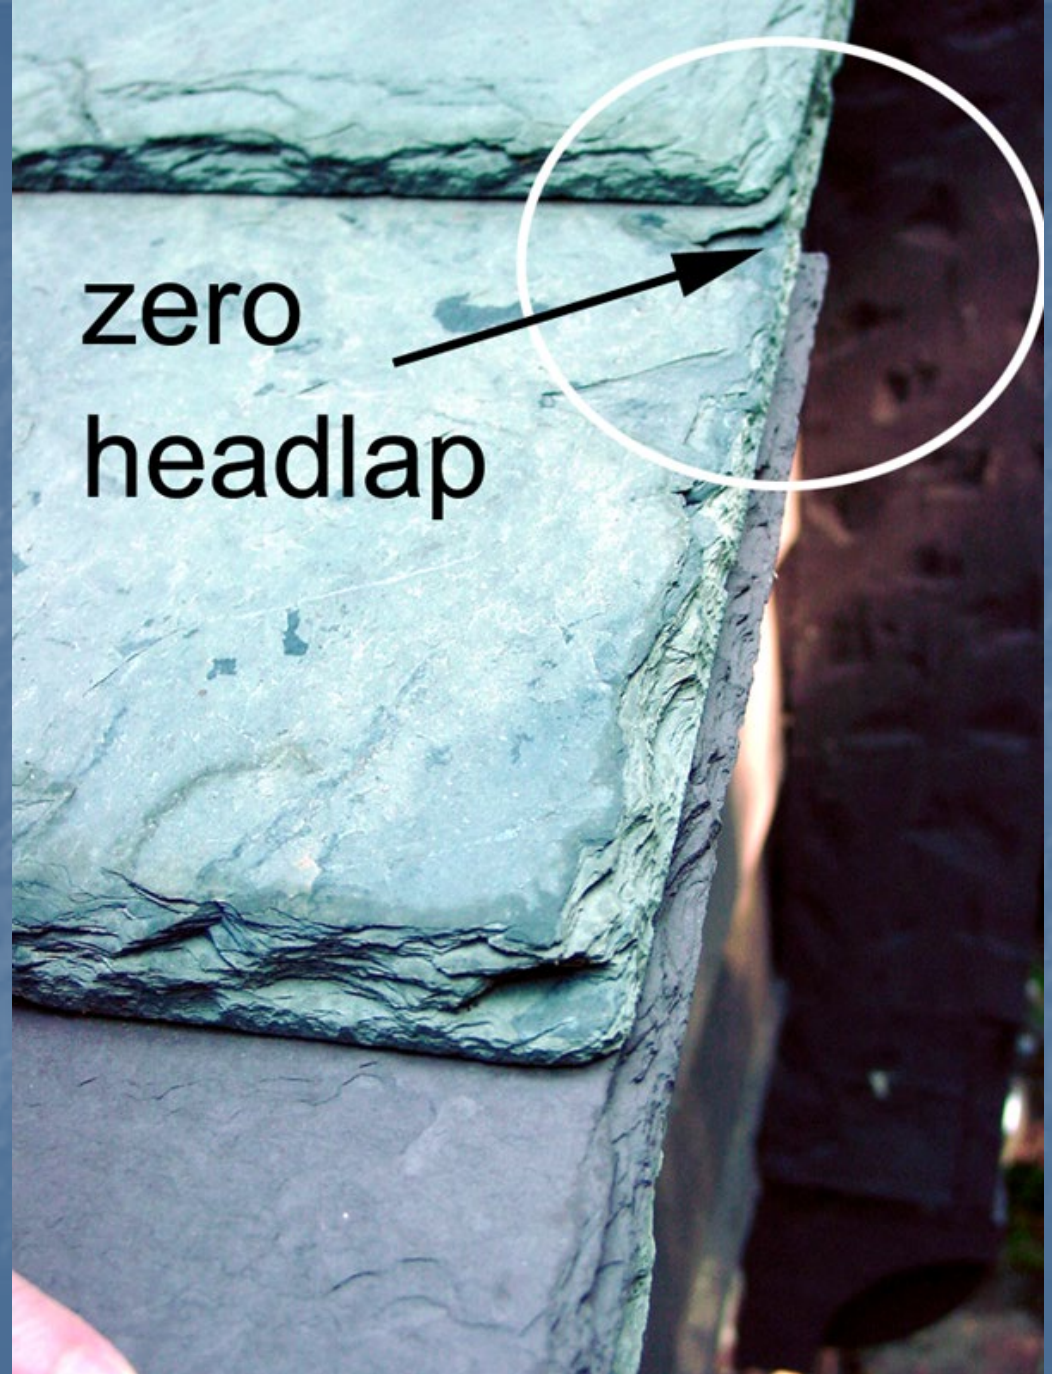
This \$450,000 slate roof was installed with no headlap. Instead, felt was laid over every slate course. When the felt wore out, the roof failed.

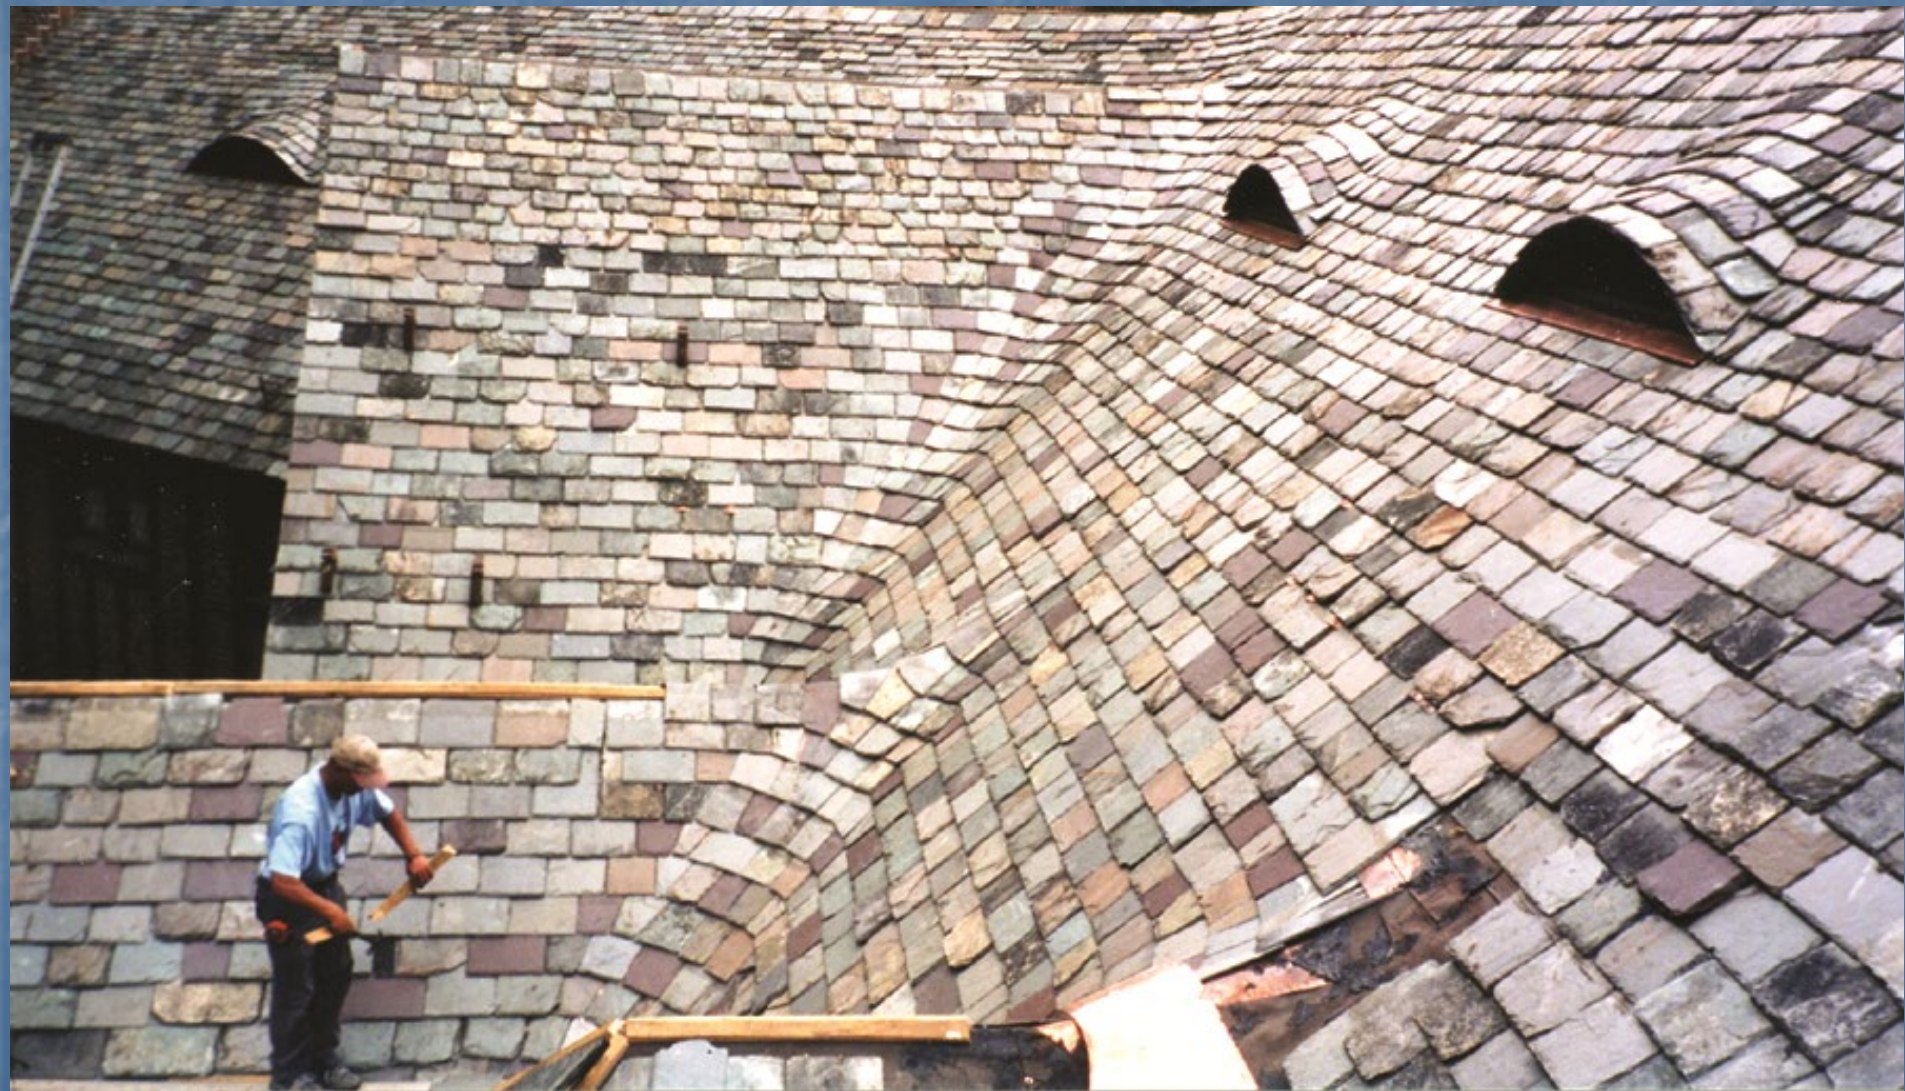
That was this roof:

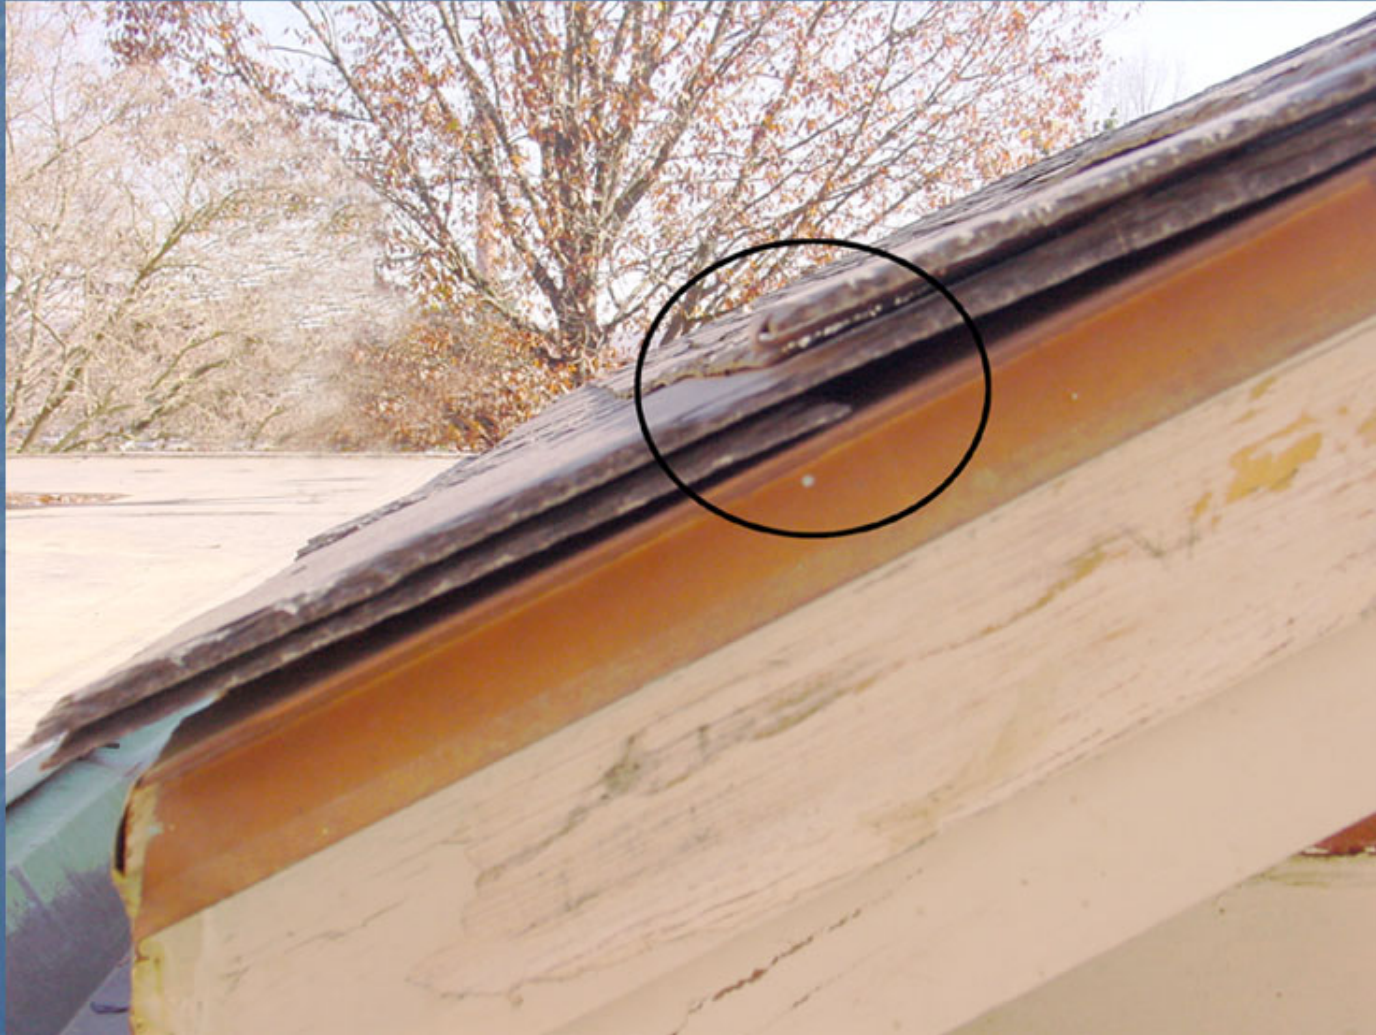
This expensive college dormitory slate roof was installed without correct headlap. This is a mistake that is very easy to avoid!

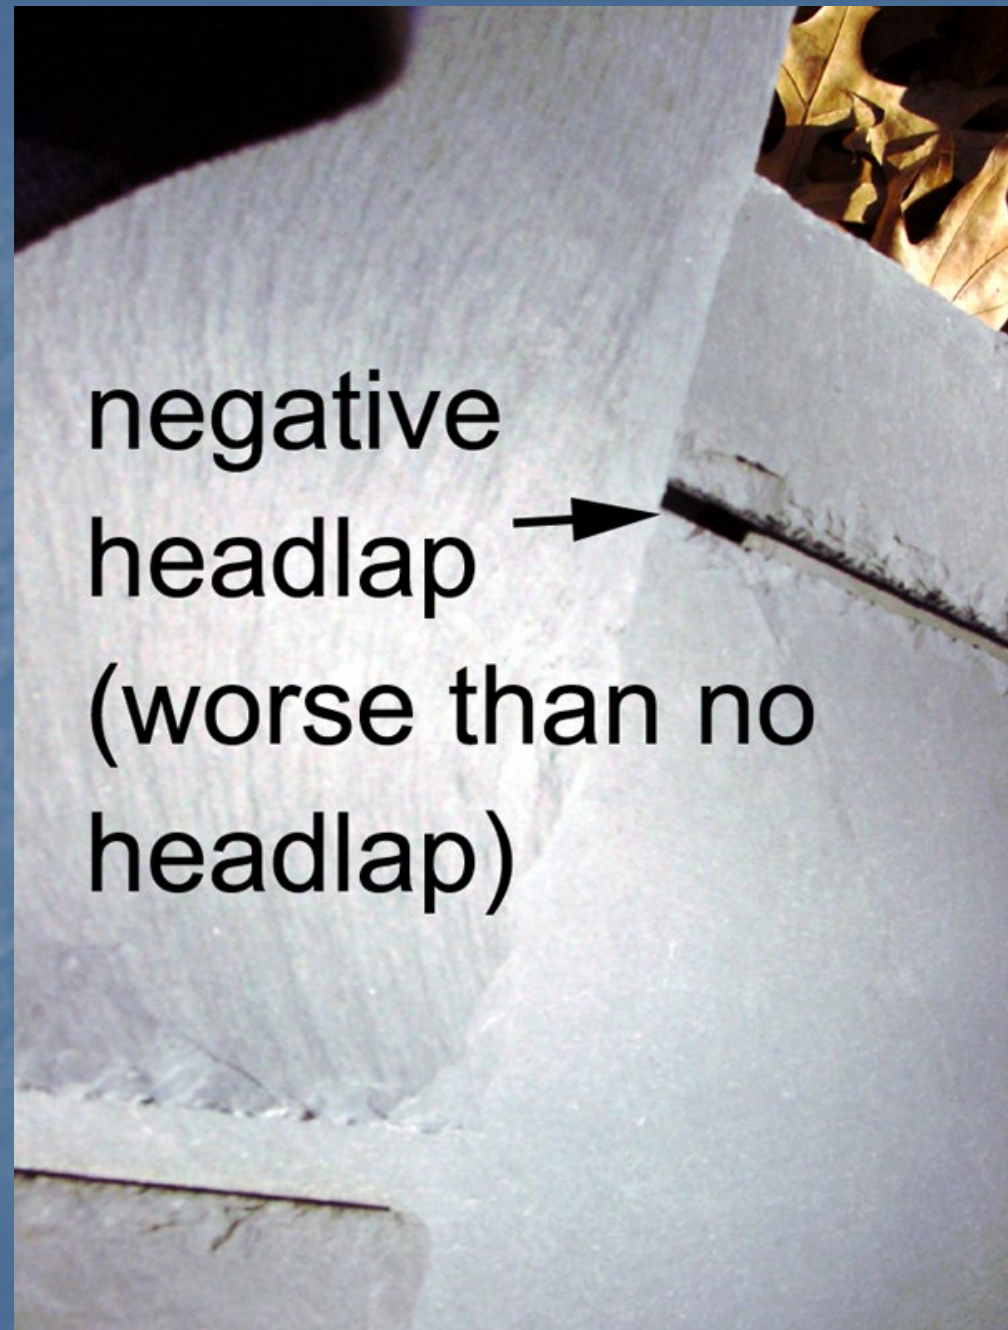
The same dormitory showed areas of negative headlap (i.e. direct water entry). This mistake is avoided very simply by the correct placement of the chalk lines when installing the slate!

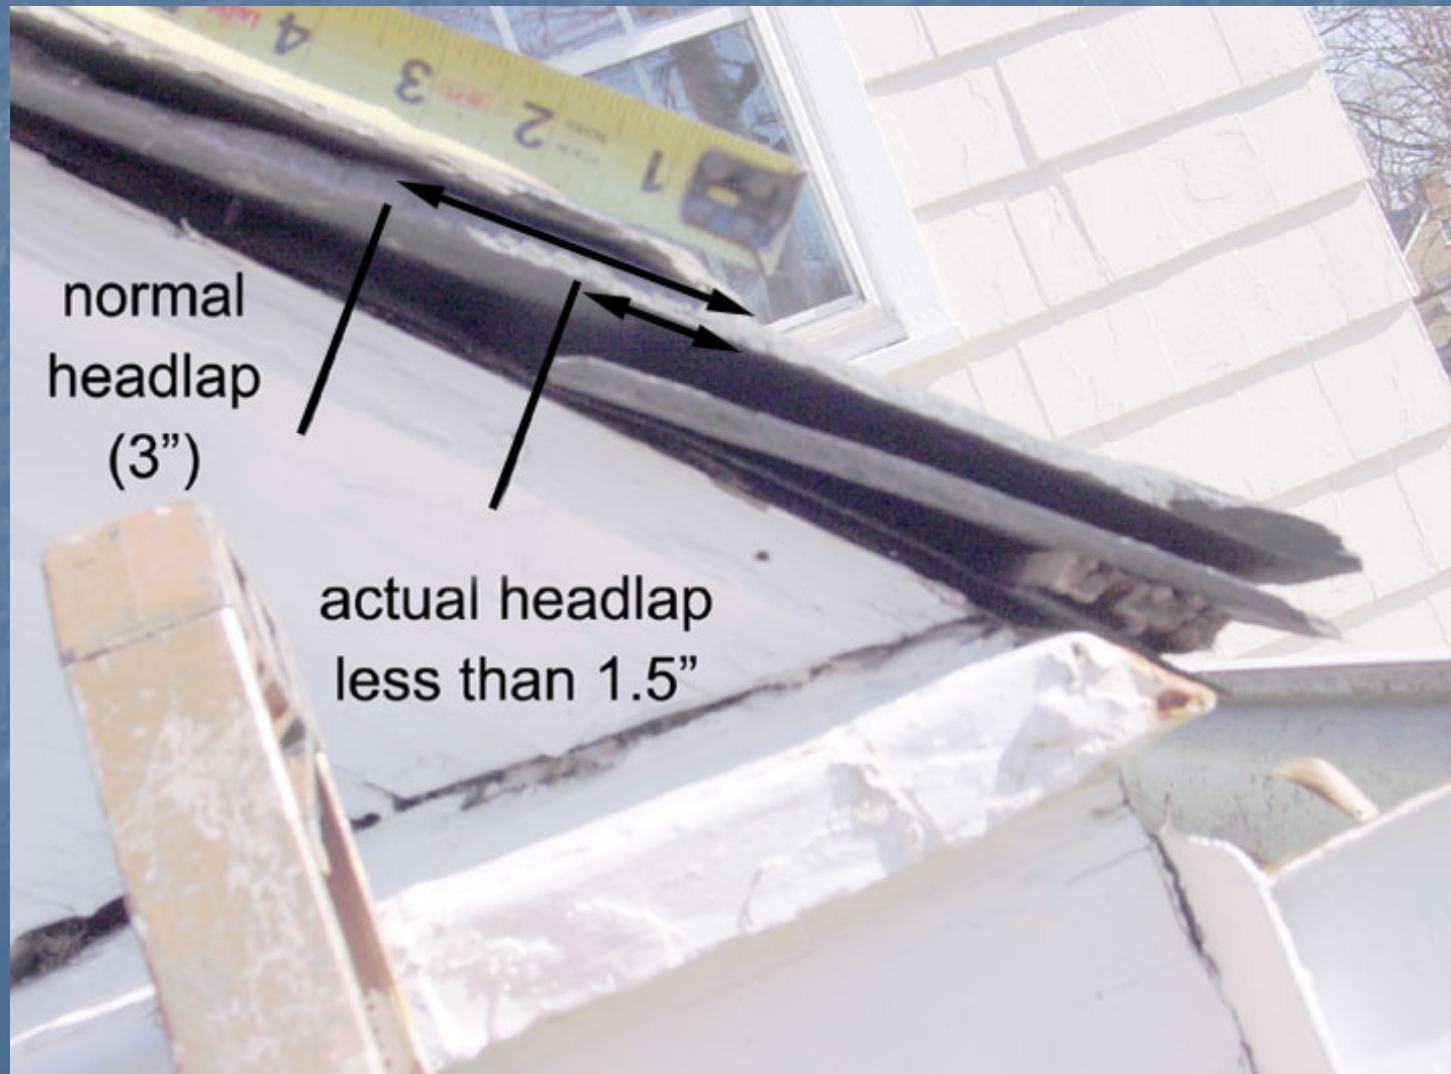
Insufficient headlap on the starter course is a common problem for inexperienced installers. This mistake can be easily avoided!

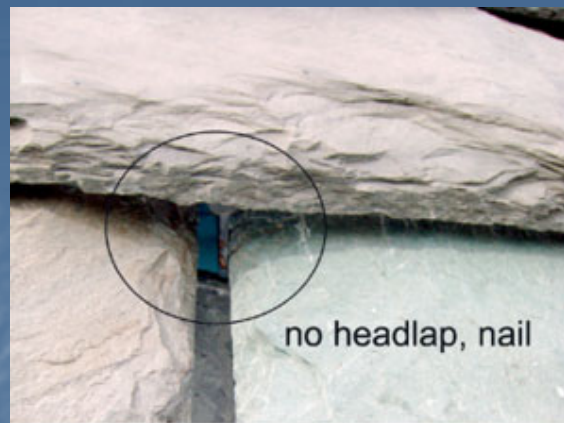
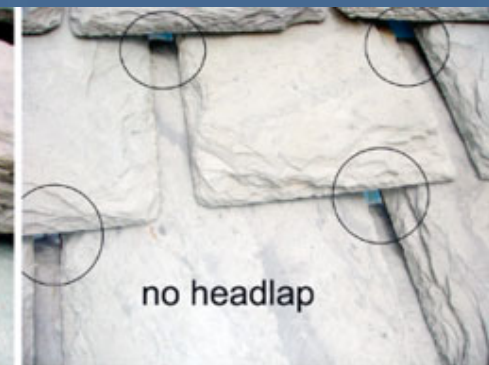
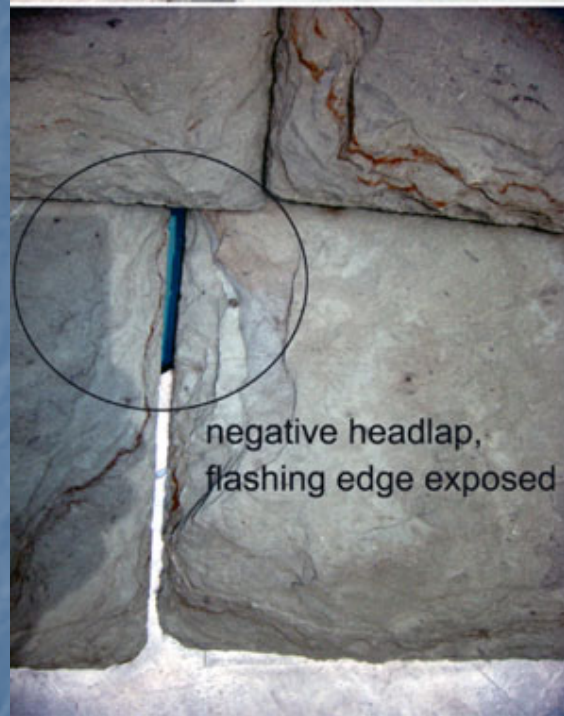
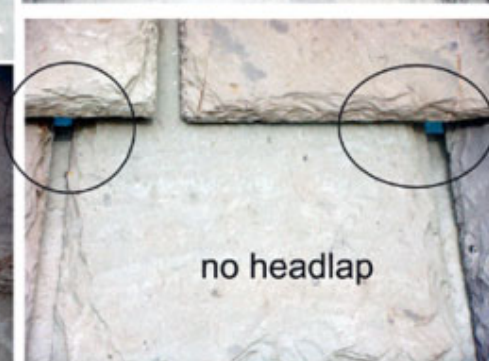
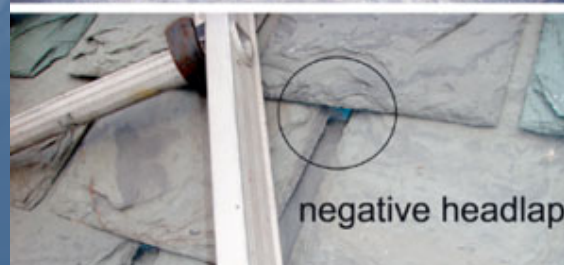
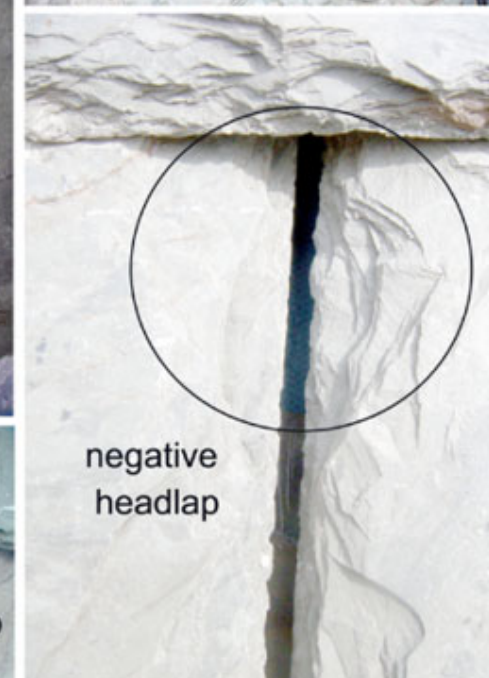
Other examples of negative (incorrect) headlap. Chalk your course lines correctly to avoid this mistake. It really is that simple!

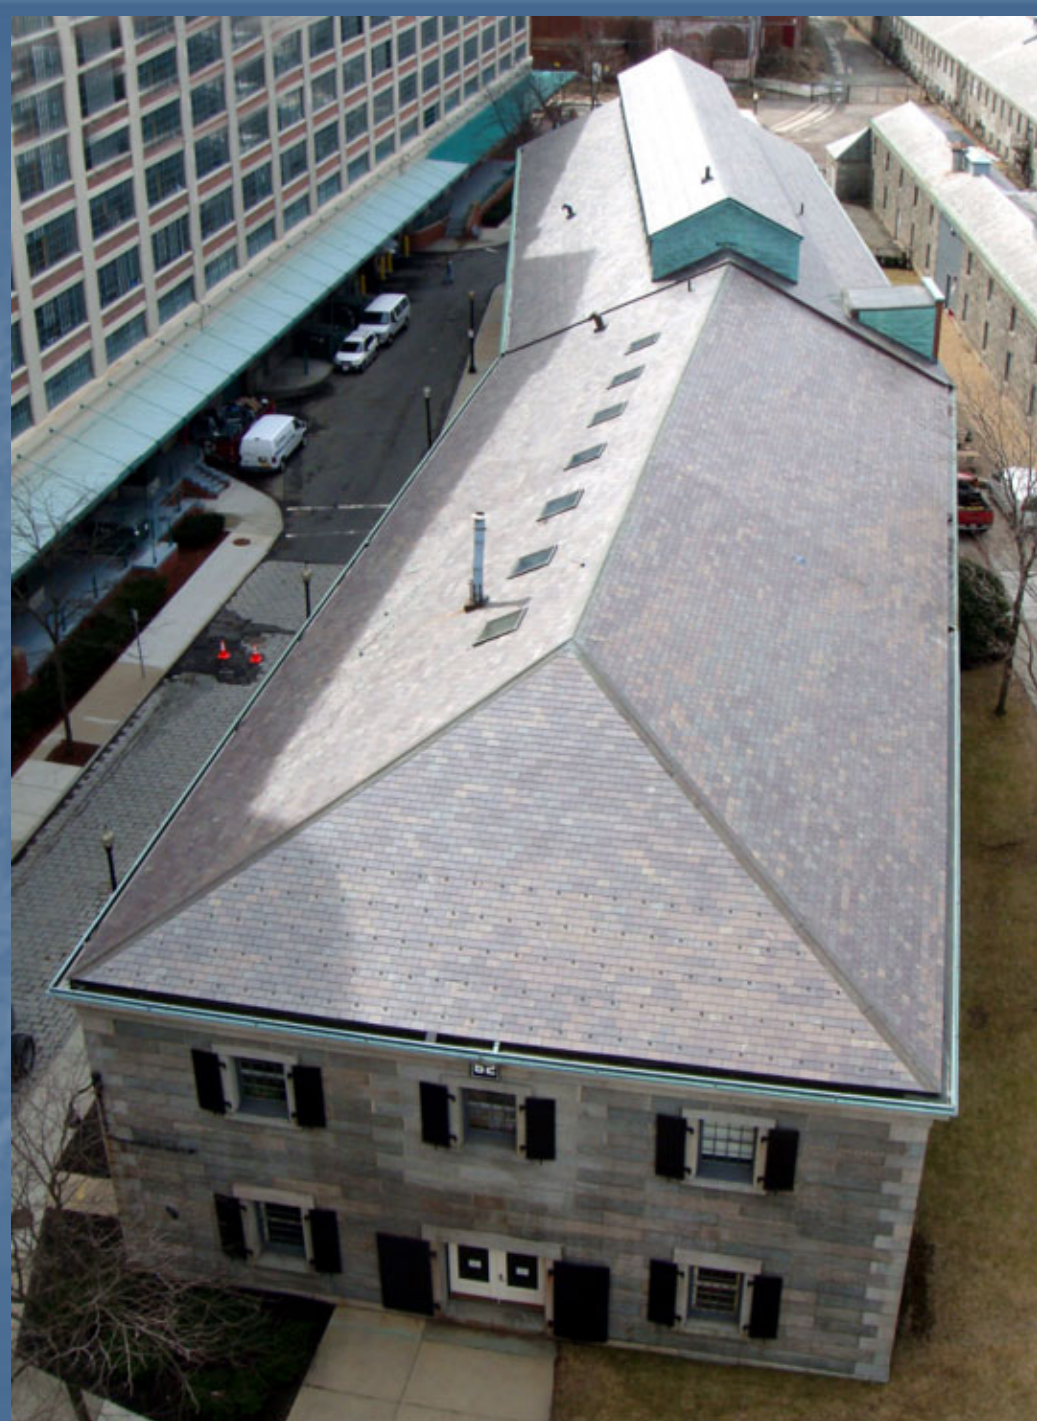
2" headlap on a 6:12 slope violates code requirements (should be 4" headlap). Ring-shank nails are not recommended for installing slate shingles. Foot traffic causes breakage of new slates. All these mistakes were evident on this roof.

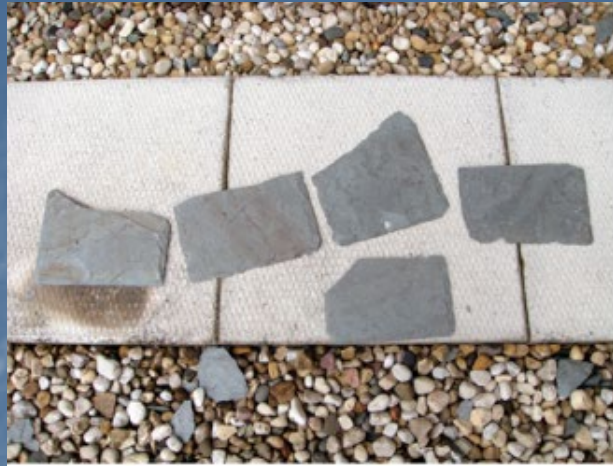
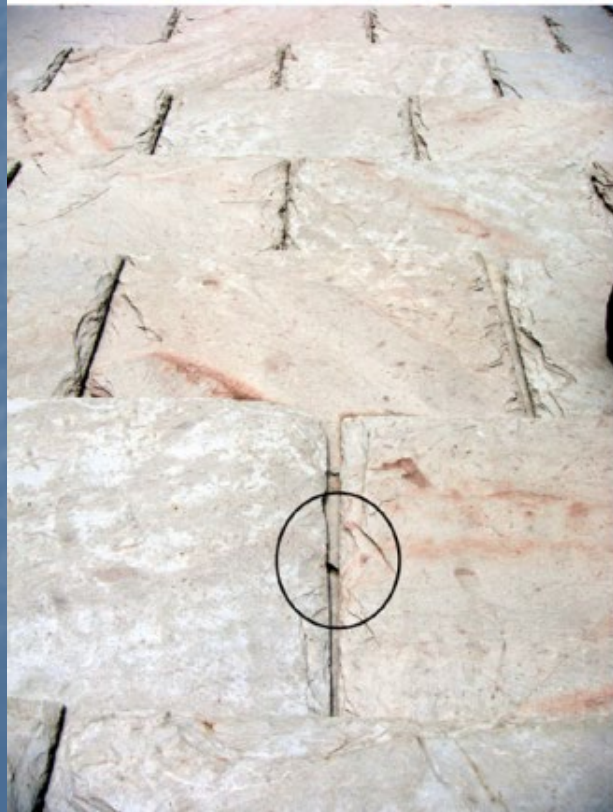
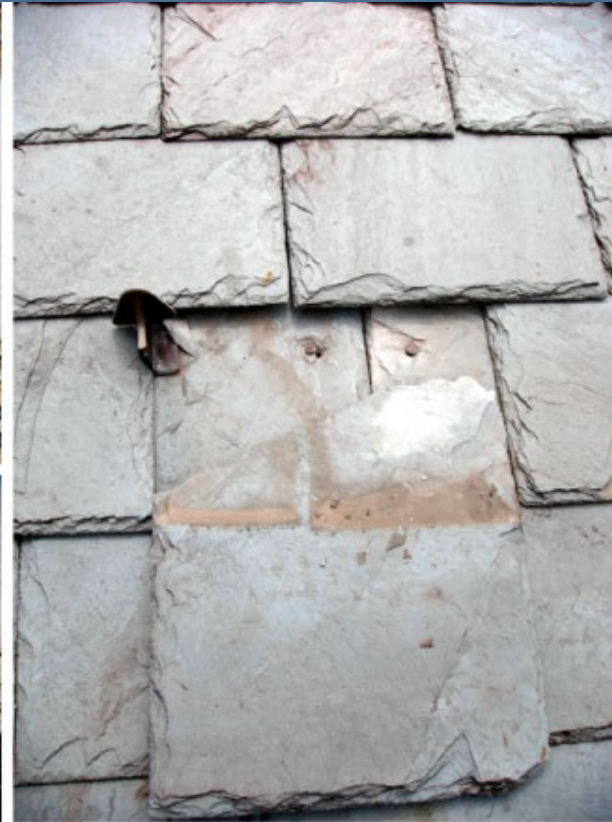
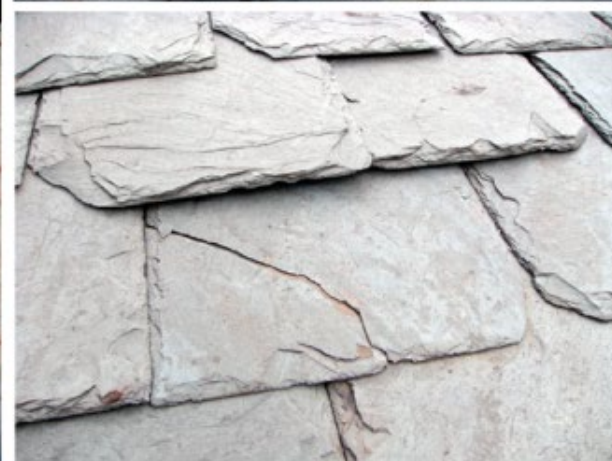
Foot traffic on a slate roof causes breakage. Make sure the roof is staged correctly during installation! These photos show foot traffic damage on a 6:12 sloped roof, newly installed.

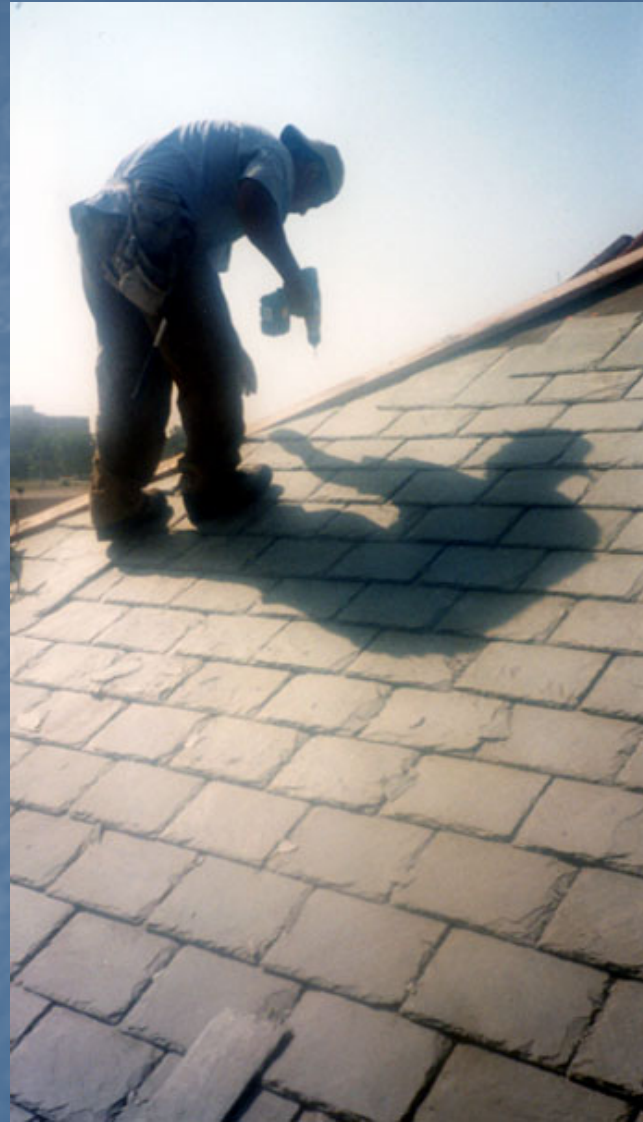
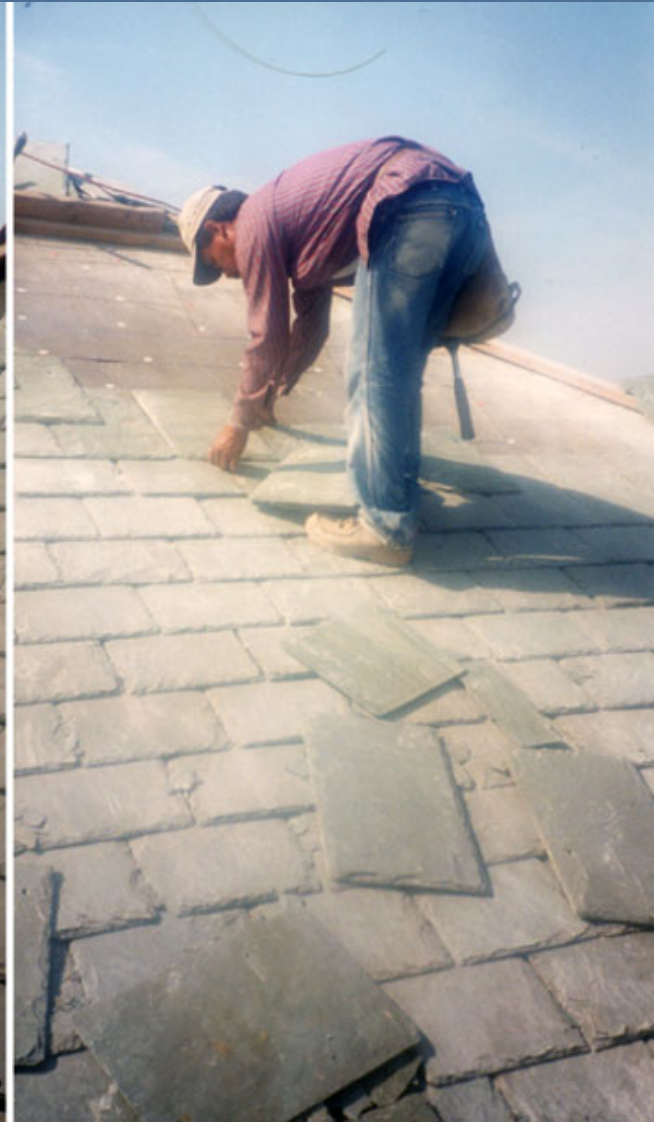
Slate roofs should not be walked on during installation or at any time unless necessary. It's easy to stage a roof correctly to avoid this problem!

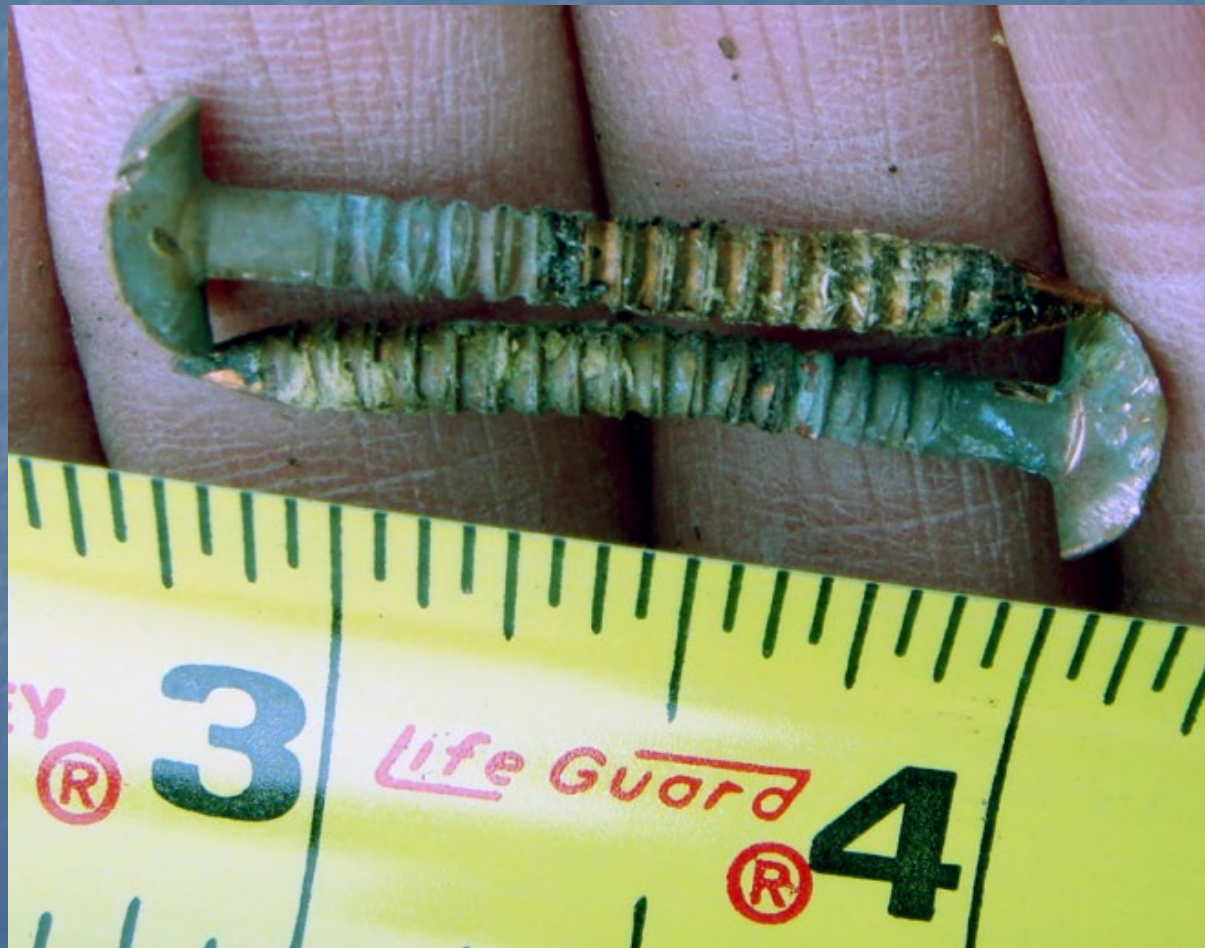
Avoid ring-shank nails when installing roofing slates. During repairs, they tend to break rather than pull out, making repair work very difficult!

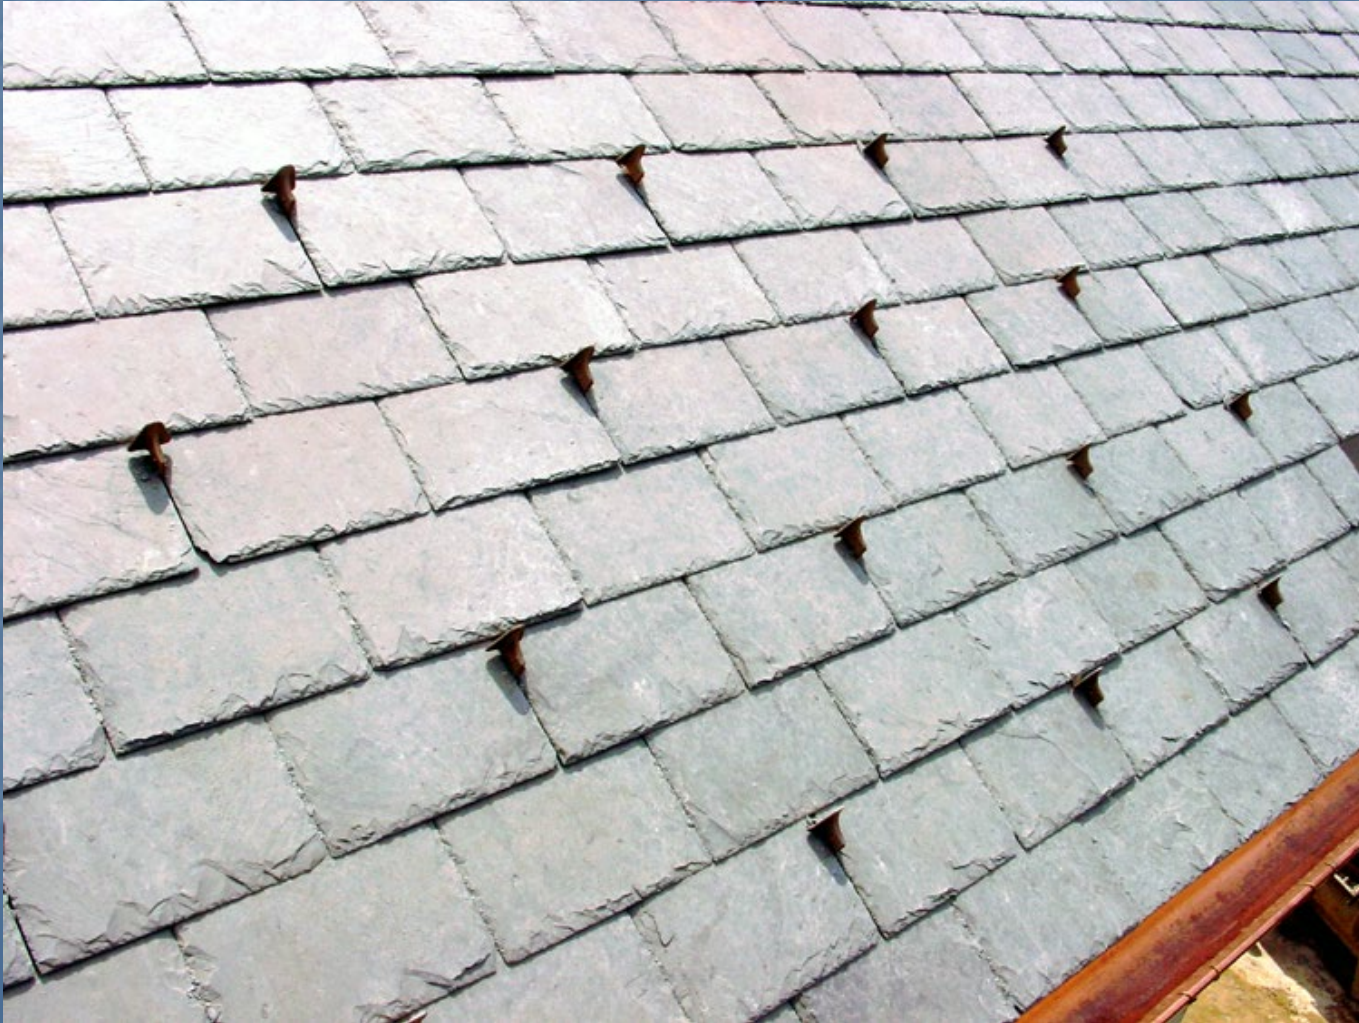
Headlap cannot be decreased, but it can be increased to mitigate ice-dam or drainage problems. The bottom 3 feet of this roof has 5" headlap, the remainder has 3".

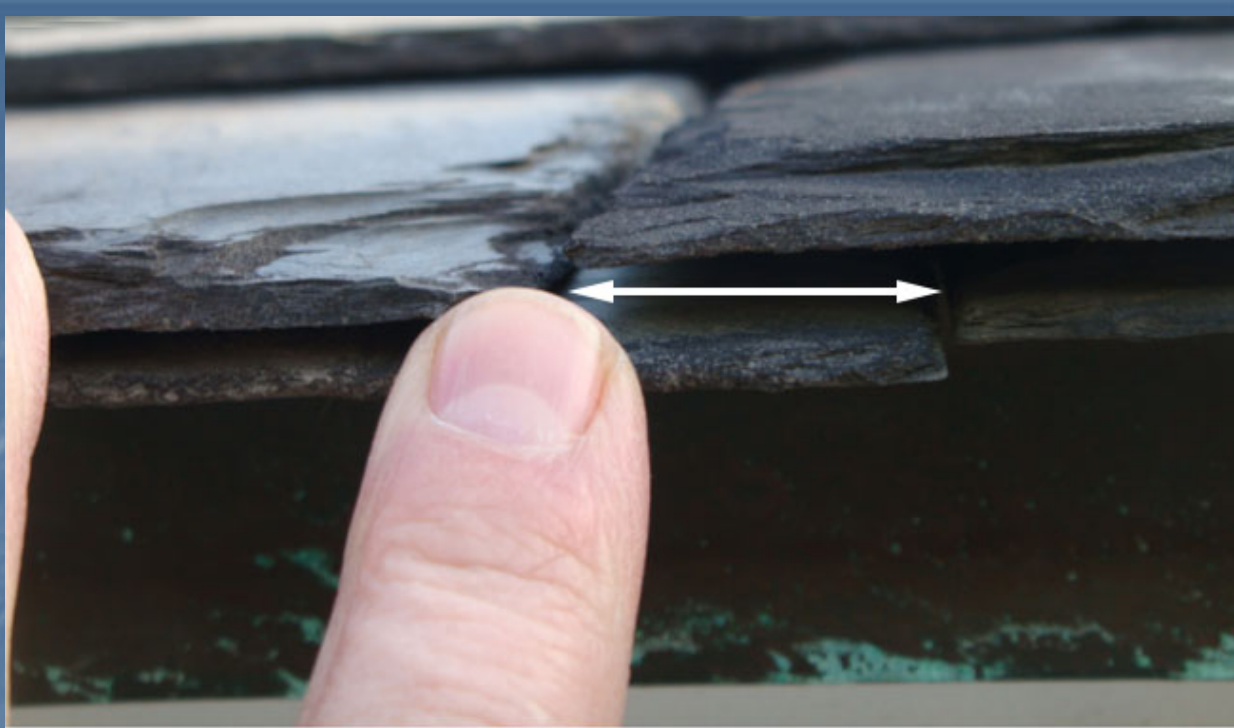
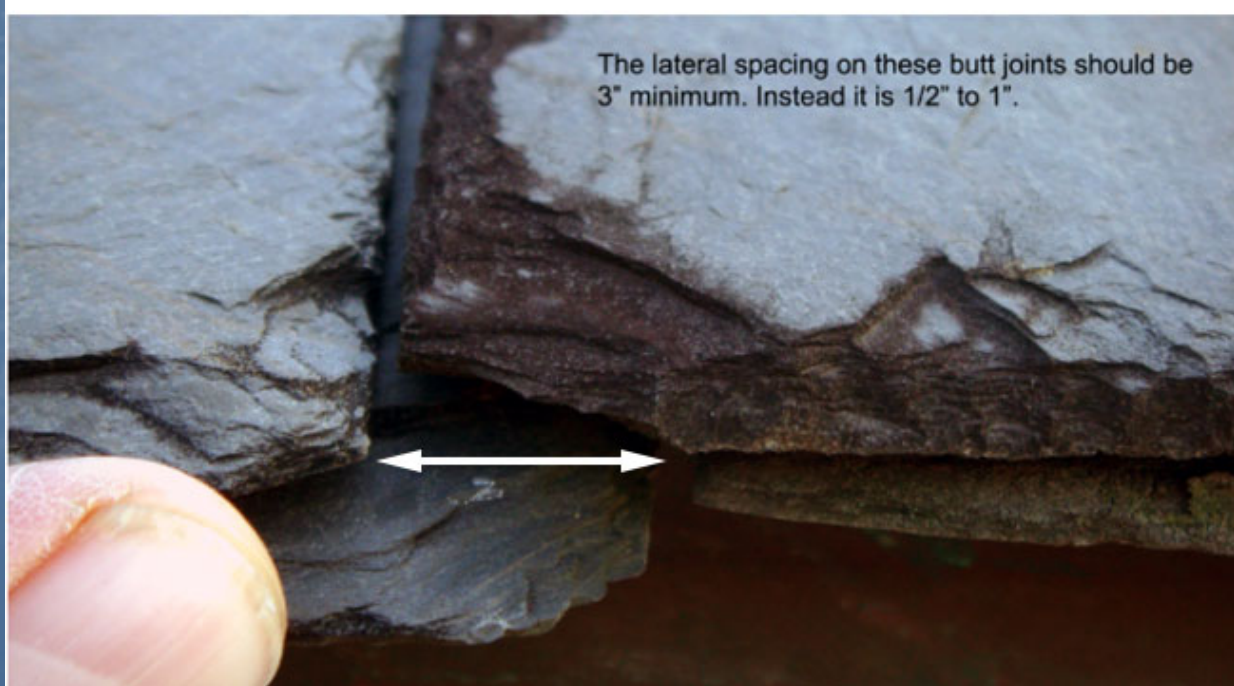
Incorrect
sidelaps on the
starter course
are a common
problem among
inexperienced
installers.

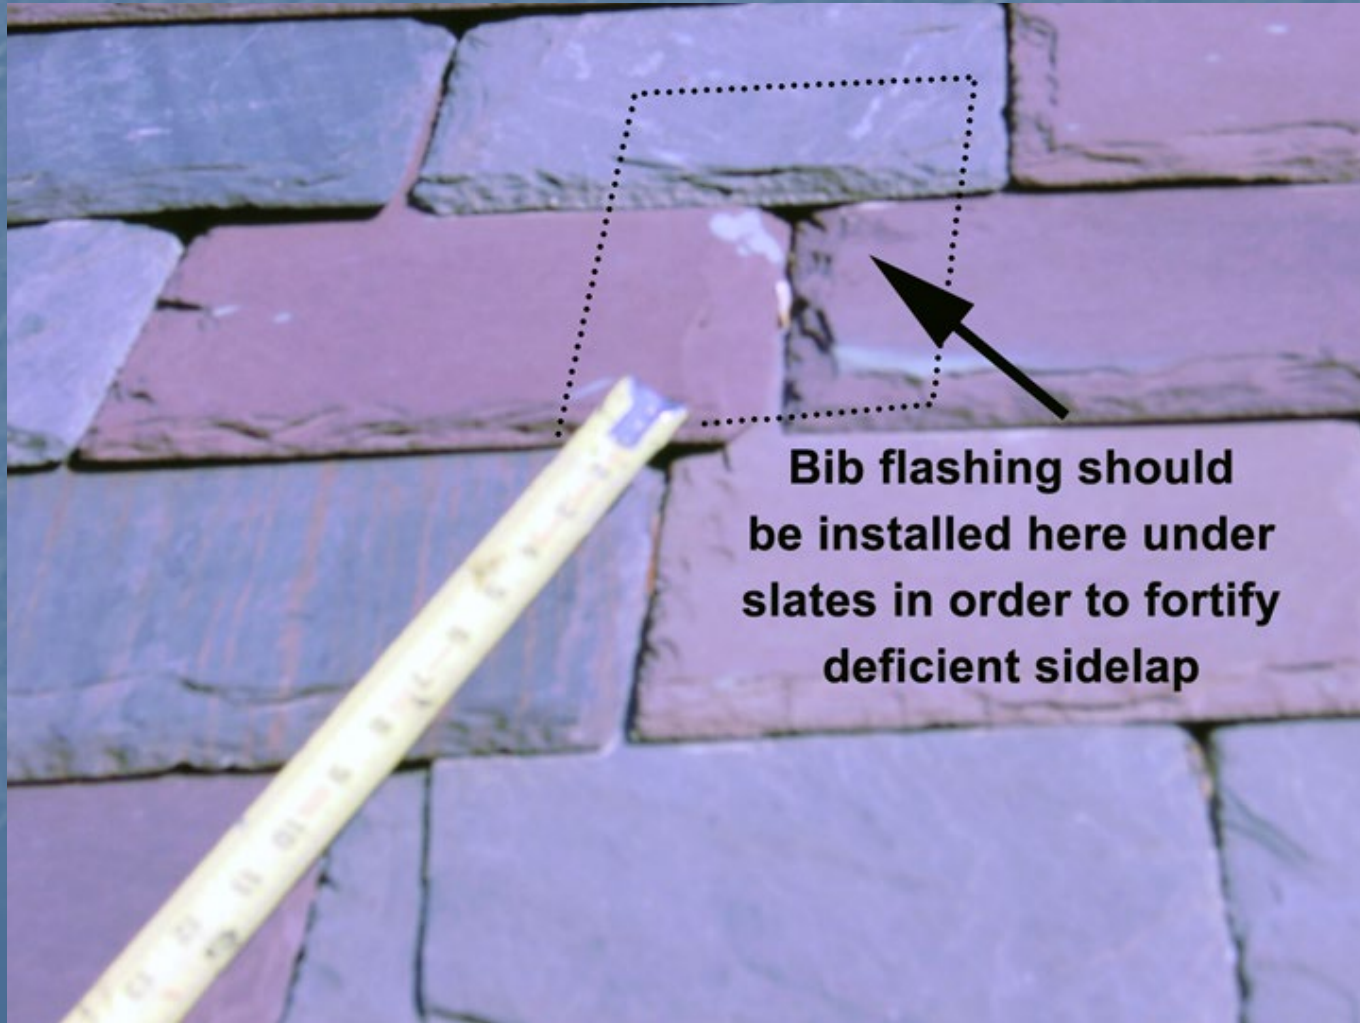
If the side butt is too close to the edge of the underlying slate, it can allow water into the underlying nail. A bib flashing can correct this.

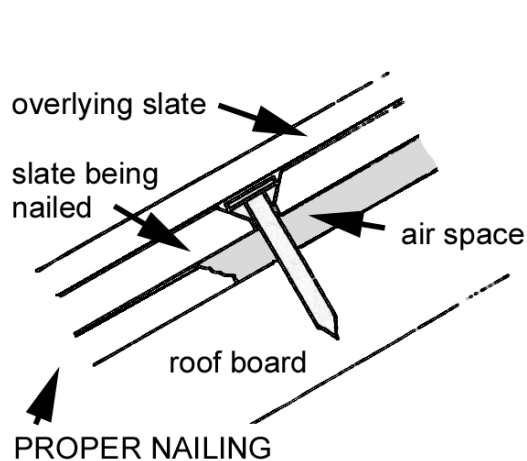
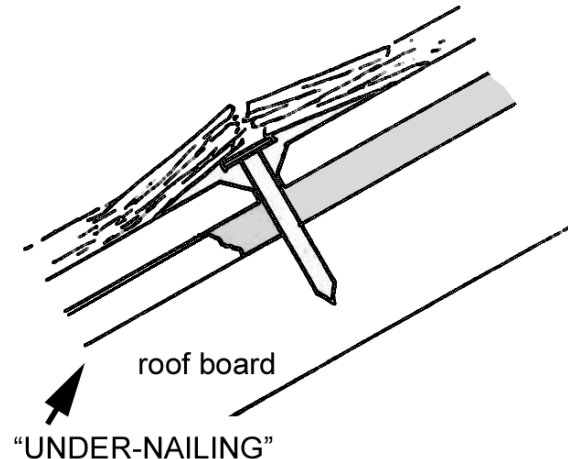
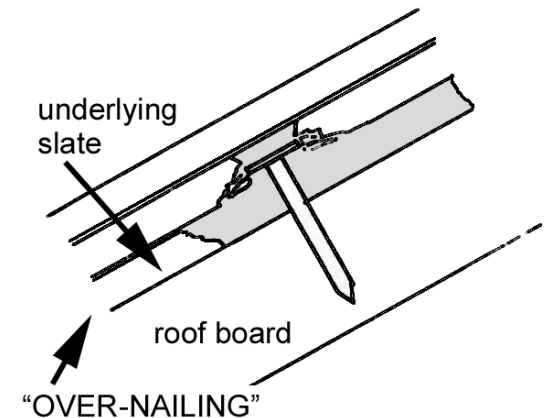
The nails should not be over-driven or under-driven.
