How to Avoid Installation Errors When Installing Slate Roofs

**ARCHITECTS AND INSTALLERS
SEMINAR SERIES**

Slate Roofing Contractors Association of North America, Inc.

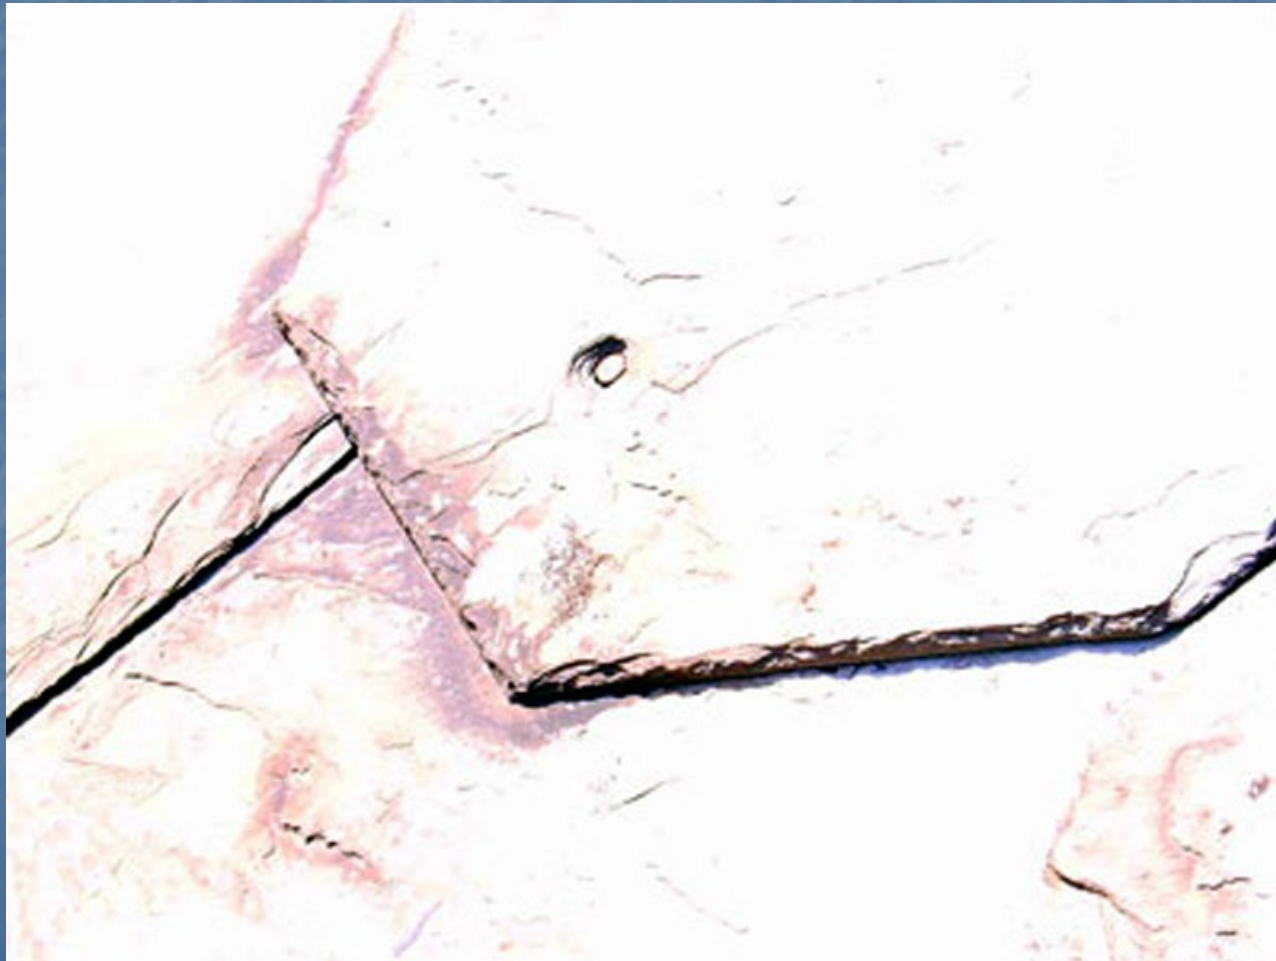
Under-nailing:
The nail head will work a hole in
the overlying slate over time.

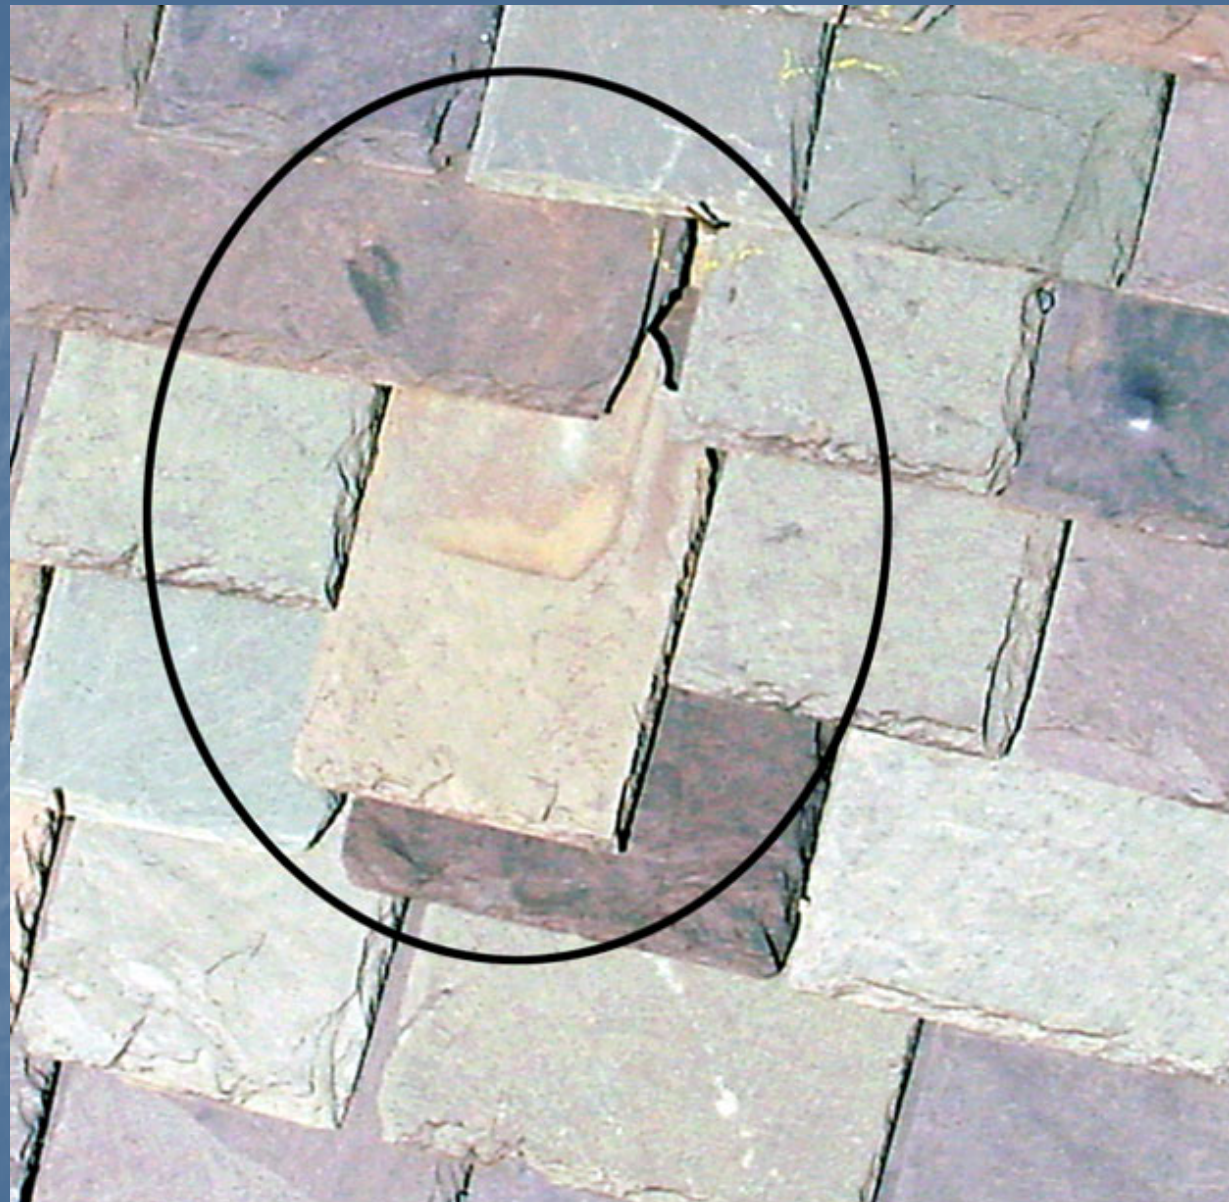
Over-nailing can result in slates sliding off the roof.

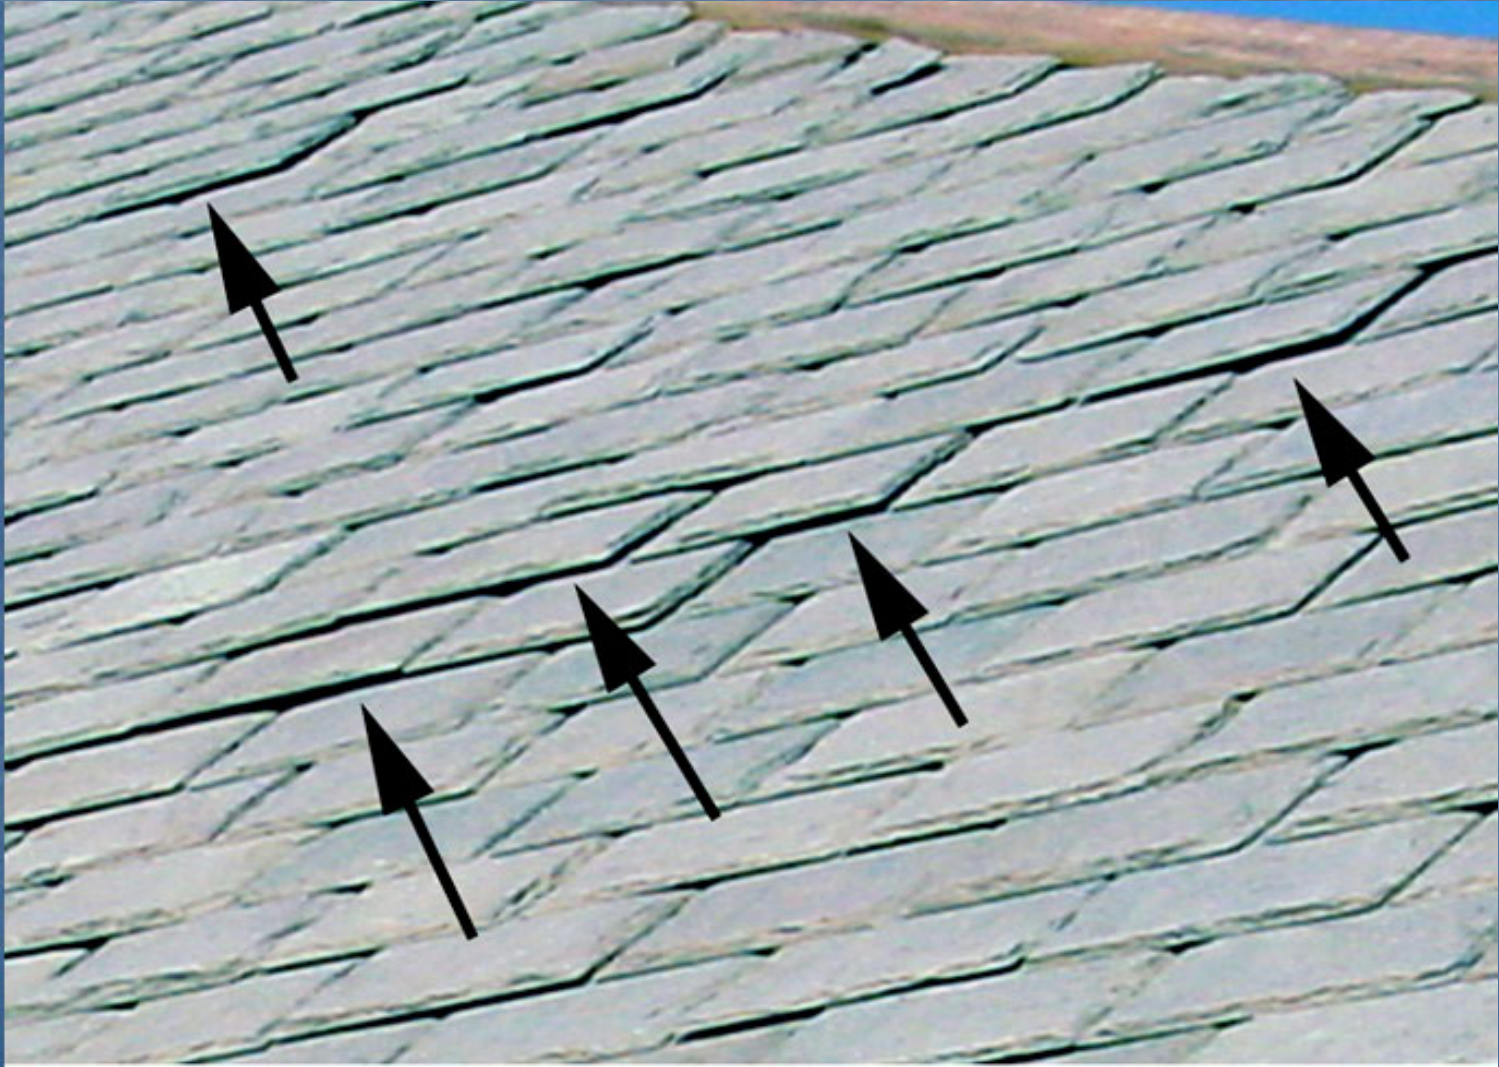
The bottom of the slate should be held down when the slate is nailed, not the top. Otherwise the slates may not lie flat (when irregular slates are being used).

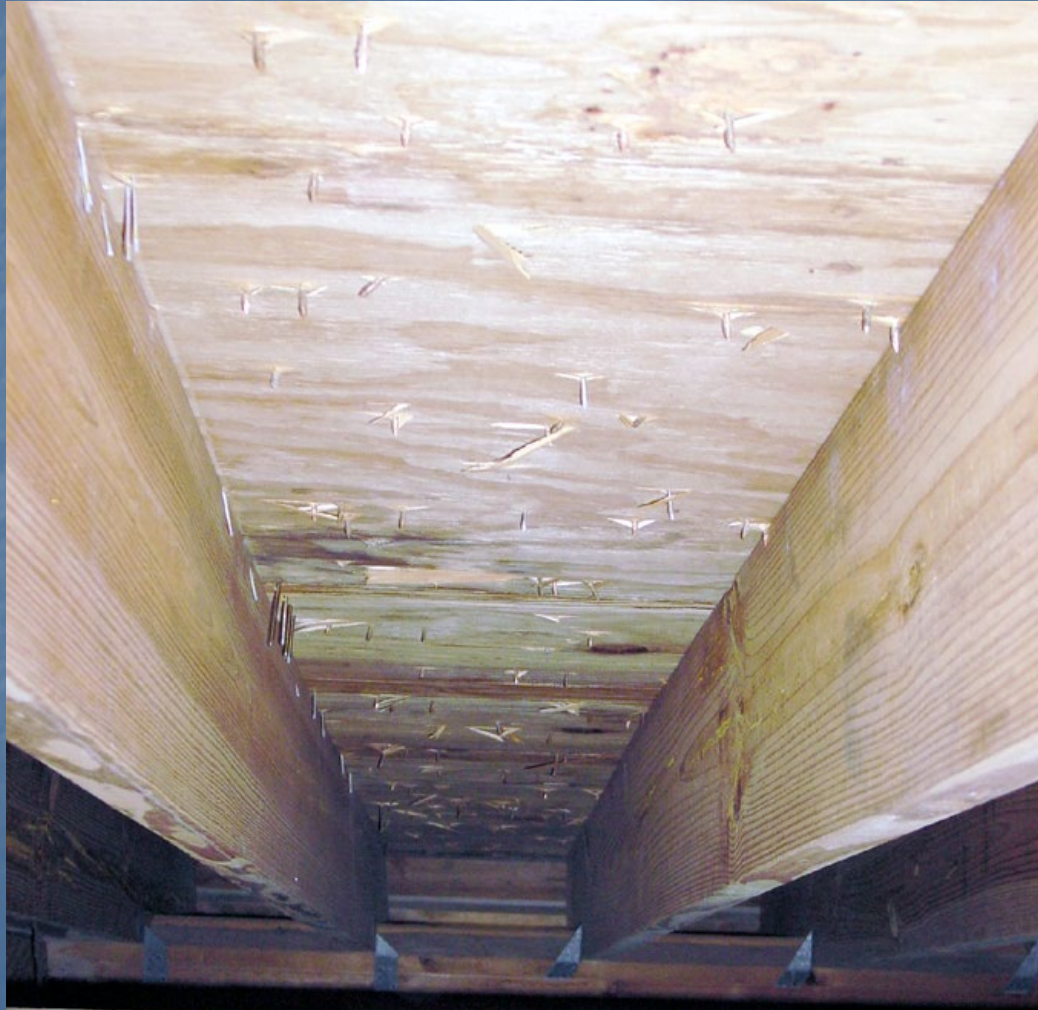
The slating nails should be twice the thickness of the slate plus 1". They should barely penetrate the roof decking. The nails used here were too long, and the roof deck was too thin.

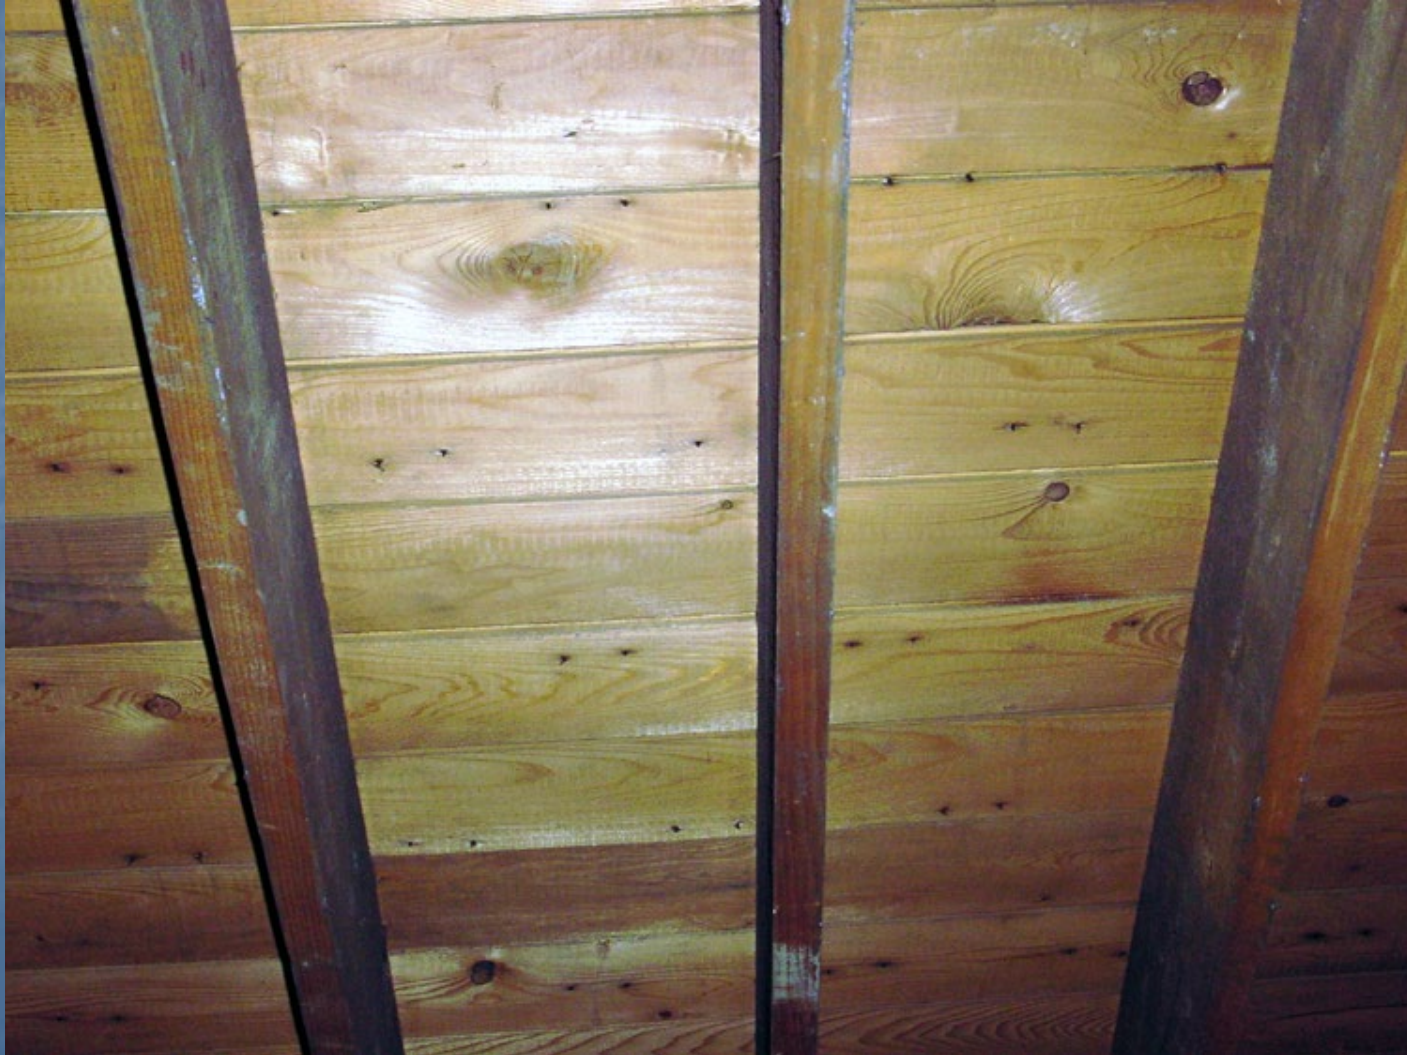
The slating nails will barely penetrate a properly nailed roof deck made with correct materials, as shown here.

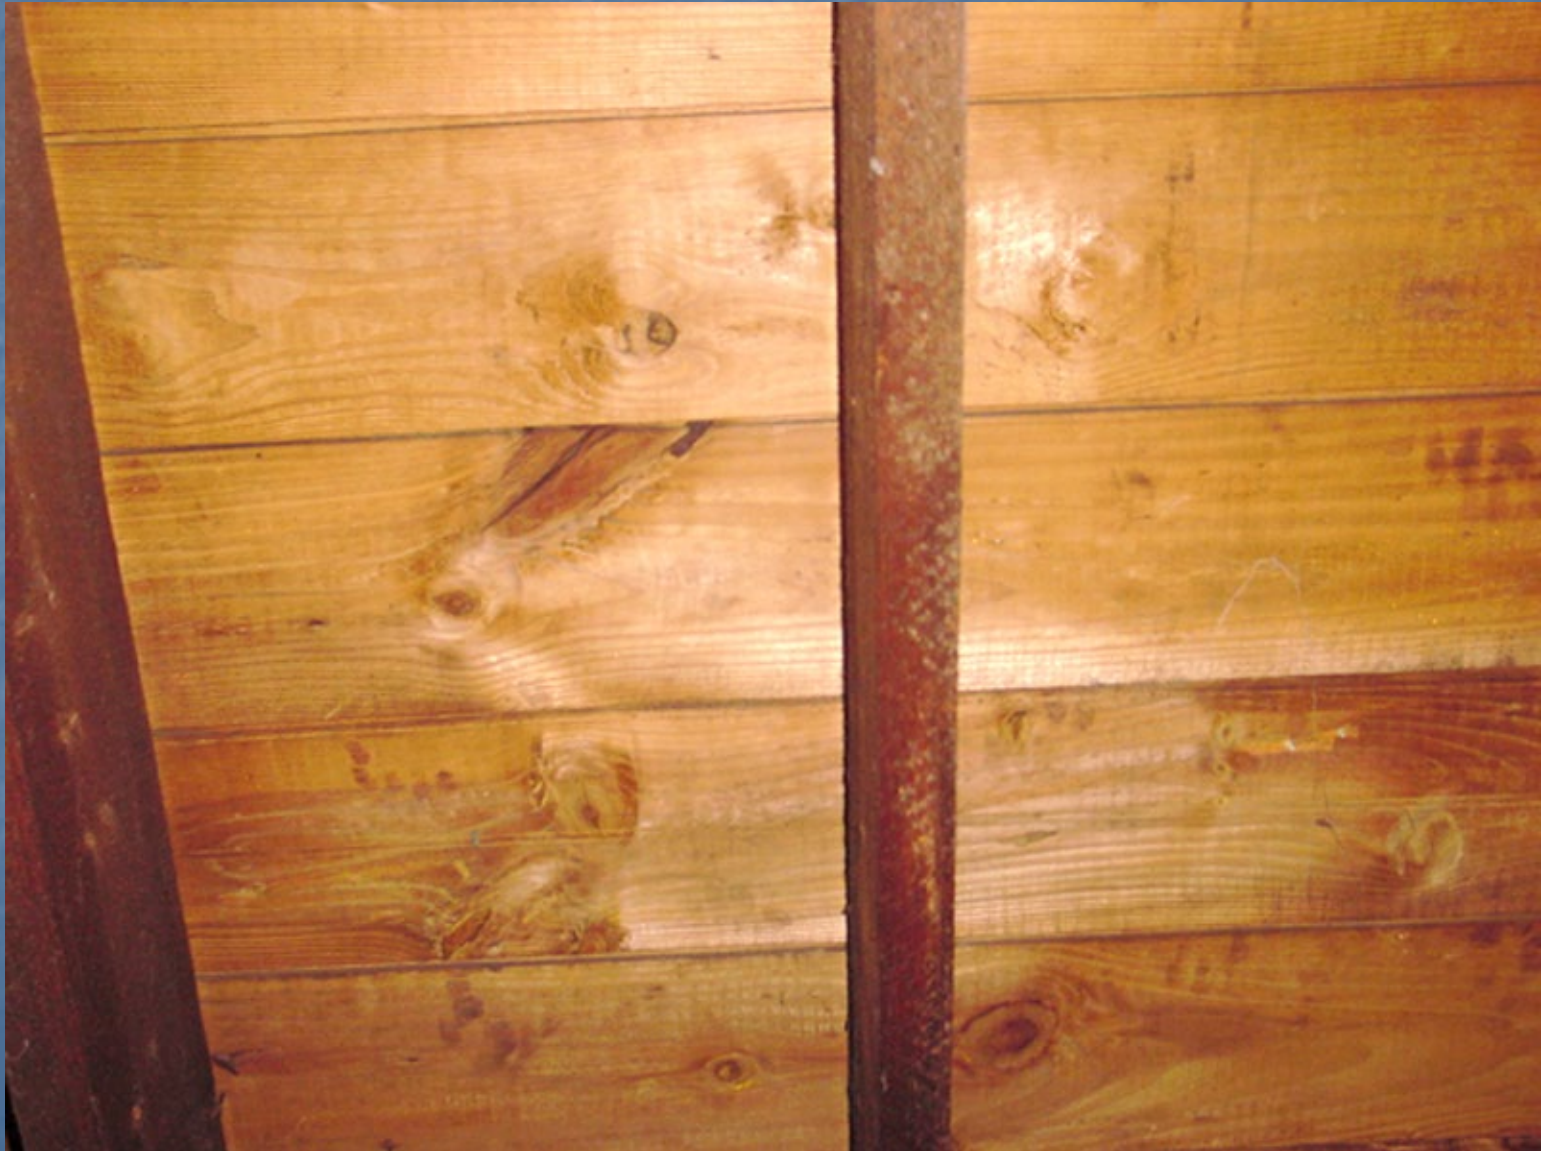
This is another properly nailed slate roof deck.
Note that there is no nail penetration.

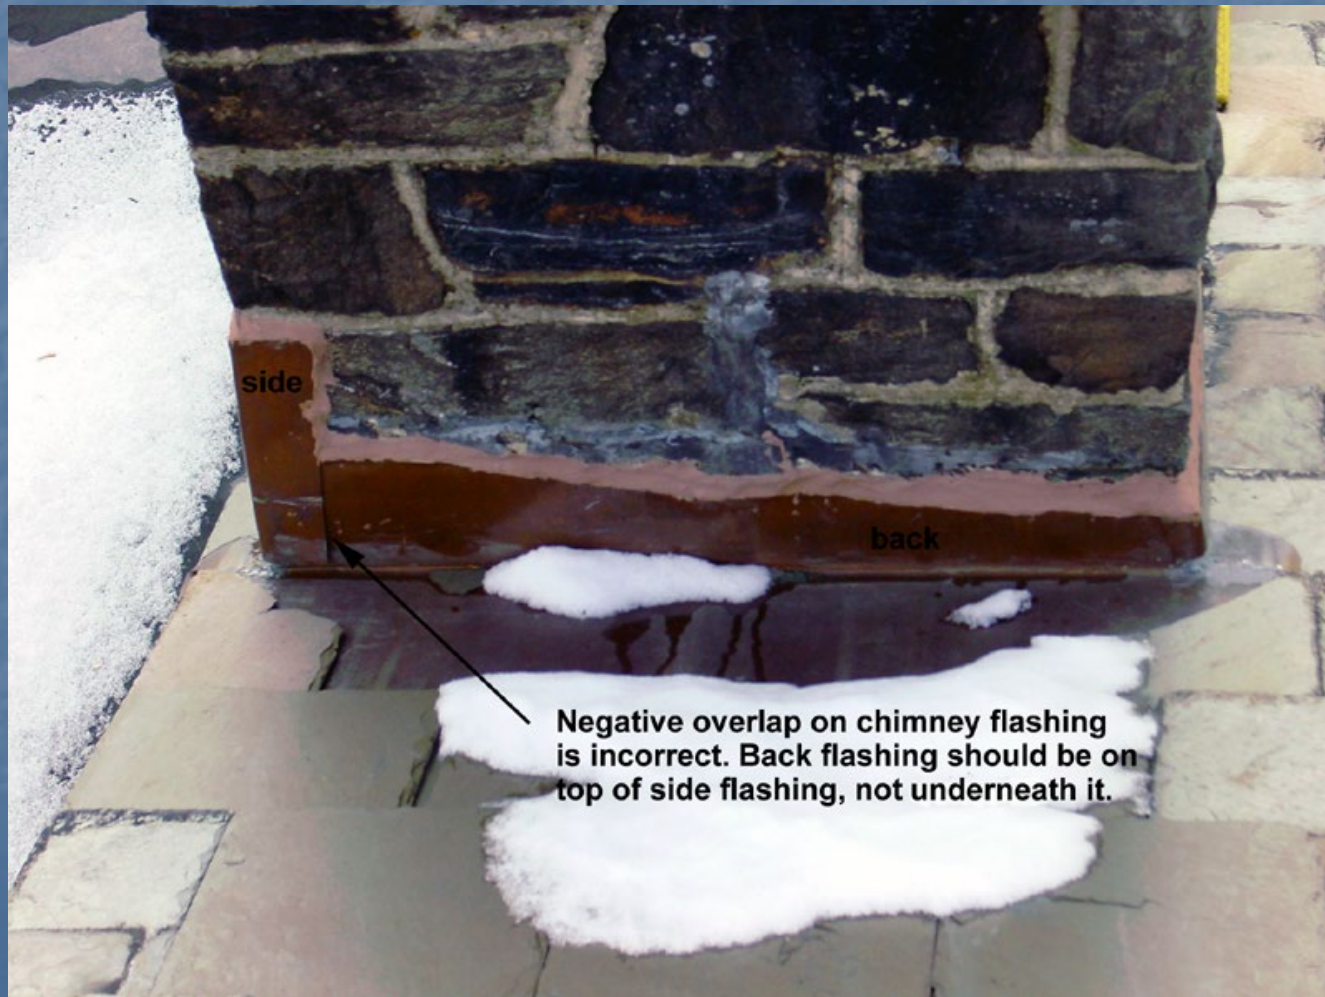
Negative overlapping means the flashing is overlapped incorrectly. Upper flashings must lie on top of lower flashings, not underneath them!

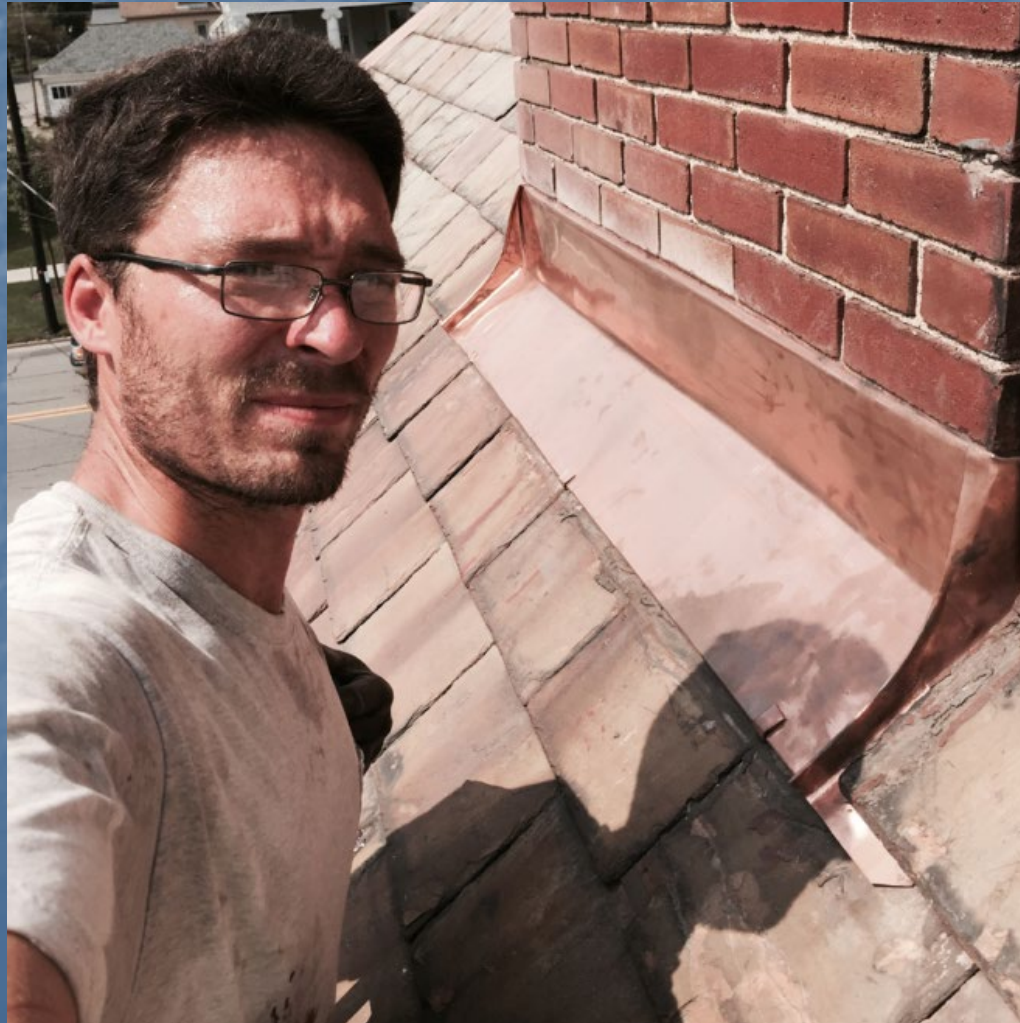
Double-locked curved standing-seam corners are leak-proof and don't require solder or sealants.

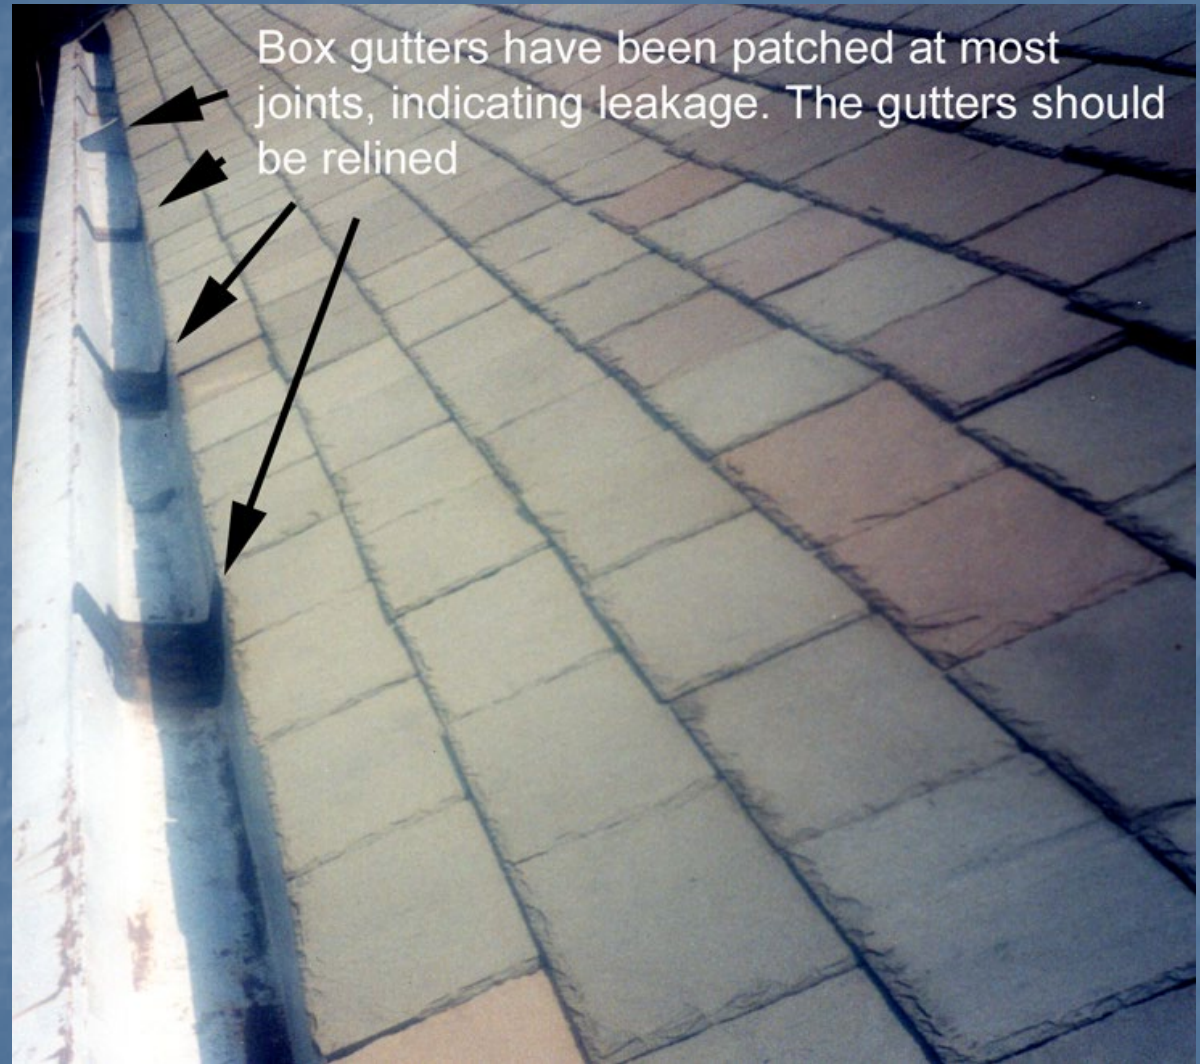
Lack of expansion joints in built-in gutters causes the solder joints to fail prematurely. Refer to SMACNA guidelines for thermal expansion allowances.

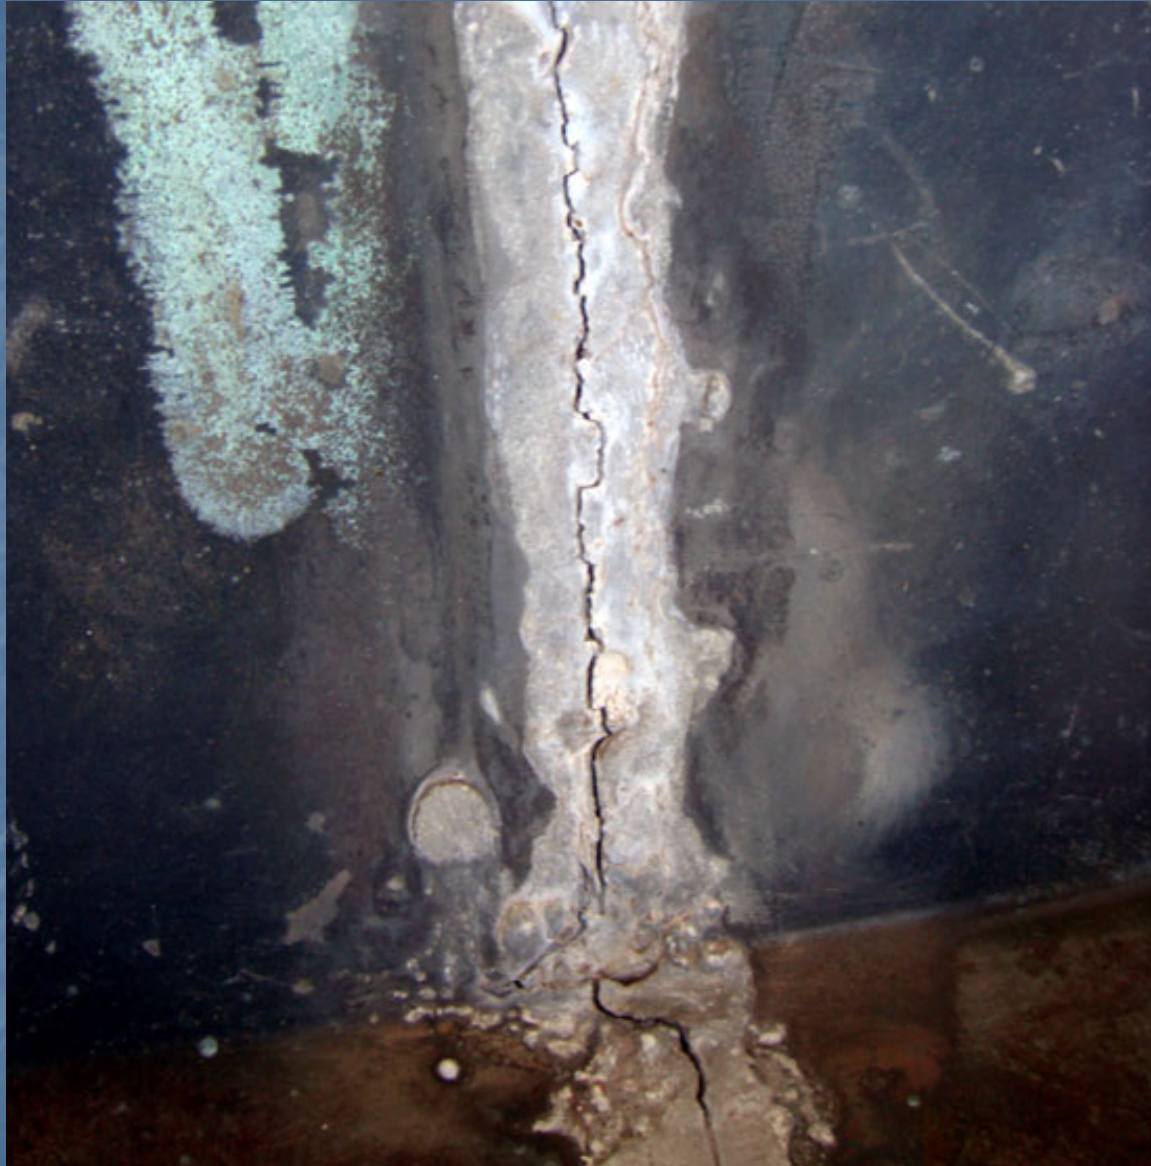
Make allowances
for thermal
movement,
otherwise solder
joints can crack
and leak.

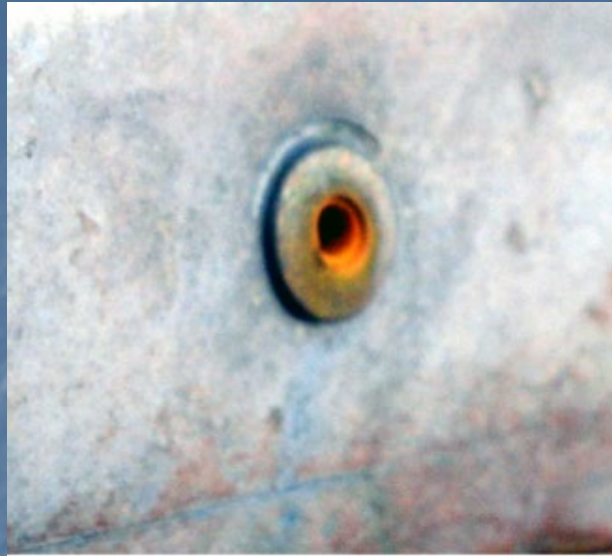
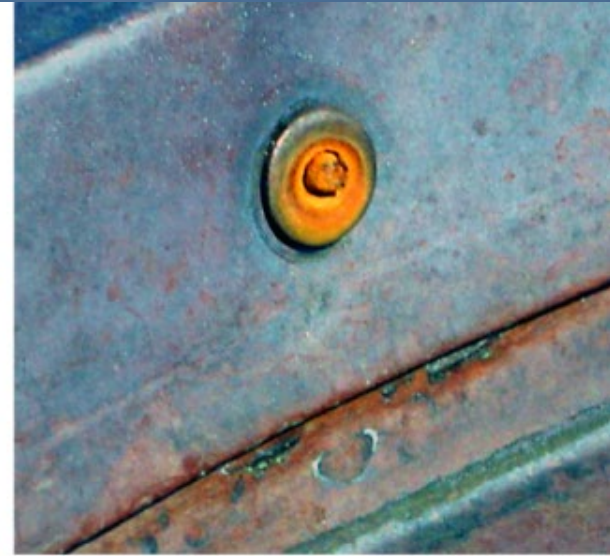
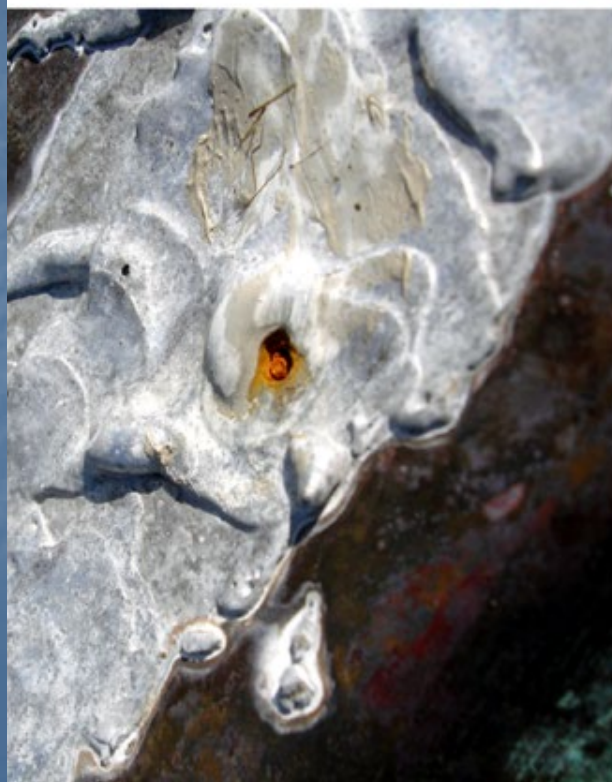
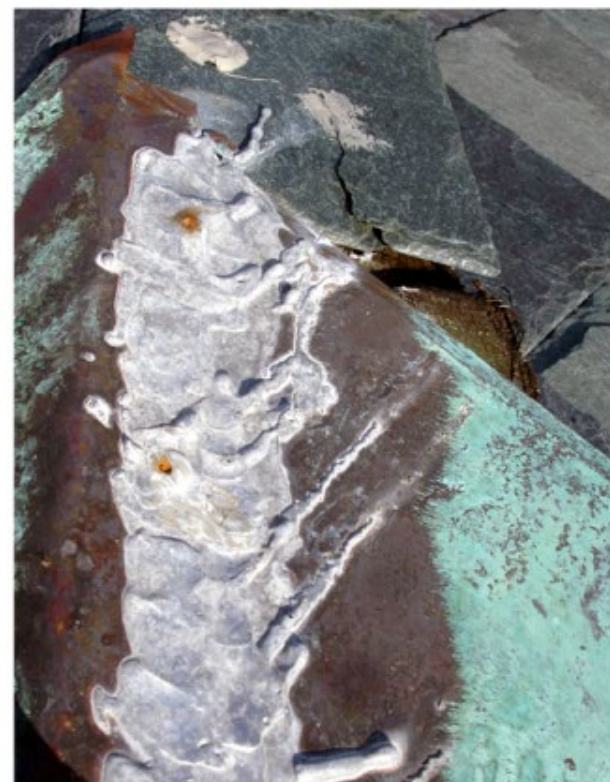
Make sure metal fasteners are galvanically compatible with the flashing metals! Here steel rivet mandrels are rusting in copper sheet metal. This is an error.

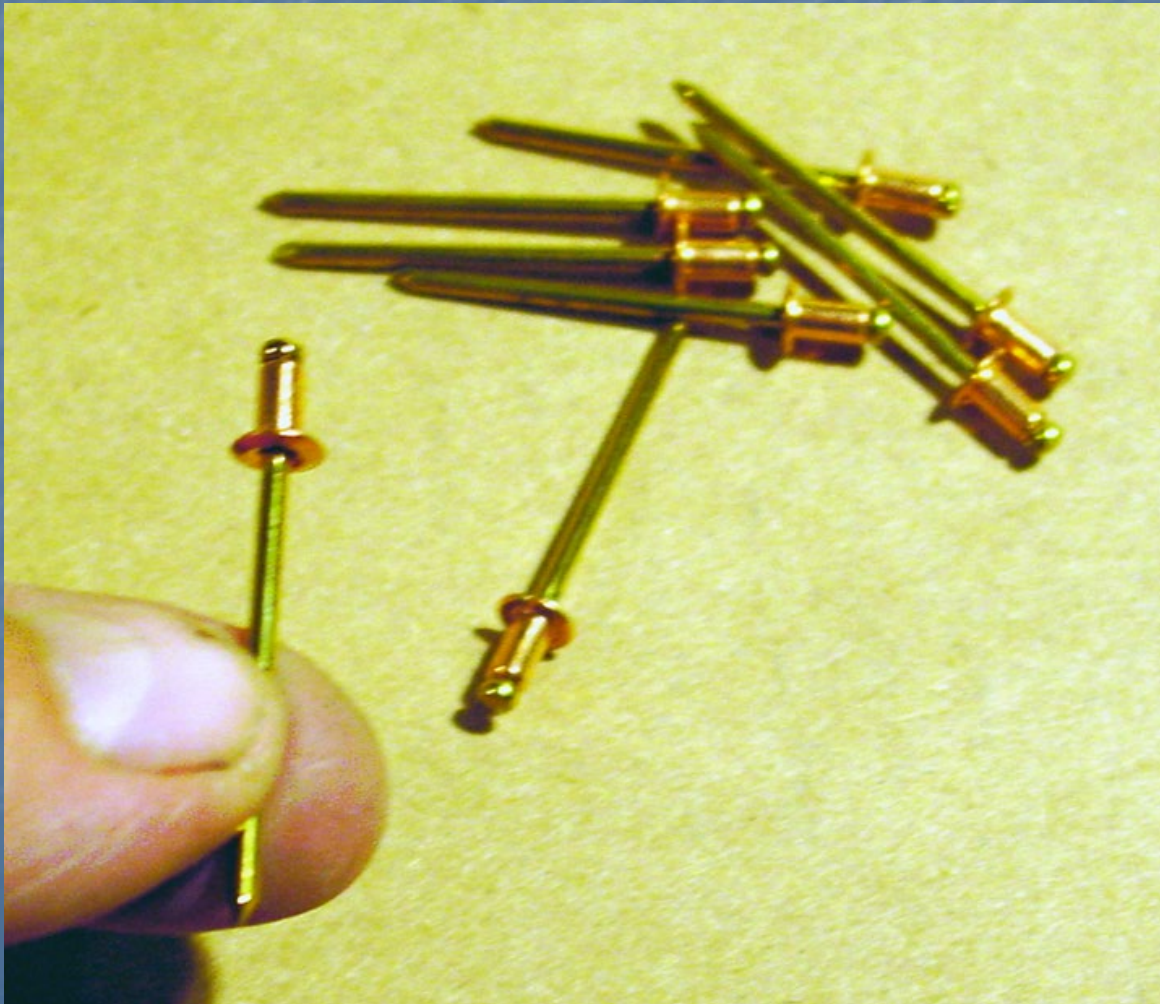
Use copper rivets with brass mandrels, or stainless-steel rivets, when riveting copper.

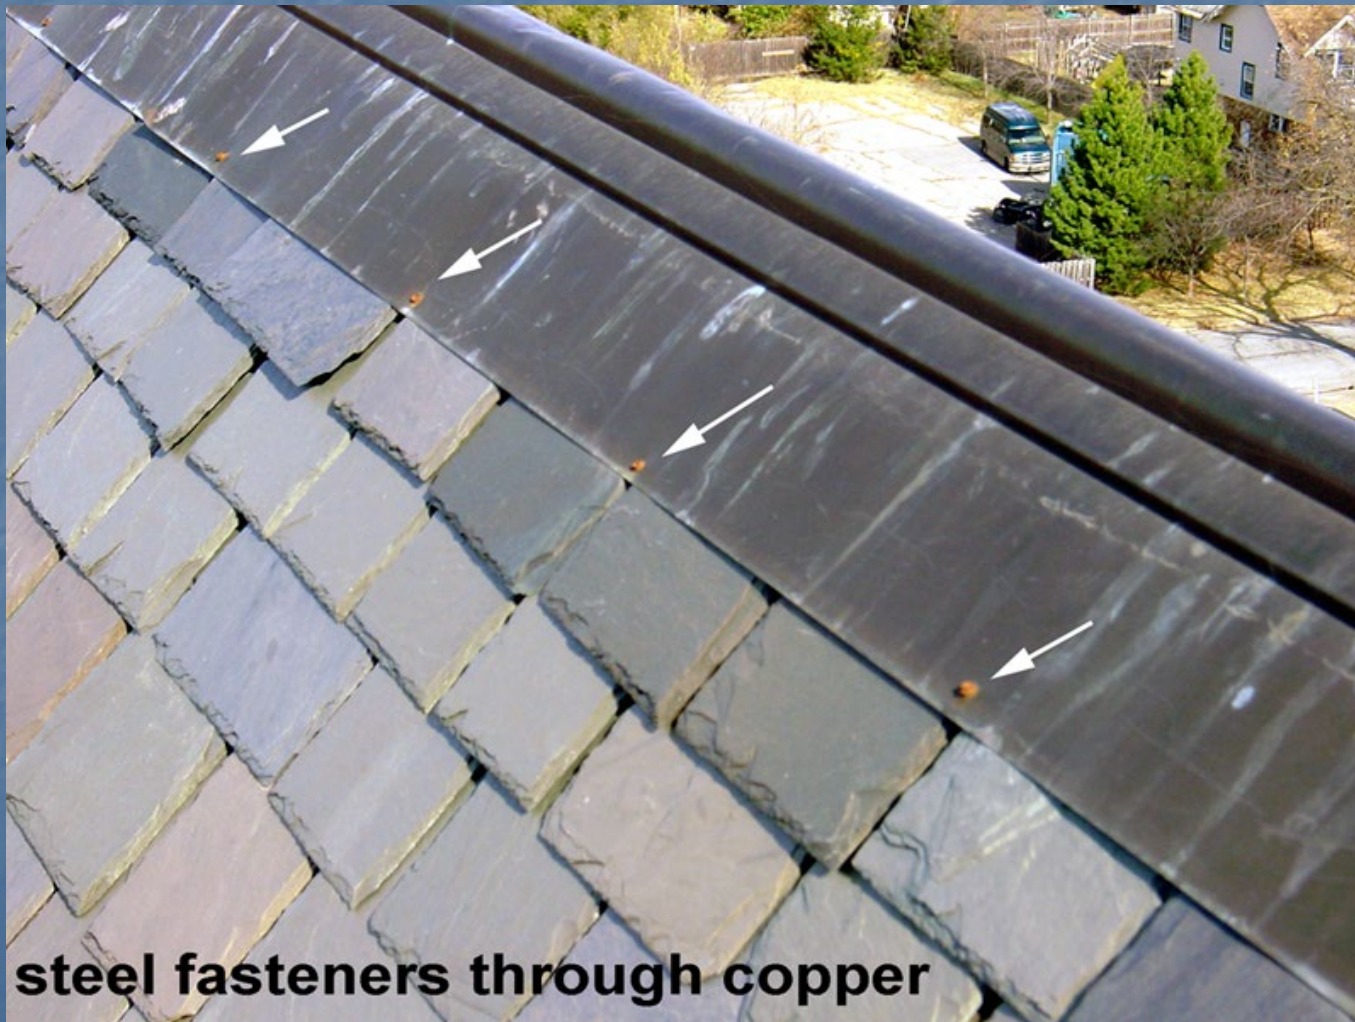
steel fasteners through copper

When steel is used on copper,
the steel rusts prematurely.

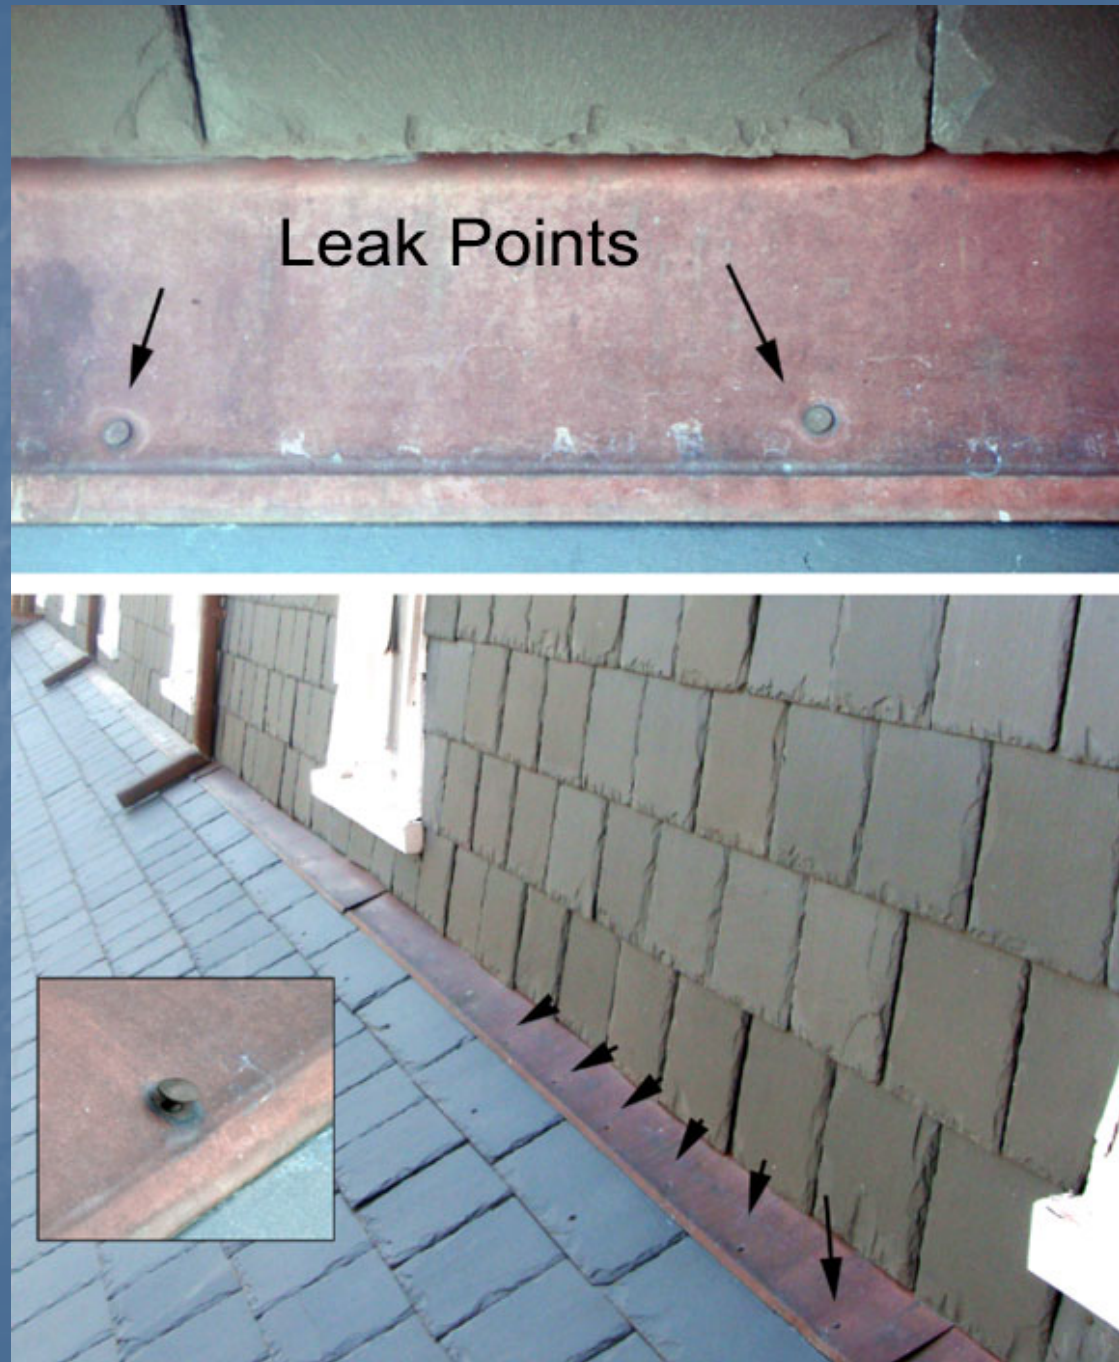
Exposed fasteners will leak. Flashings should be installed with concealed fasteners whenever possible.

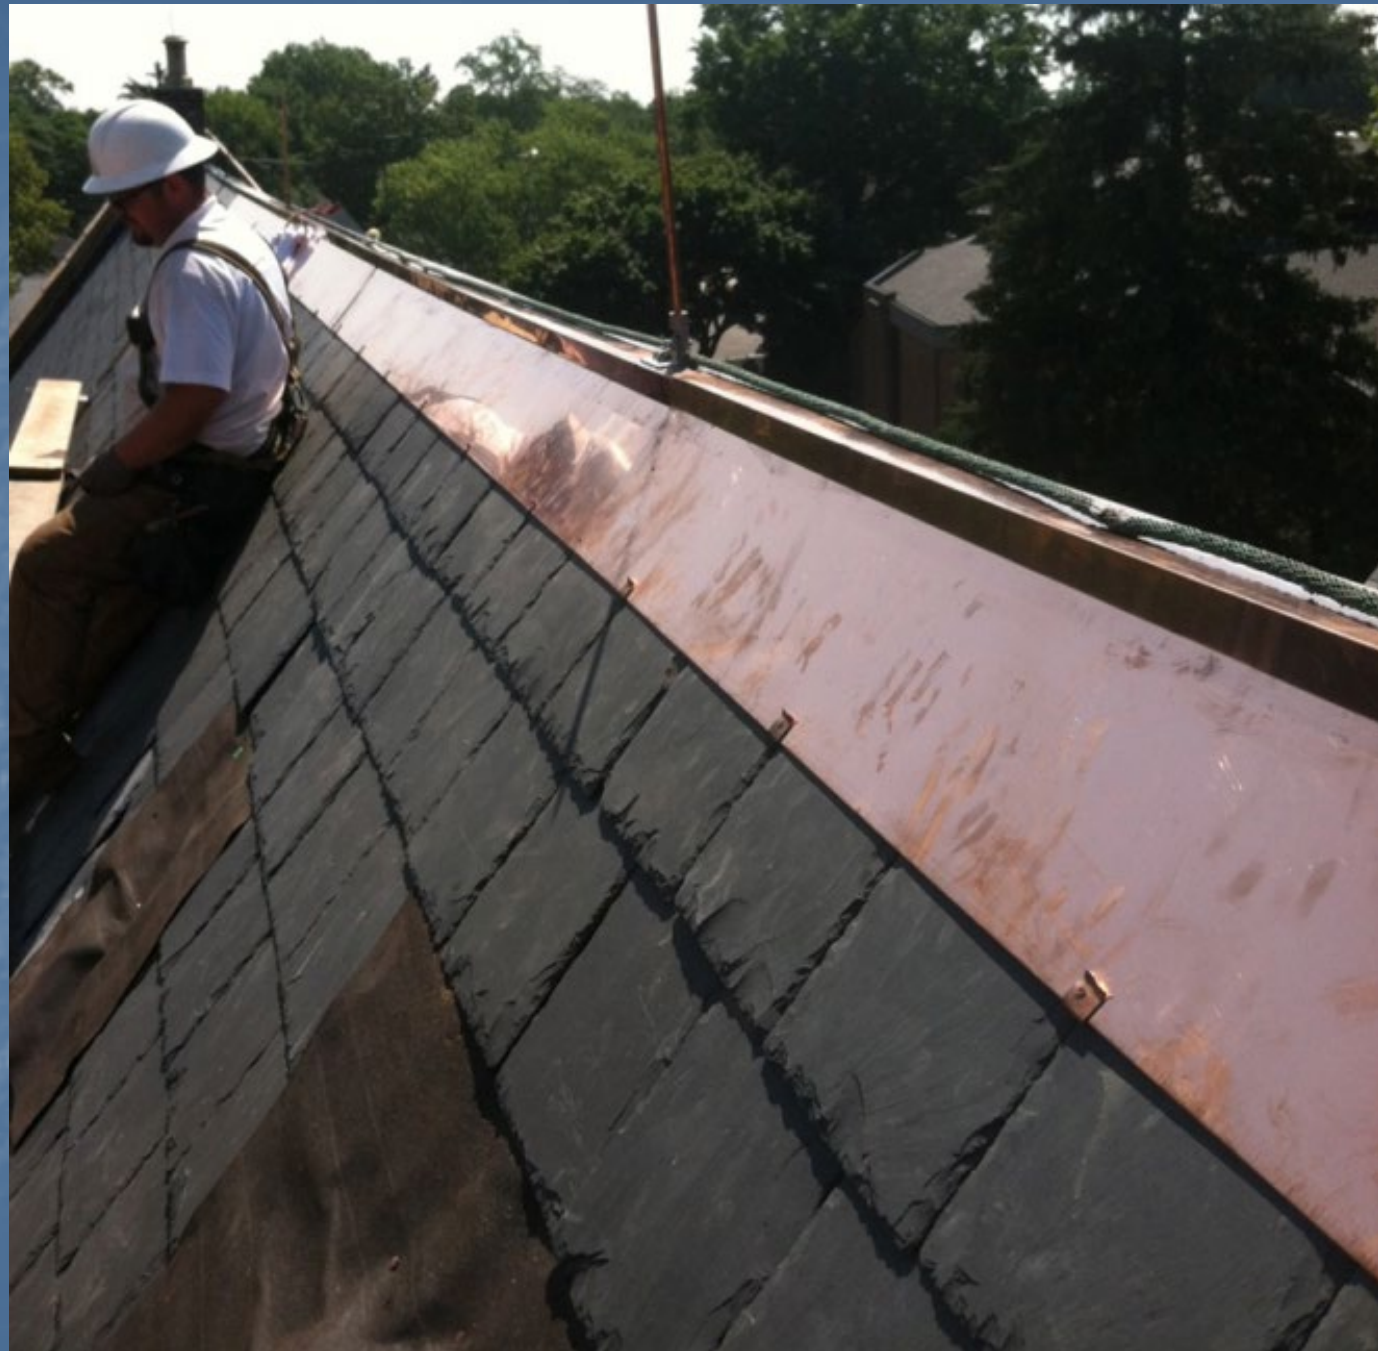
This copper ridge is riveted to copper cleats, leaving no exposed fasteners. The cleats are fastened to the roof underneath the ridge

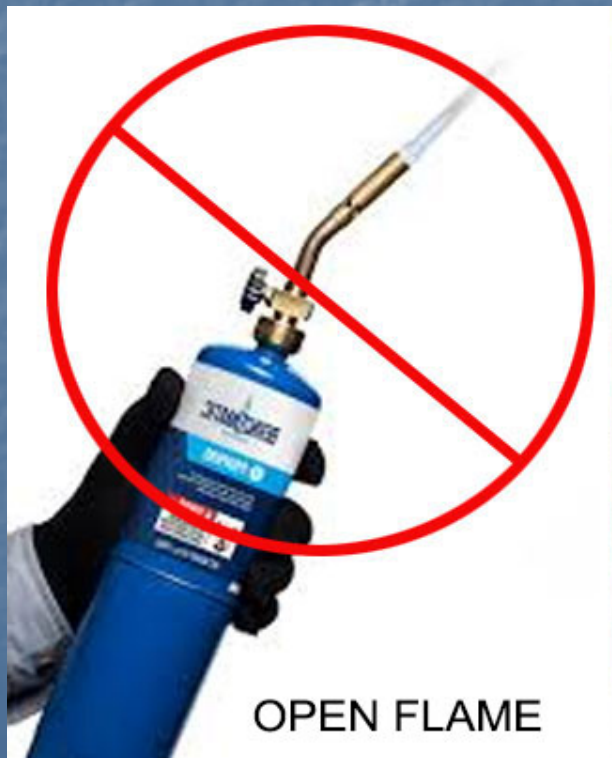
OPEN FLAME

Open flame torches used to solder flashings can start a building on fire. Use closed-flame soldering devices such as this one shown.
