How to Avoid Installation Errors When Installing Slate Roofs

**ARCHITECTS AND INSTALLERS
SEMINAR SERIES**

Slate Roofing Contractors Association of North America, Inc.

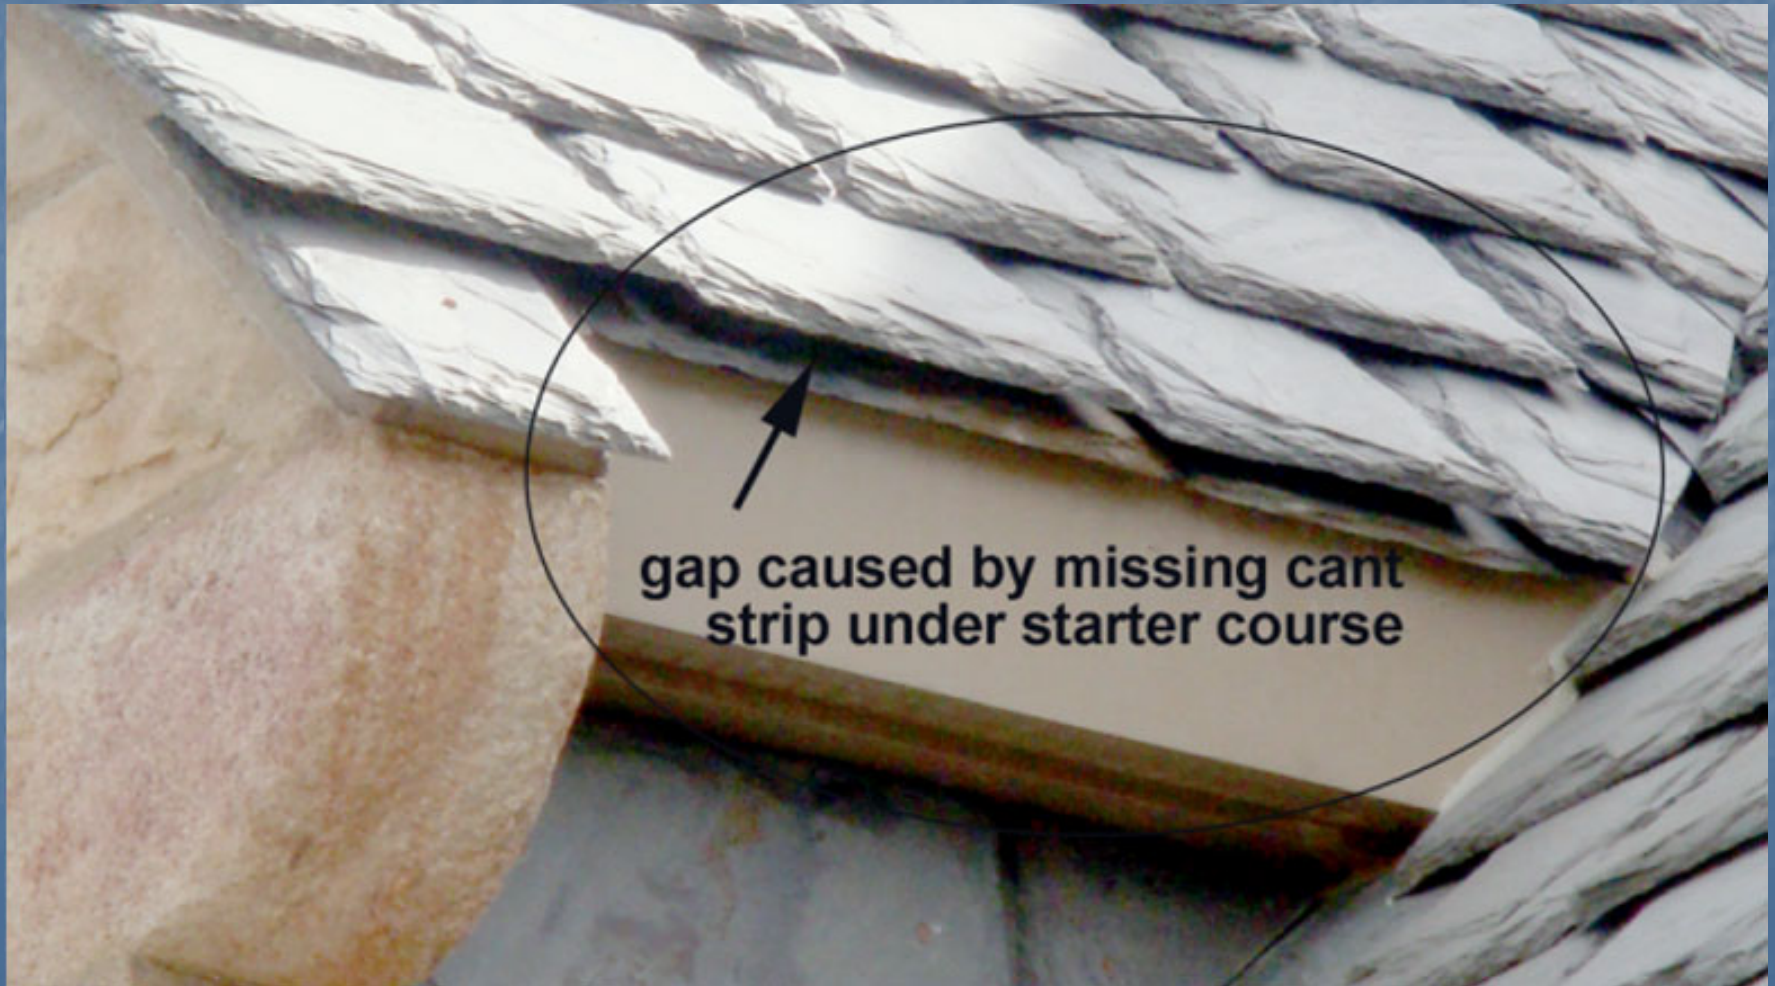
Lack of a cant strip prevents the starter course from lying flat.

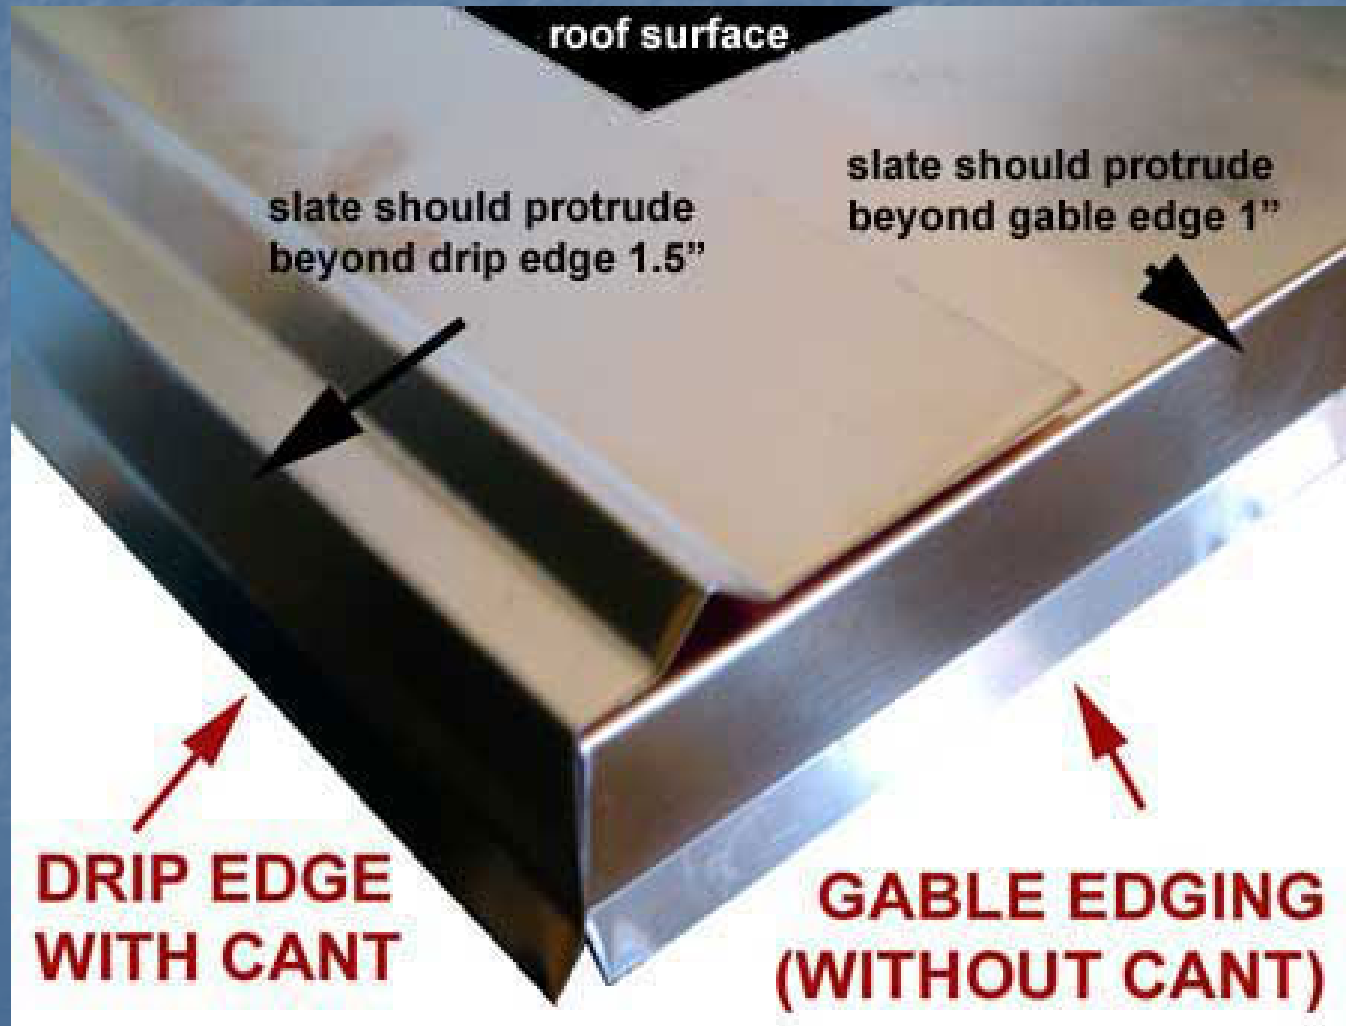
Traditional wooden cant strips work well. A cant can also be formed into a copper drip edge.

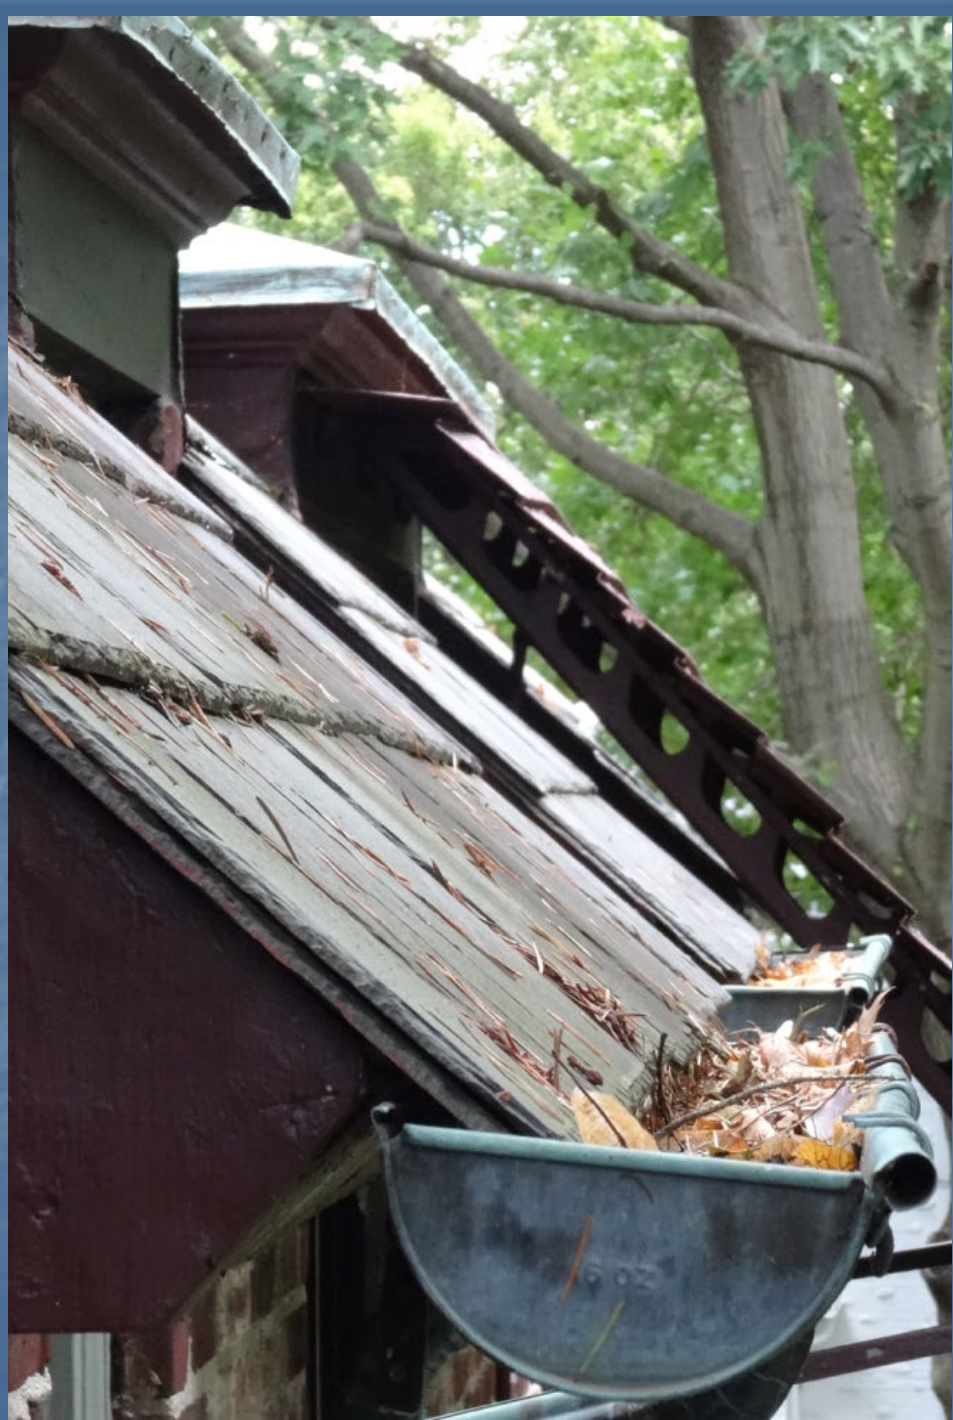
Gutters hung too tight against a roof will be damaged by sliding ice and snow.

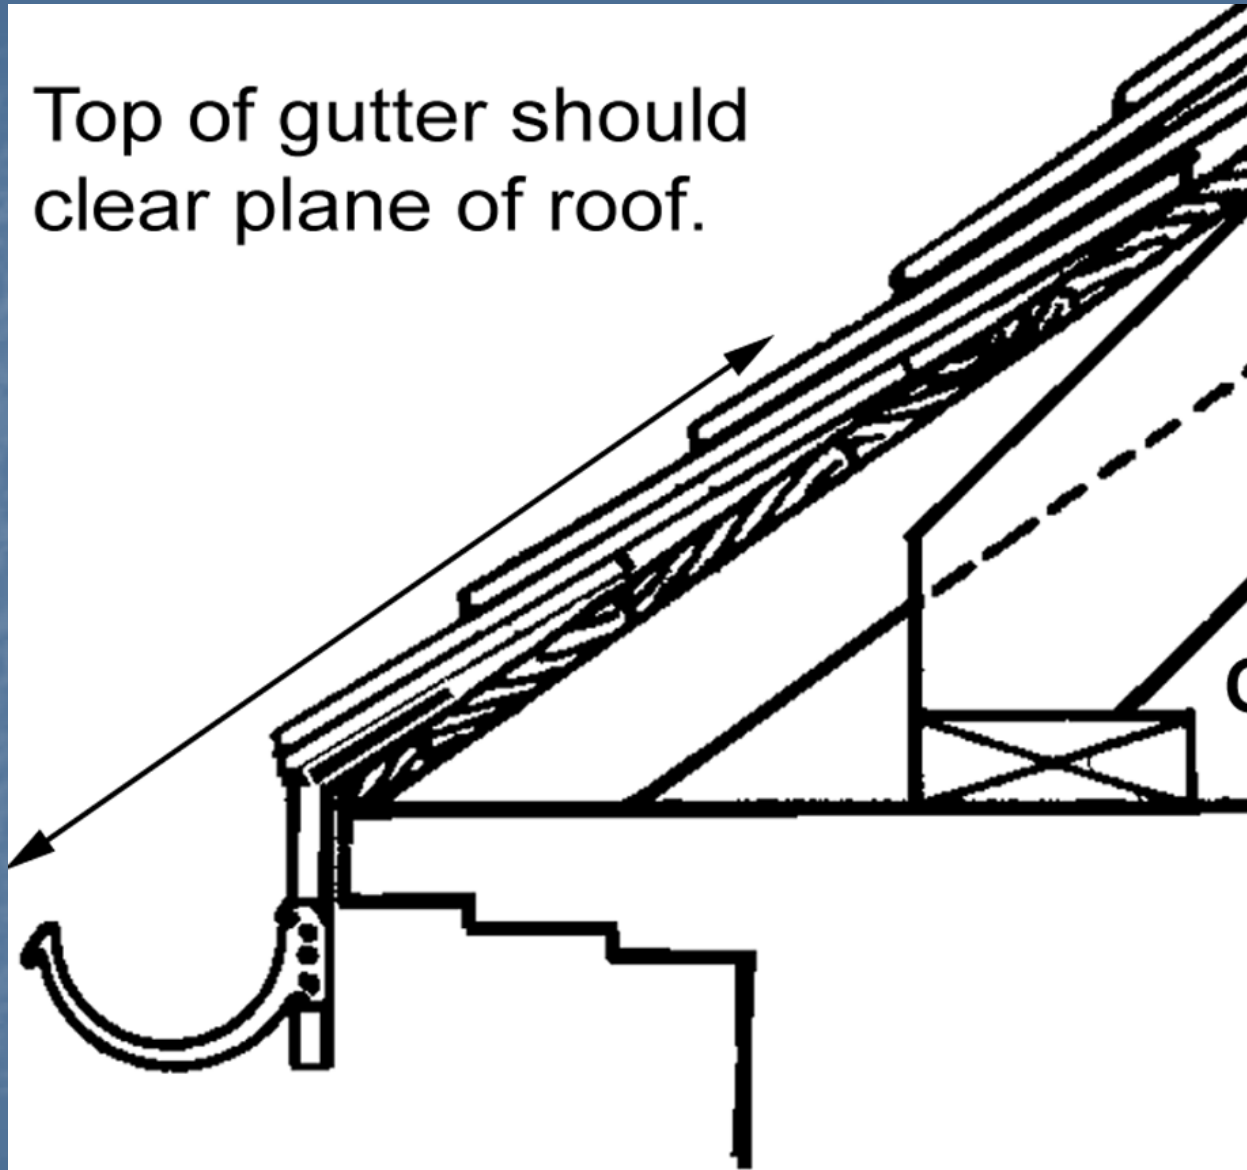
Top of gutter should
clear plane of roof.

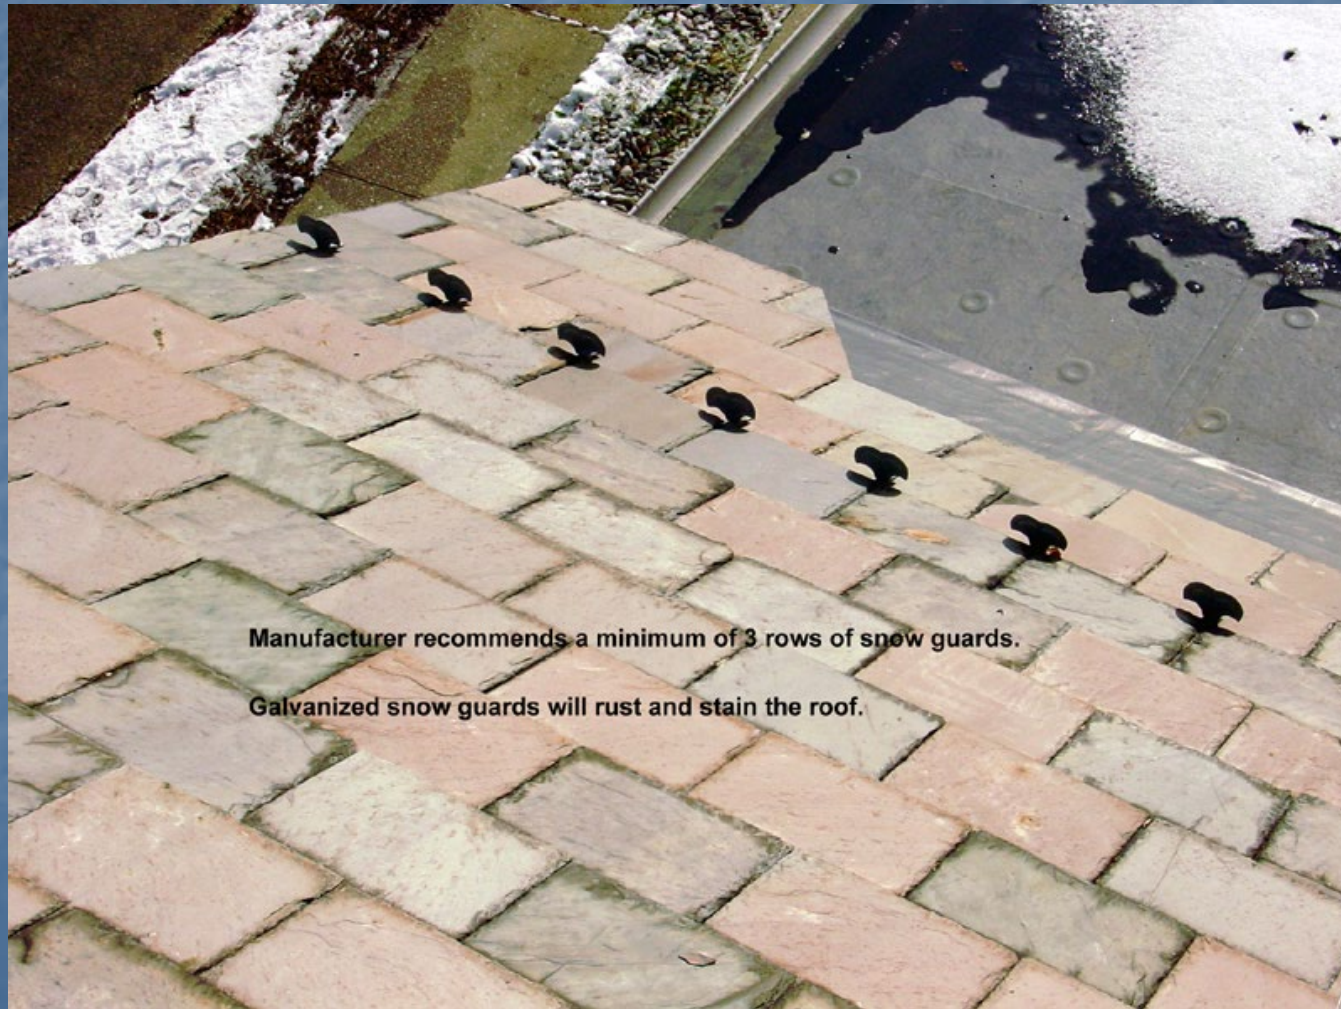
Snow guards must be installed in adequate numbers, otherwise they can fail and damage the roof. One row is not adequate.

Manufacturer recommends a minimum of 3 rows of snow guards.

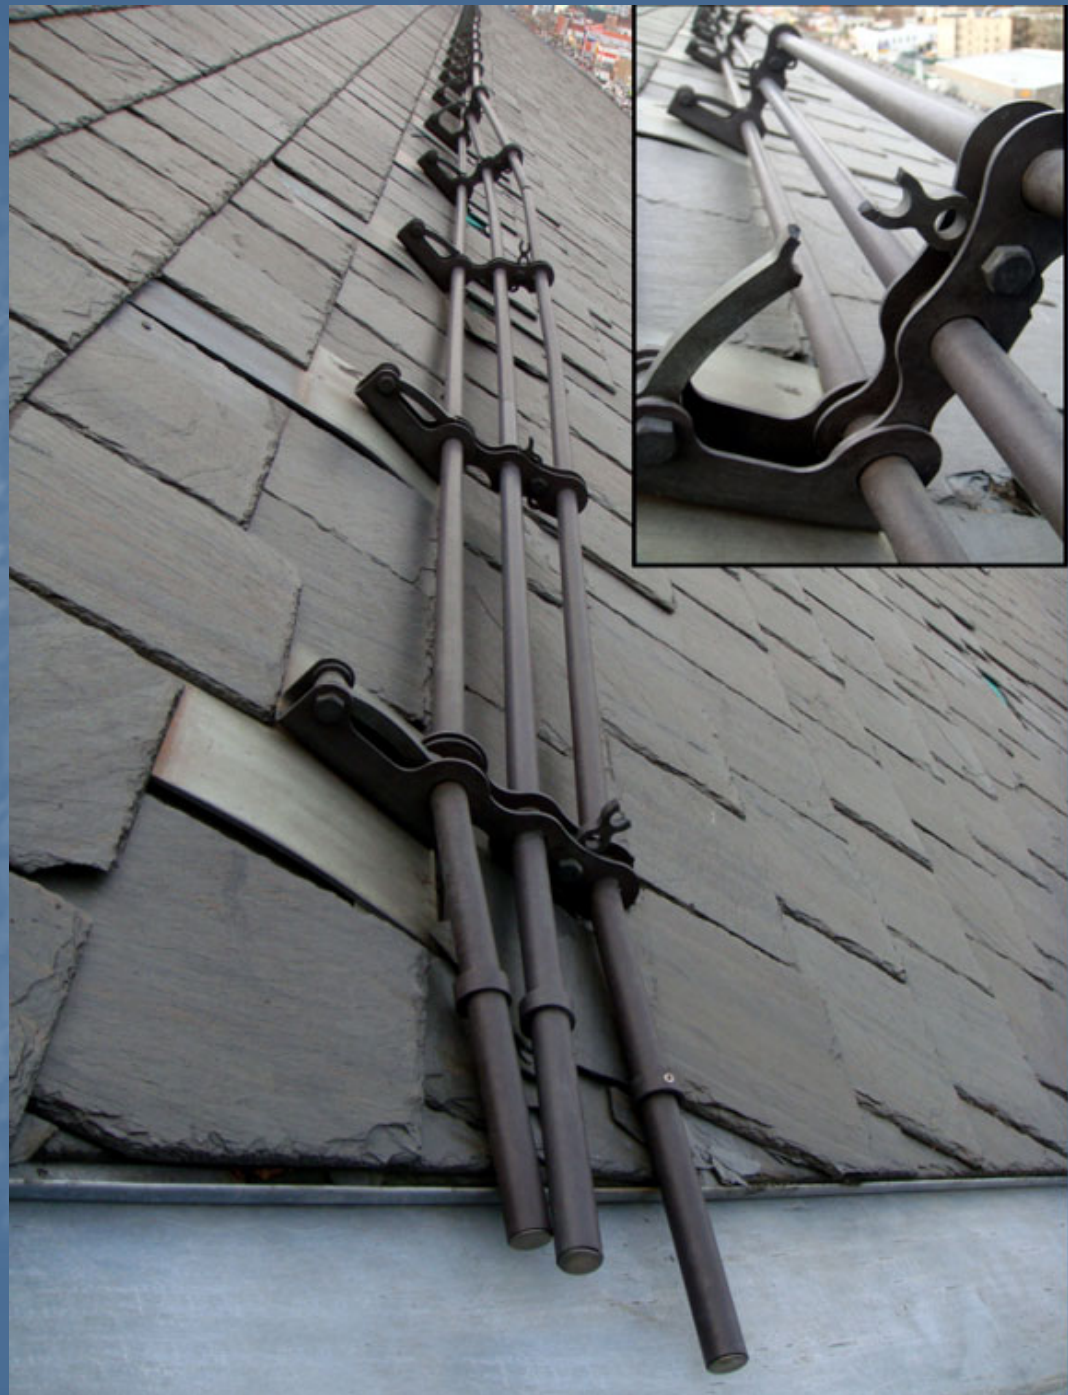
Galvanized snow guards will rust and stain the roof.

Even heavy snow rails will fail under extreme circumstances if not installed in adequate quantities.

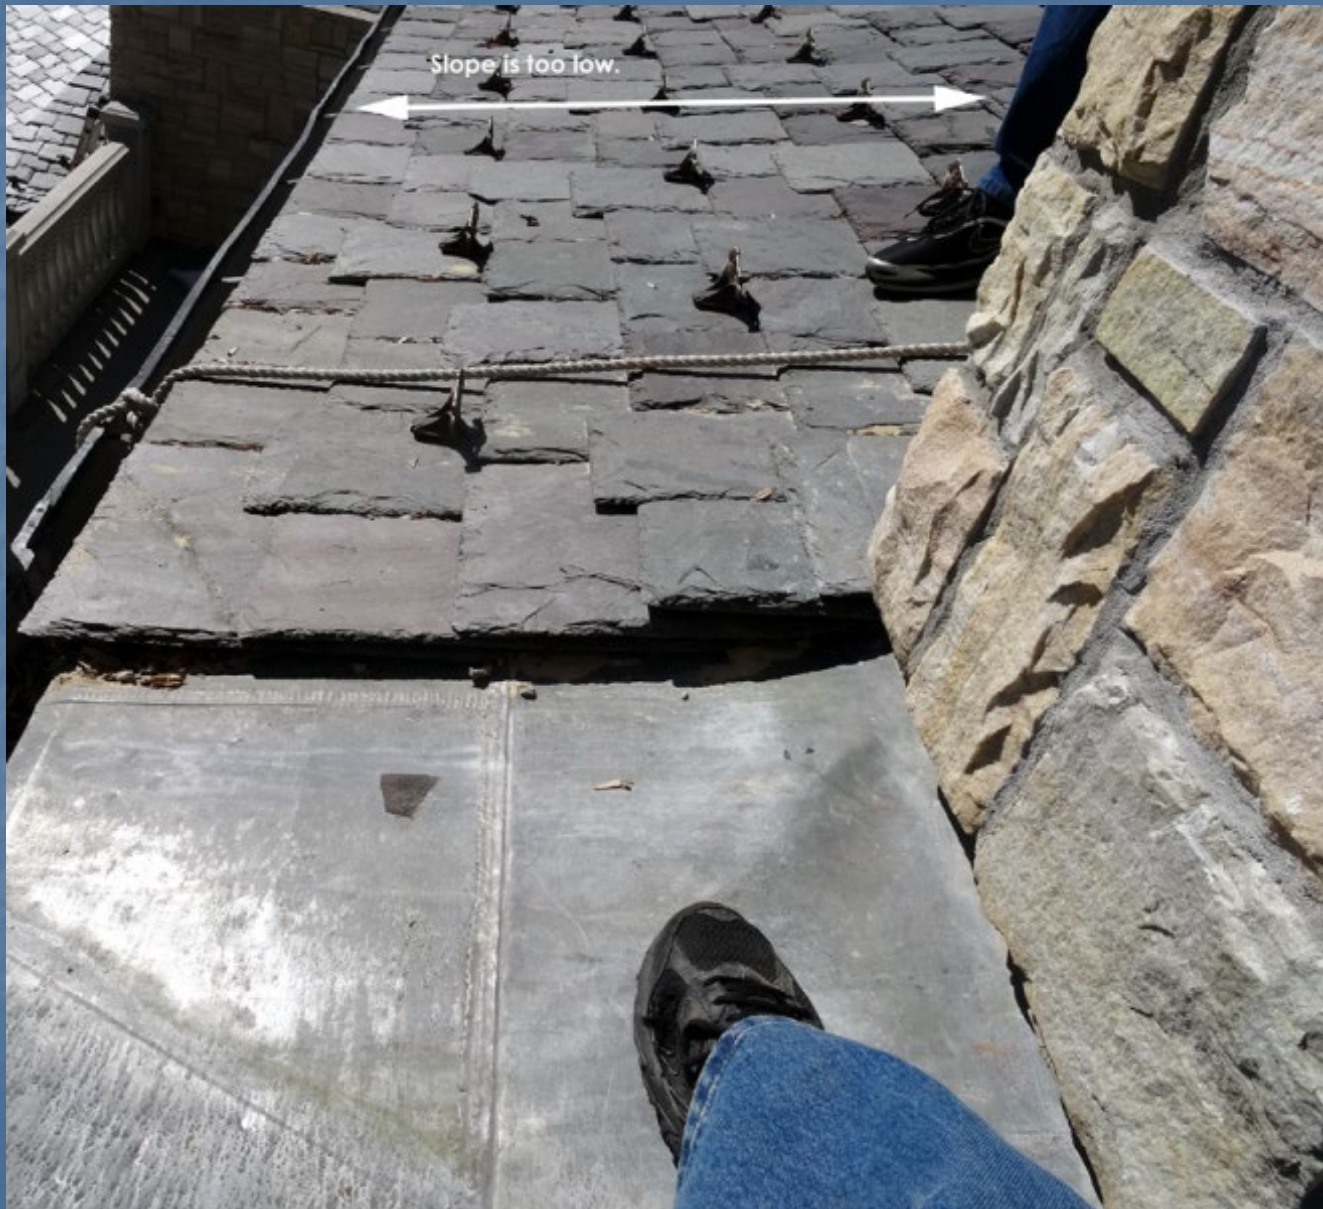
Don't install slate below a 4:12 slope!
